5th IASPEI / IAEE International Symposium: Effects of Surface Geology on Seismic Motion

# Soil Liquefaction Issues in Meinong Earthquake

August 15-17, 2016

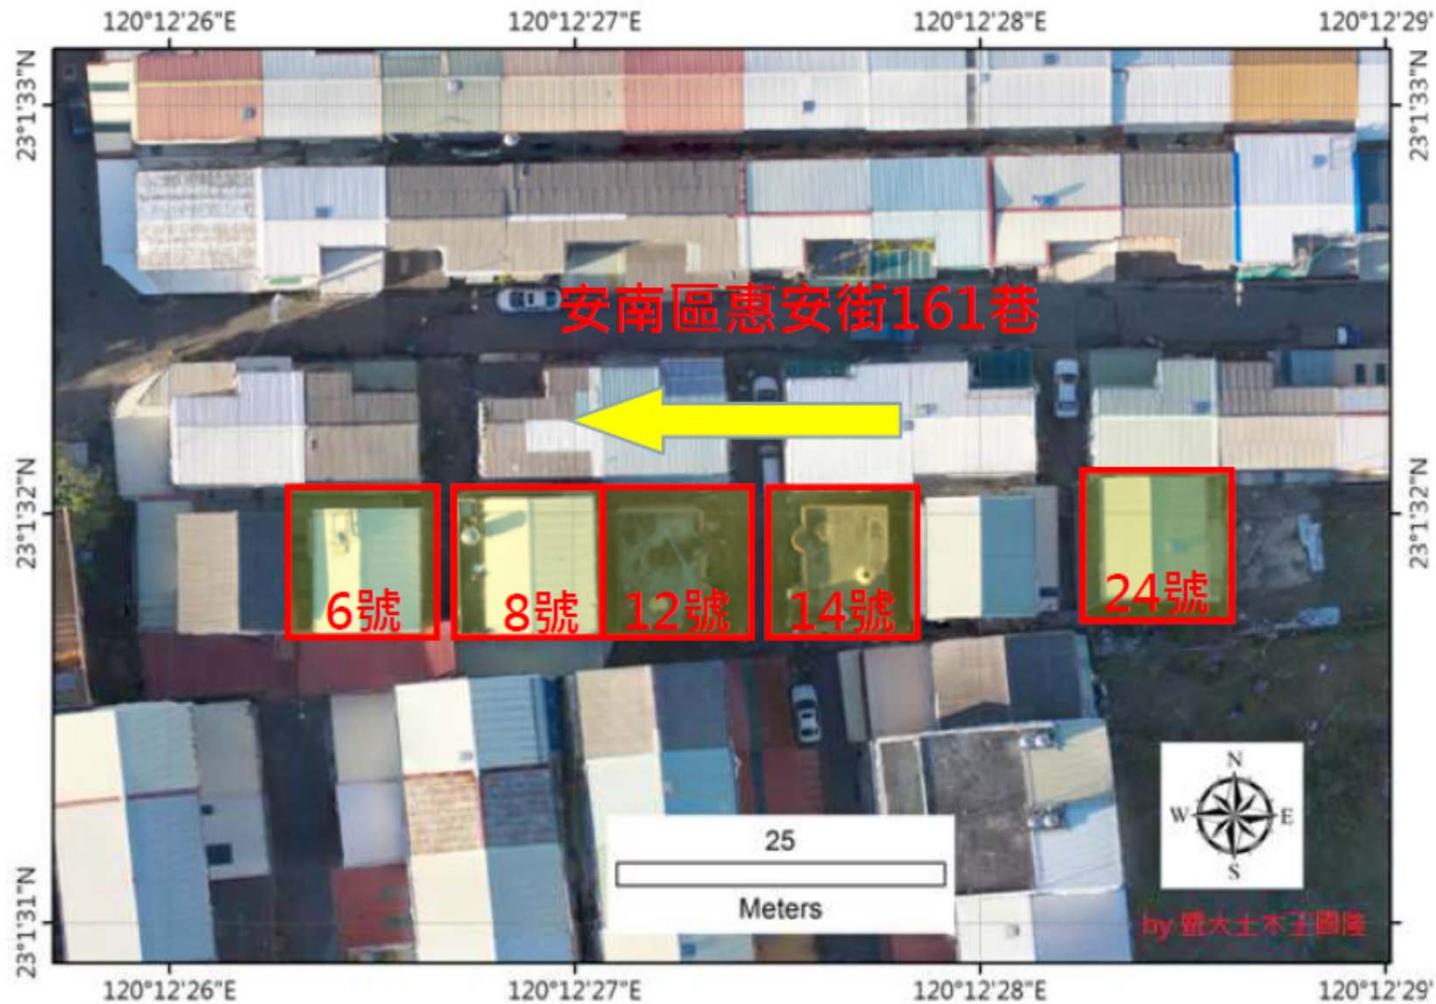
# GF3 Buildings at Lane 161, Huian Street

Location	Index	Description
Annan	GF1	The settlement of this area ranged from 10~20cm mainly occurred at and around the building. The differential settlement caused cracks between the building and road, meanwhile, the pipeline at the interface was destroyed.
Annan	GF2	
Annan	GF3	The building in this area seriously settled (40~90cm) and tilted (1~7 degrees). The road heaved much and had extensive sand boiling.
Sinshih	GF1	The settlement of building is minor due to soil liquefaction.
Sinshih	GF2	The maximum settlement of column was about 10cm. the maximum tilt of building is about 1 degree. Boiling sand deposited in the kitchen and ditch behind the building. The first floor slab heaved and cracked. The edge of road cracked and damaged the water pipeline.
Sinshih	GF3	The area was fishpond before. The three-story building here is a two span frame structure in long direction with a garage add-on in front of house. Due to soil liquefaction, the column seriously settled and caused the indoor first floor slab heaving and cracking much. The sand/mud boiling was obvious inside the house. Fire lanes heaved and sand deposited in the ditch. The road in front of building heaved and the pipeline was damaged. The sand boiling could be observed everywhere.

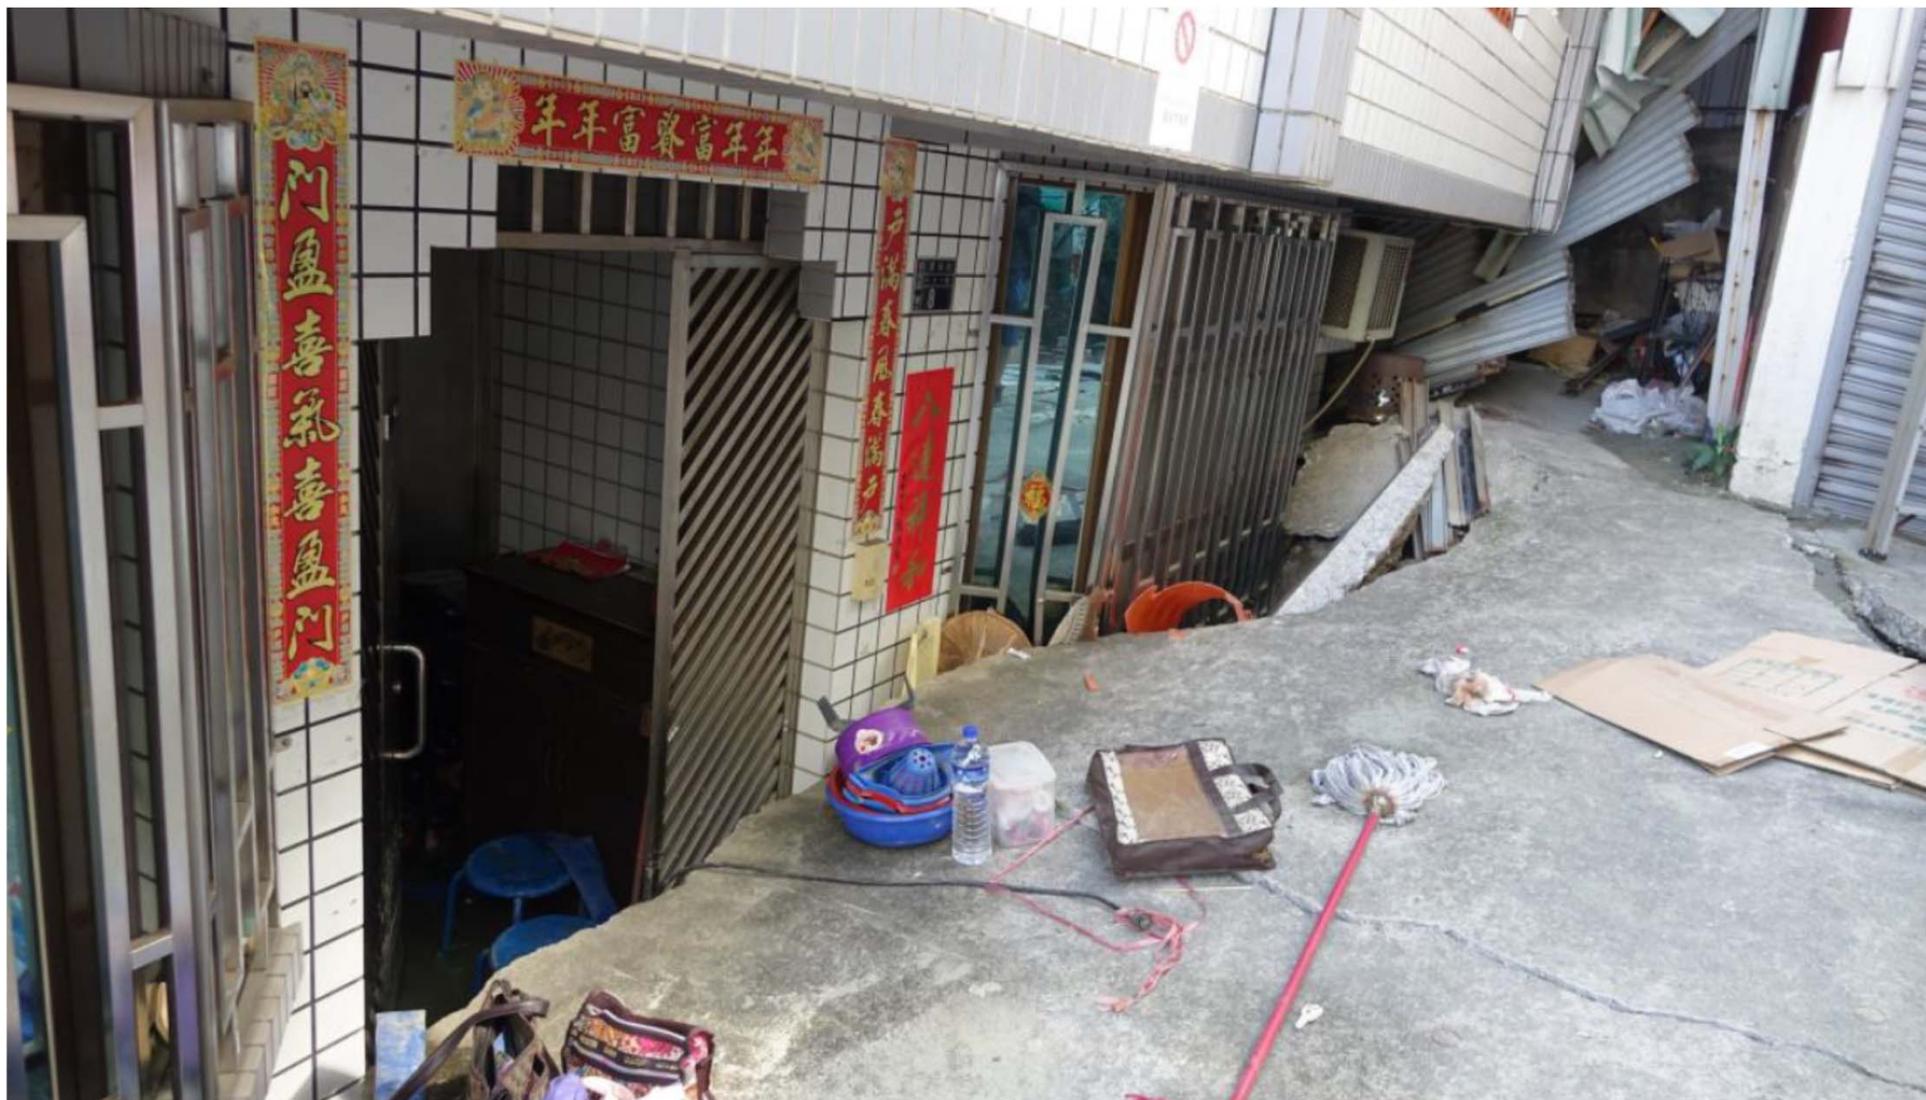
# Close view to No. 8 Building

Settlement: 90cm  
Tilt angle: 3 deg. Clockwise in EW  
4 deg. Clockwise in NS

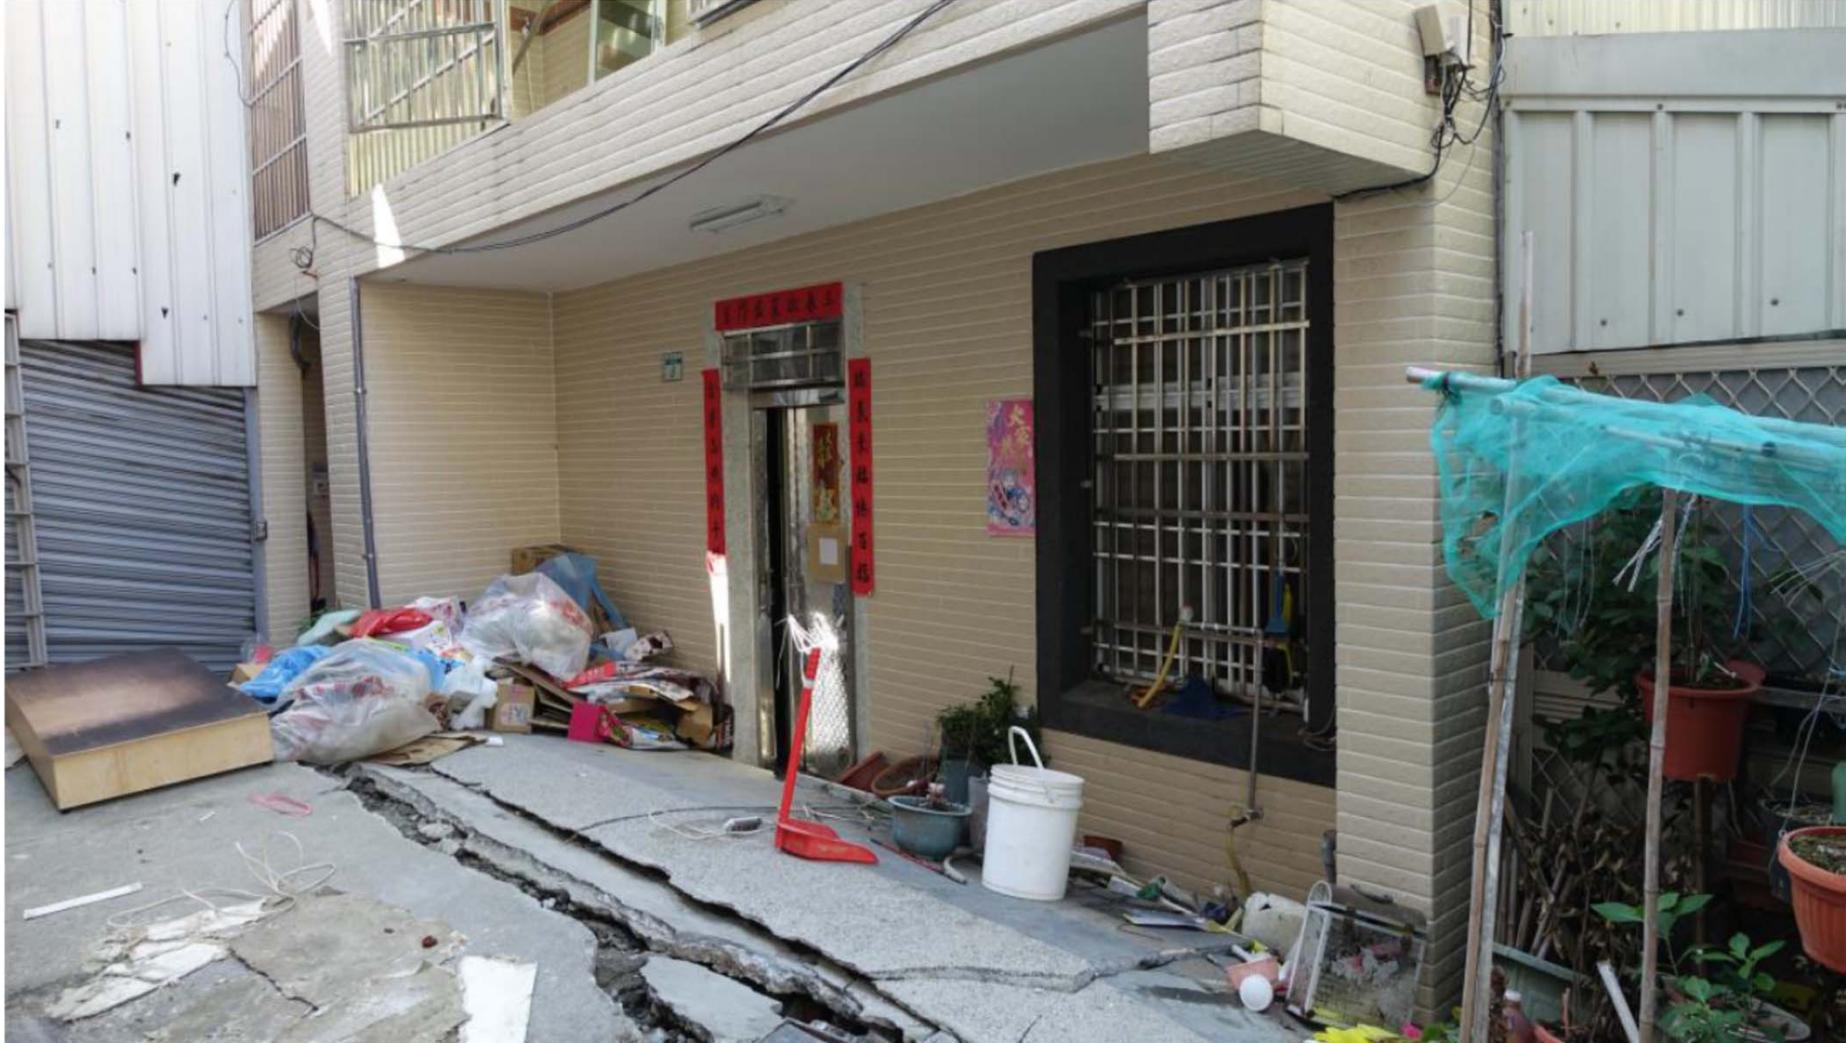
# Close view to No. 6 Building

Settlement: 60cm  
Tilt angle: 2 deg. Clockwise in EW  
2 deg. Clockwise in NS

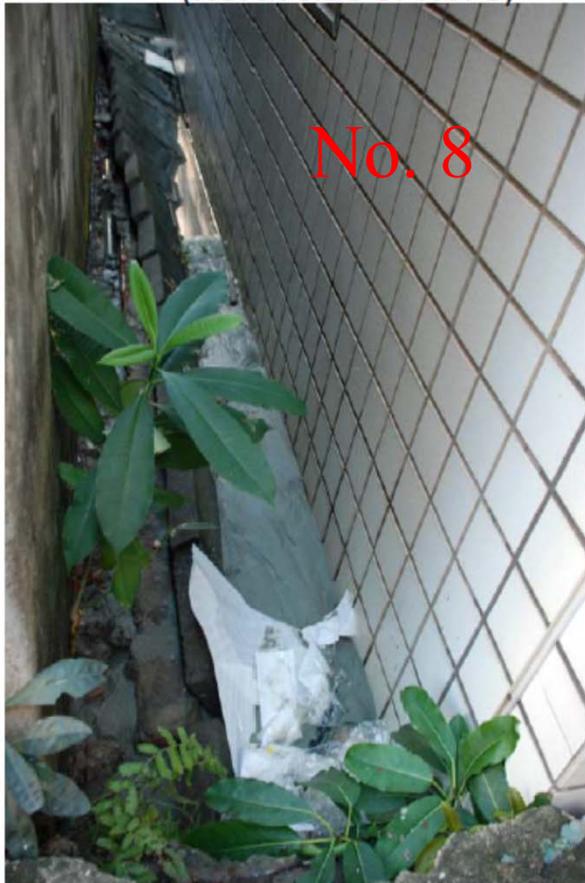
Ejecta and foundation settlement  
(North side of No. 8)

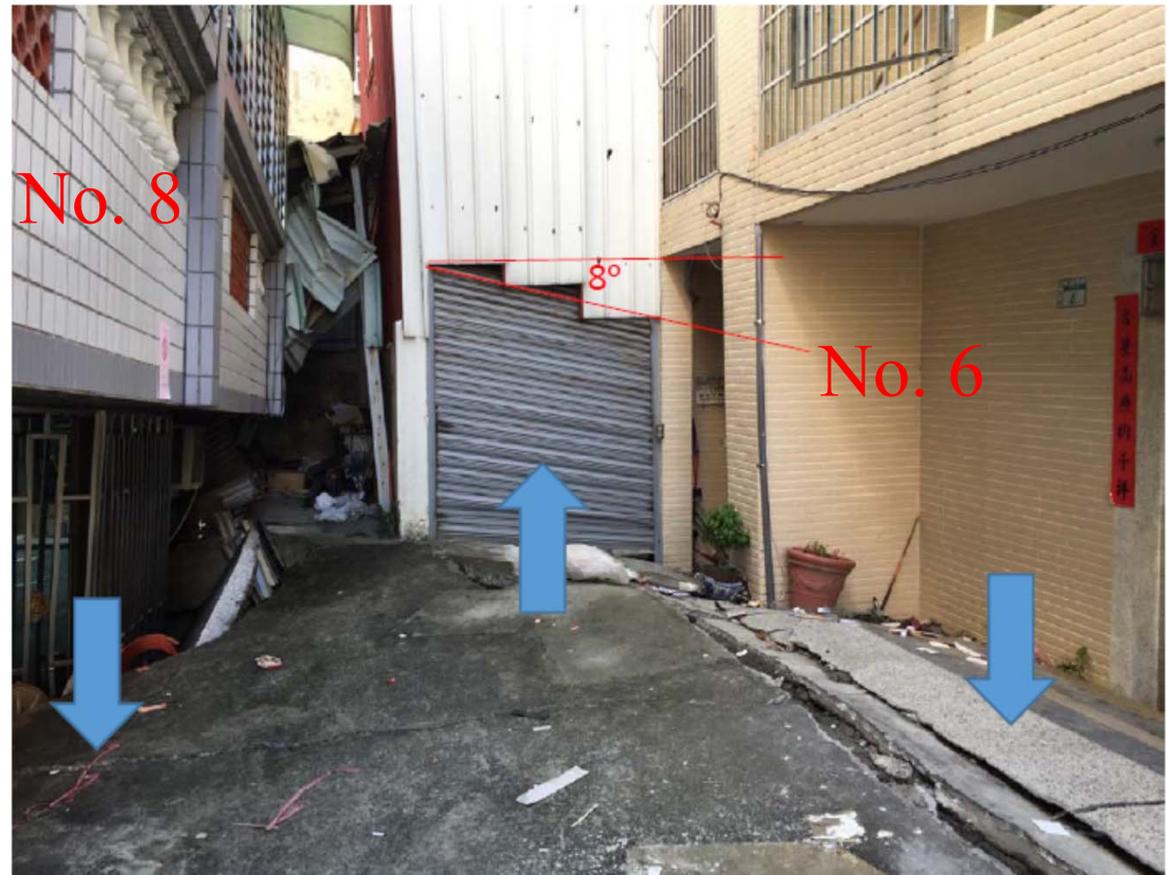
Heave at the center of road and subsidence near the building

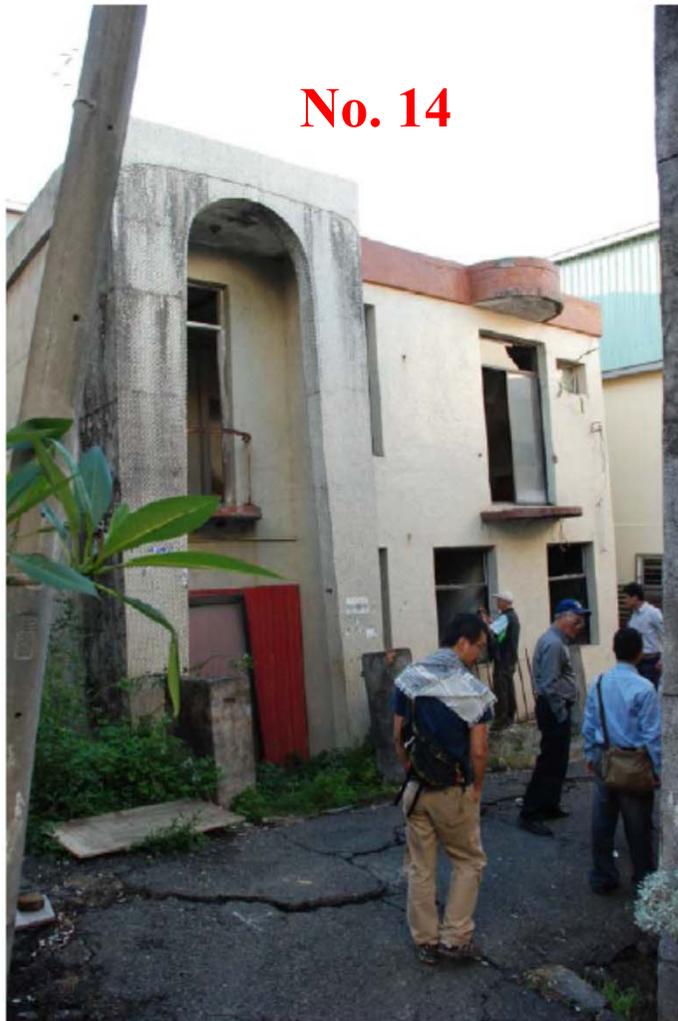
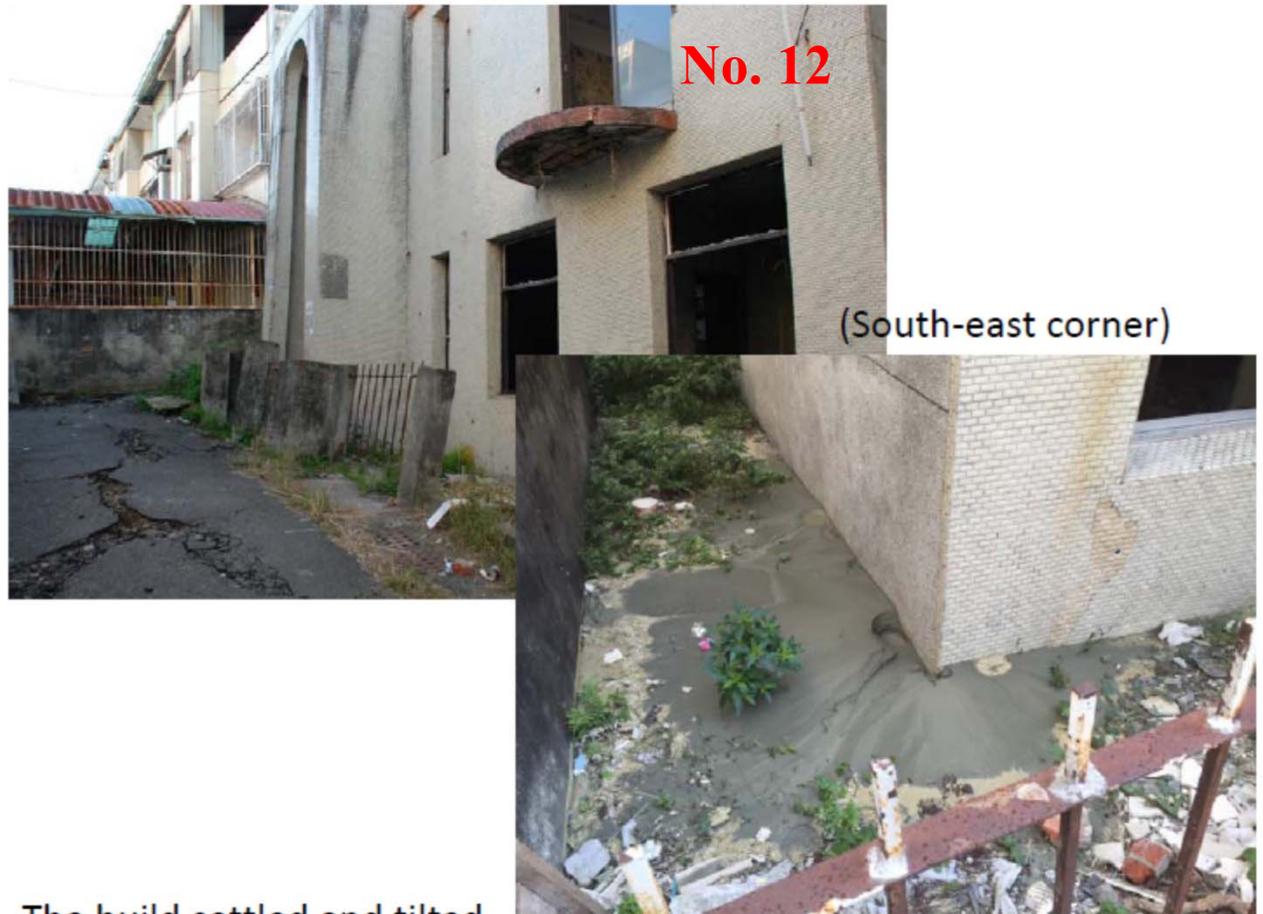
# No.12 and No.14, Lane 161, Huian Street

- The build settled and tilted
- Ejected sediment filled the first floor

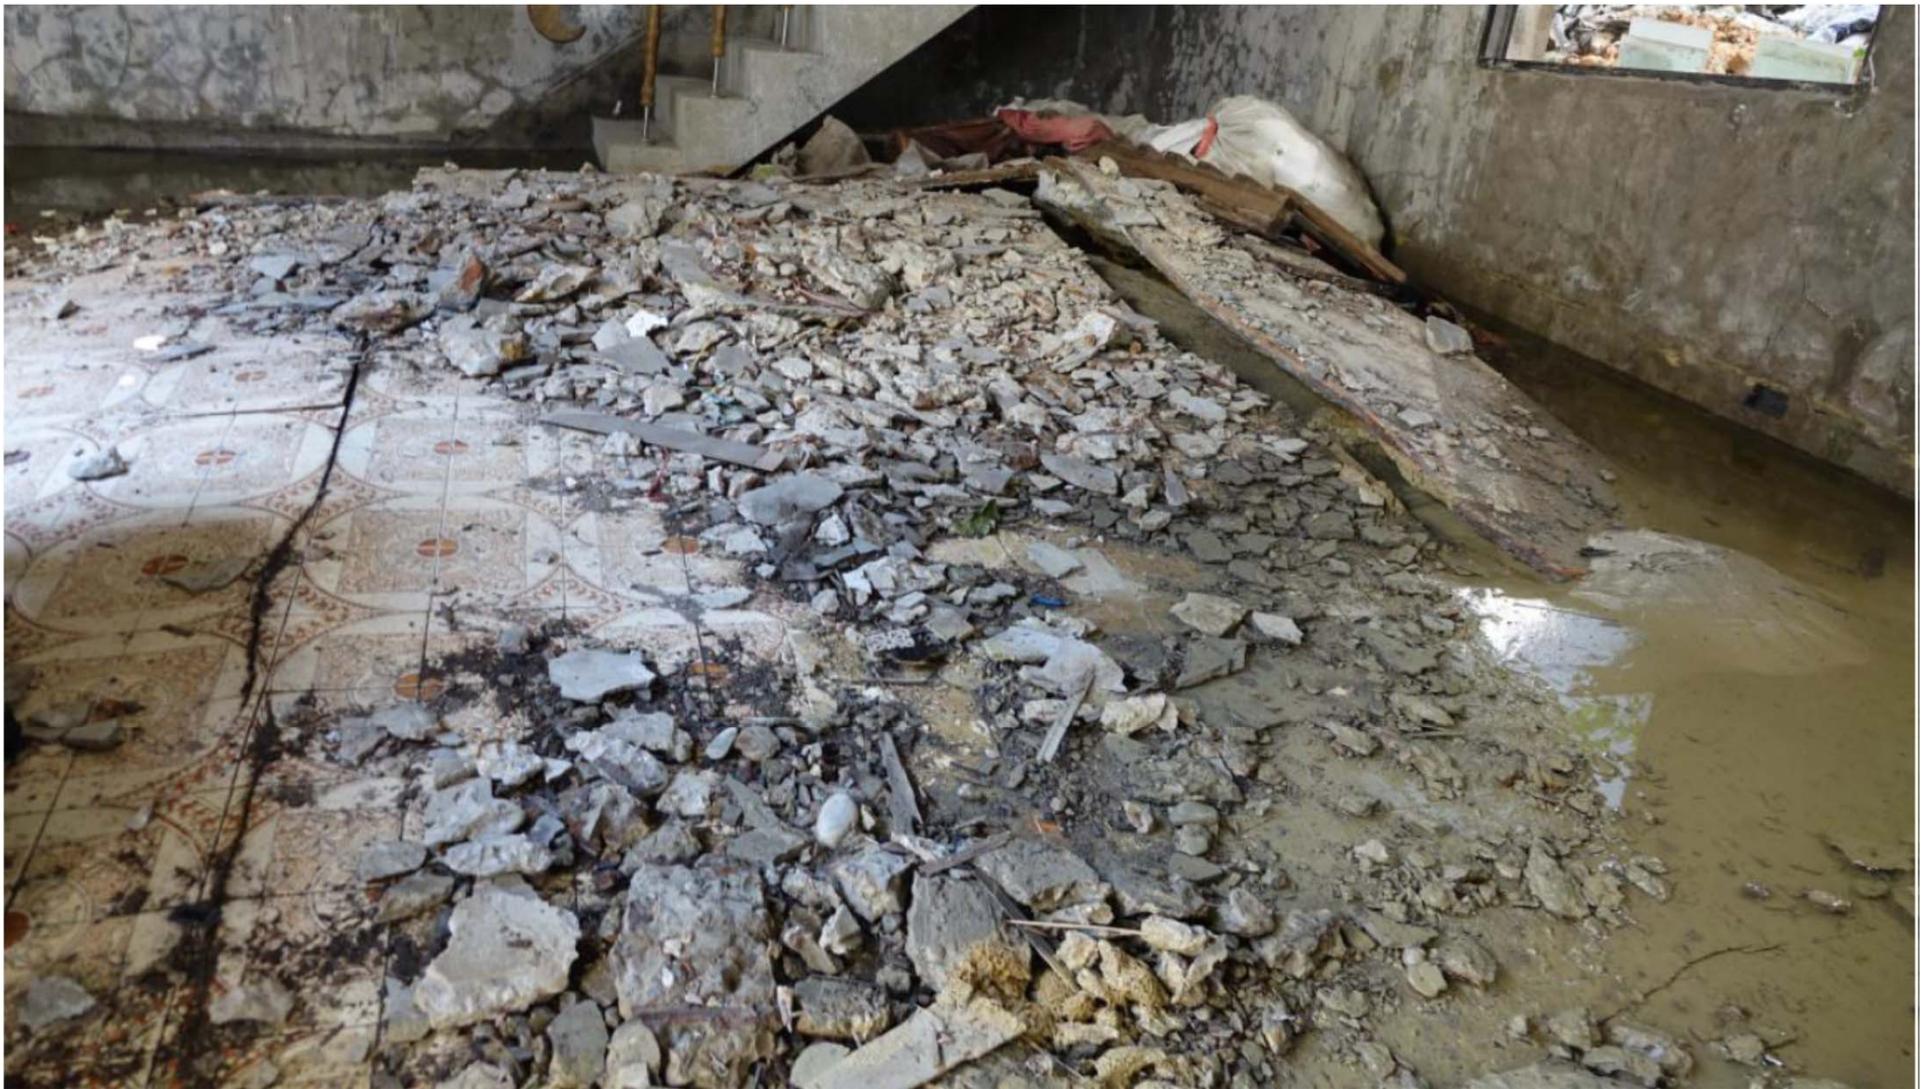
## Heave of Ground Floor in No.12

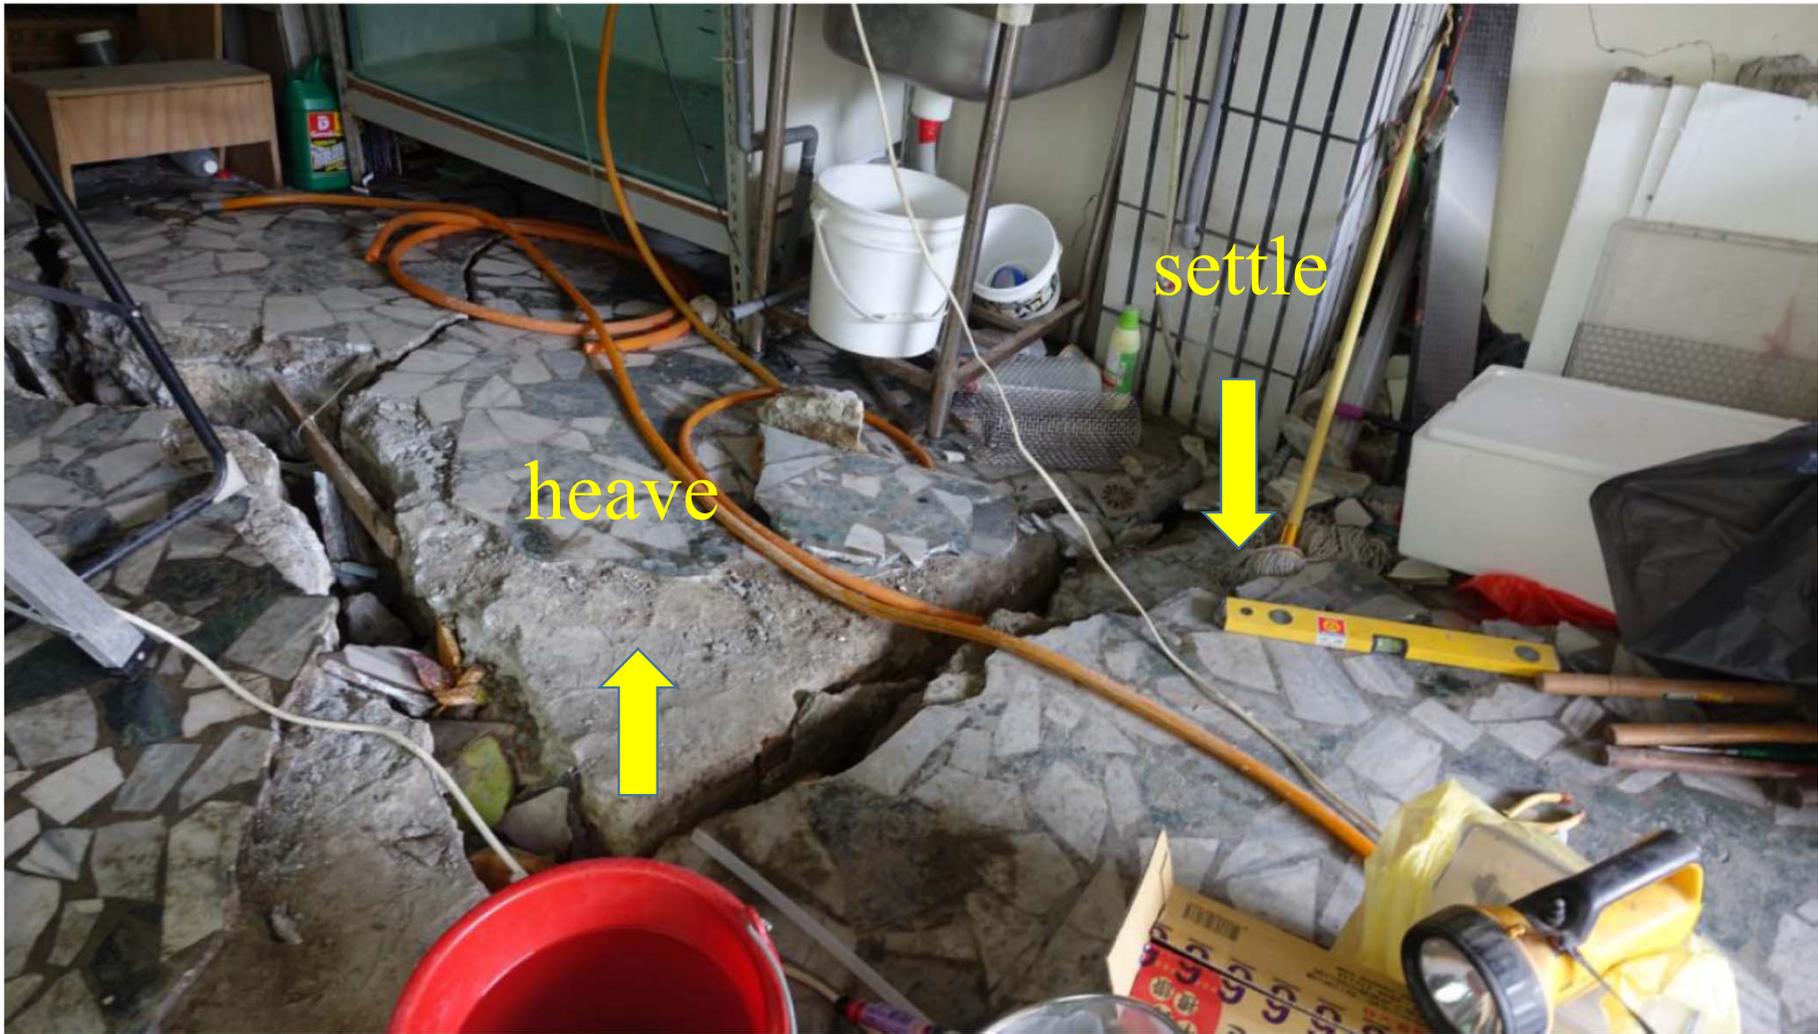
# Settlement of Column No.7, Alley 10, Lane 50, Sanmin St.

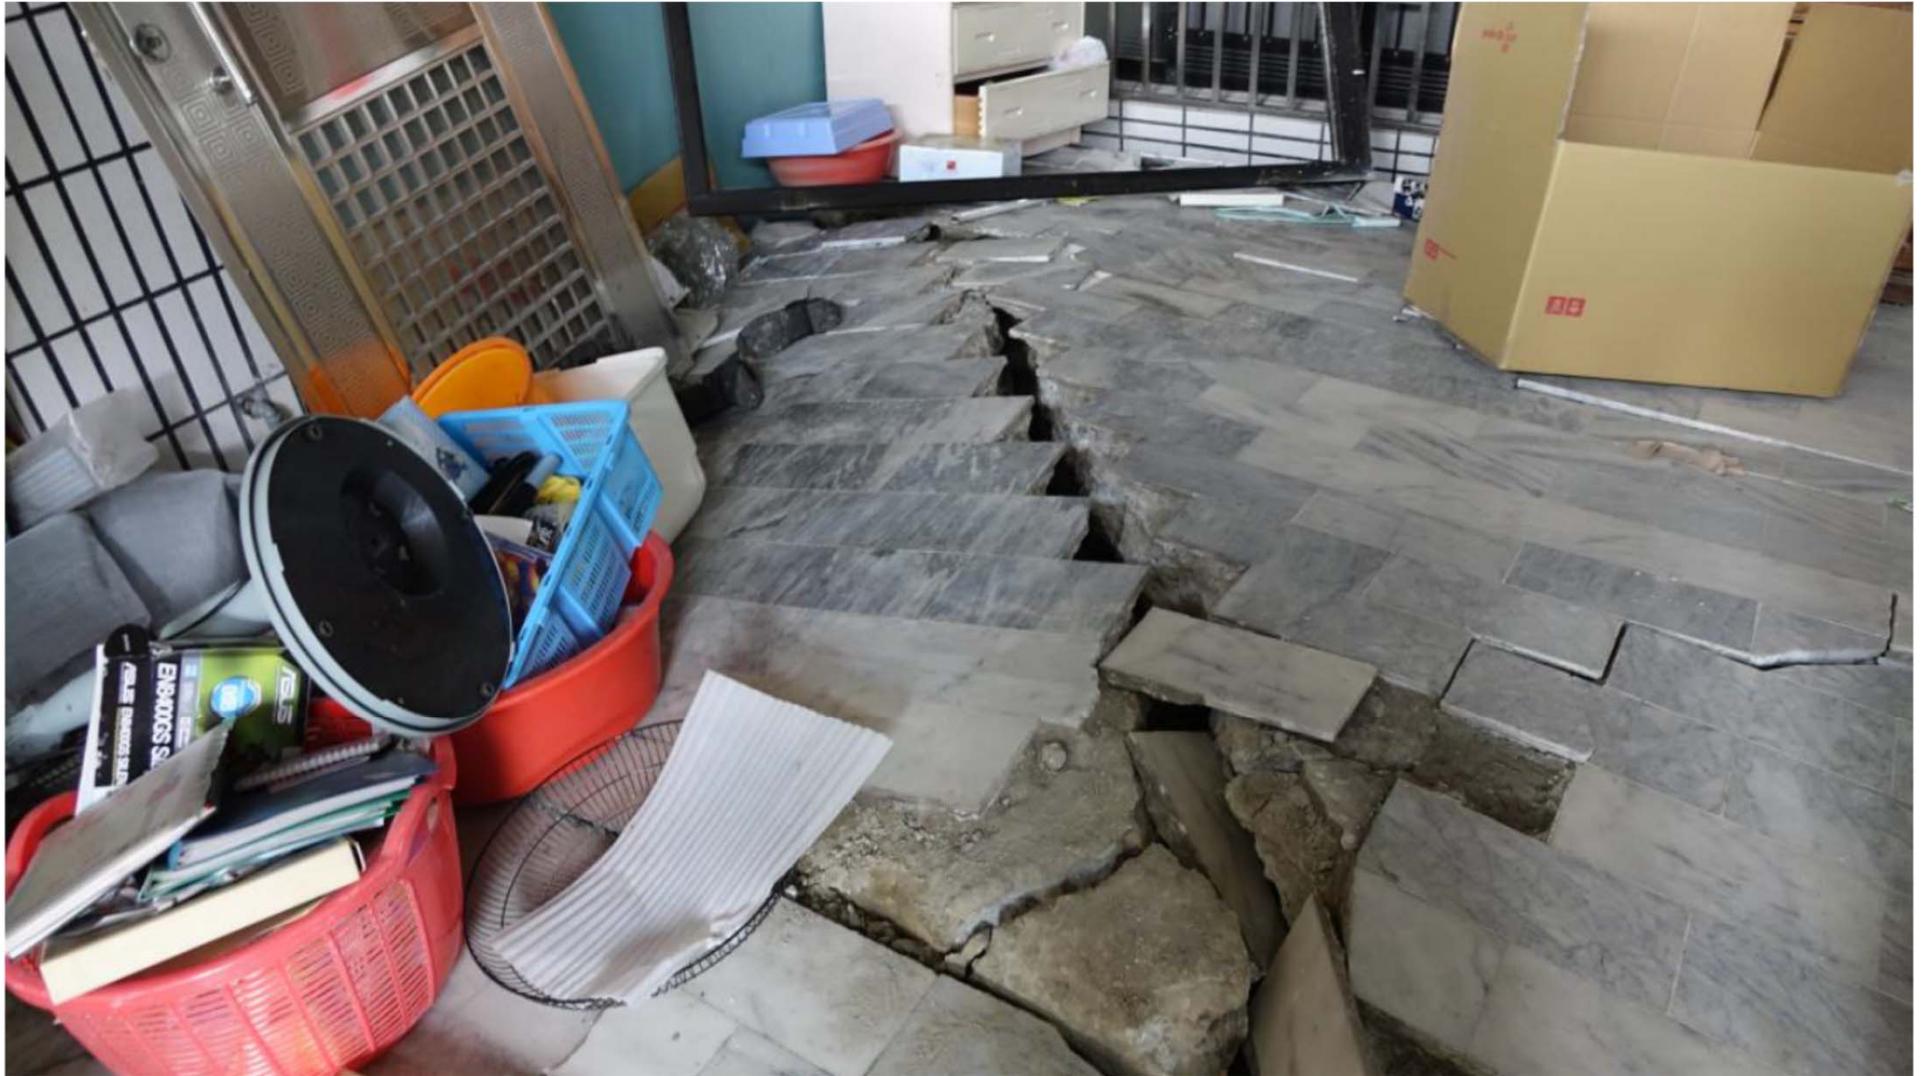
# Heave of Garage Floor of No.5 Building

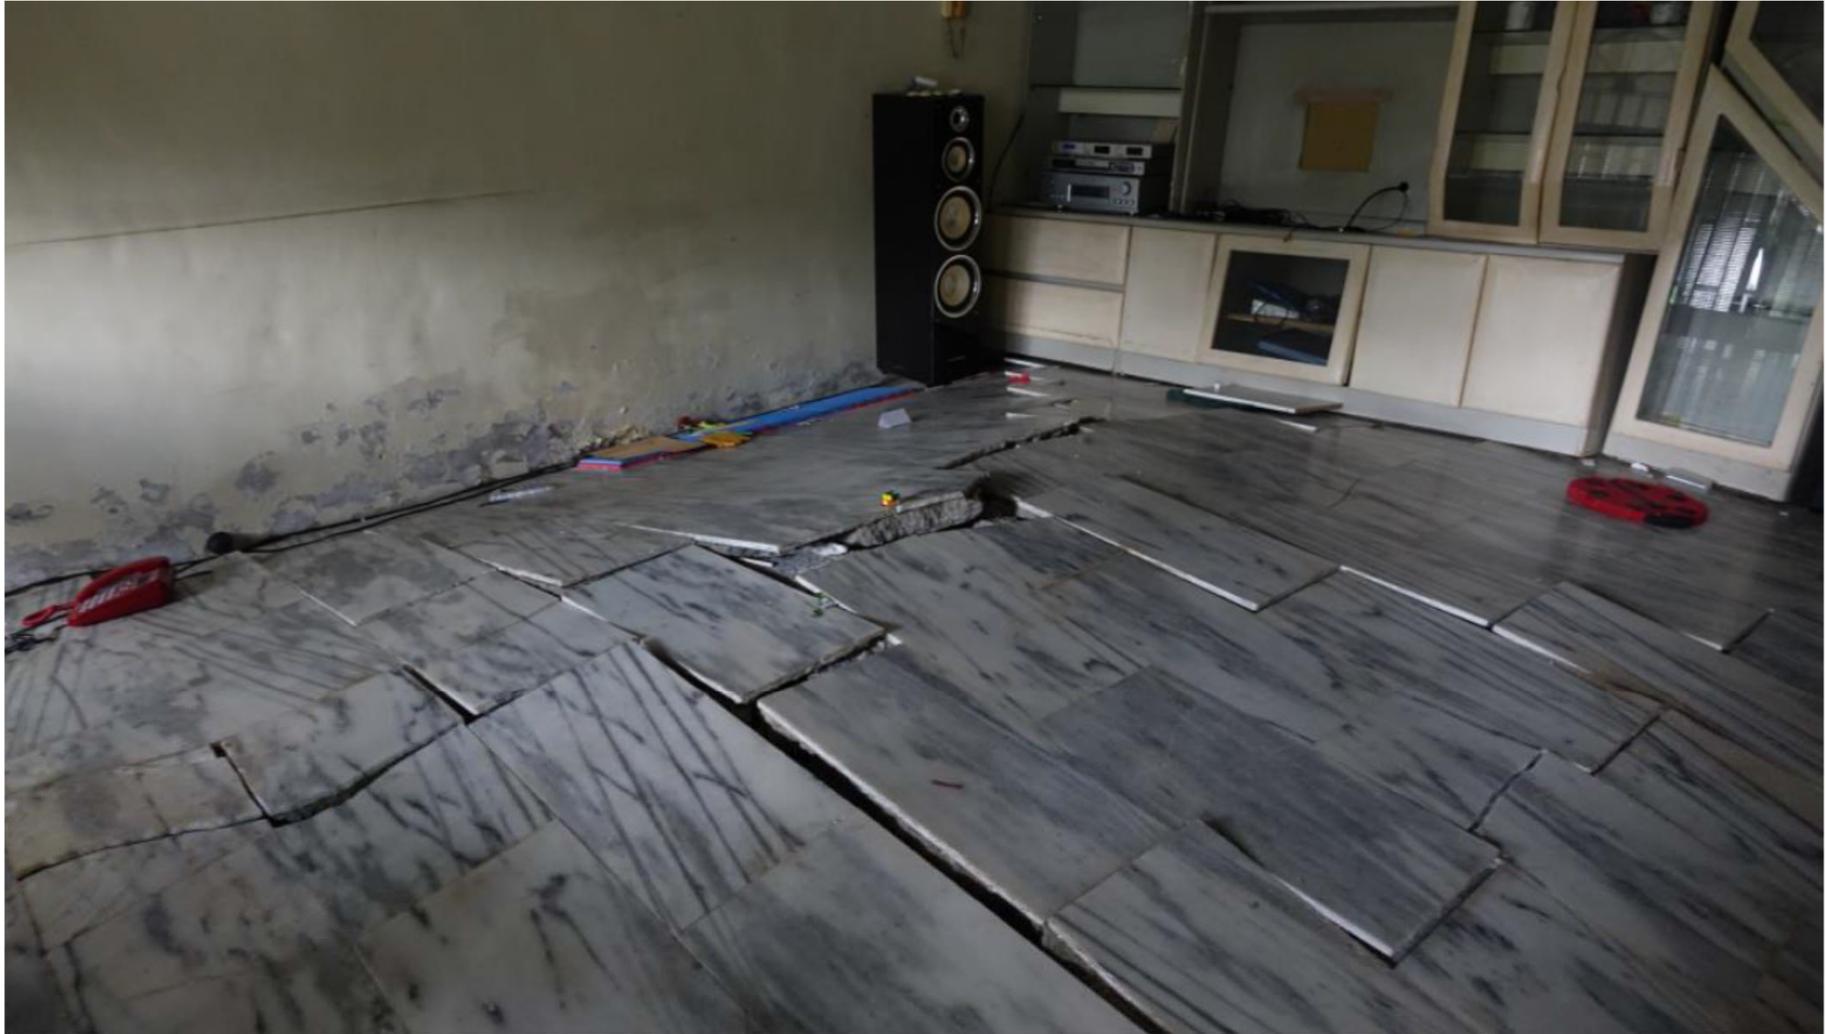
# Heave of 1st Floor of No.5 Building

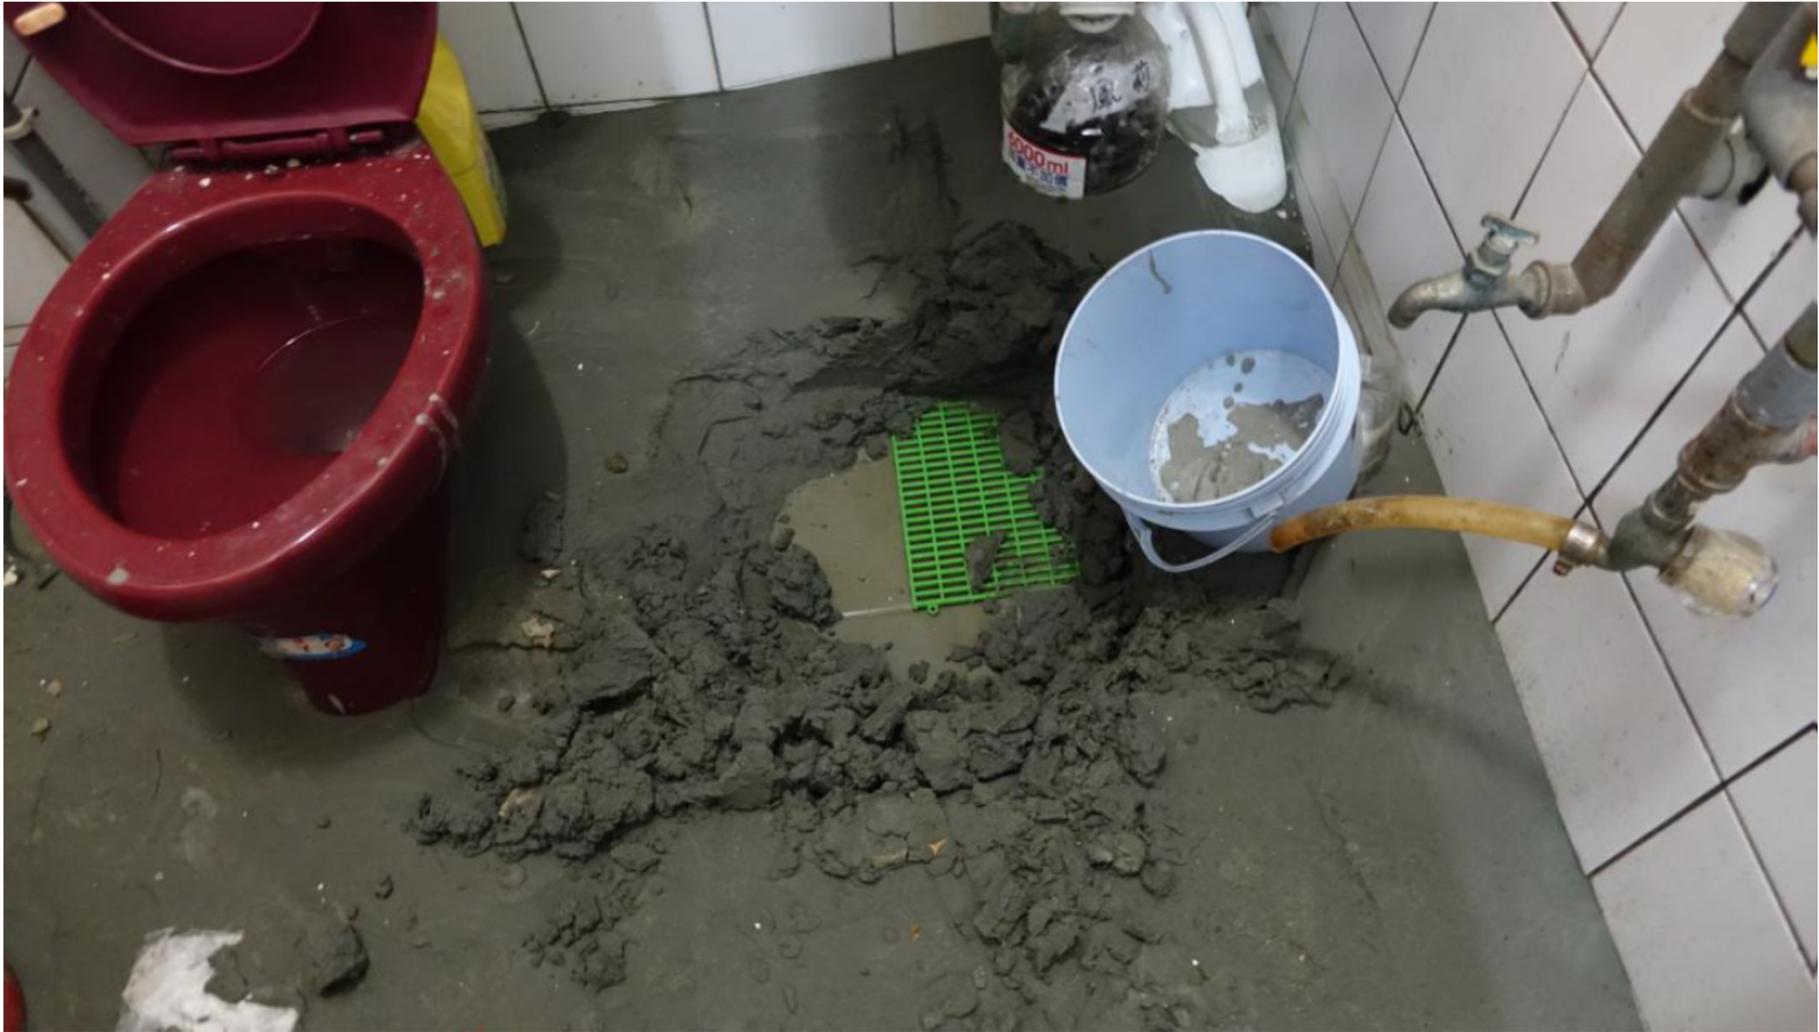
Deposited Sand in the Bath Room  
of No.5, Alley 10, Lane 50, Sanmin St.

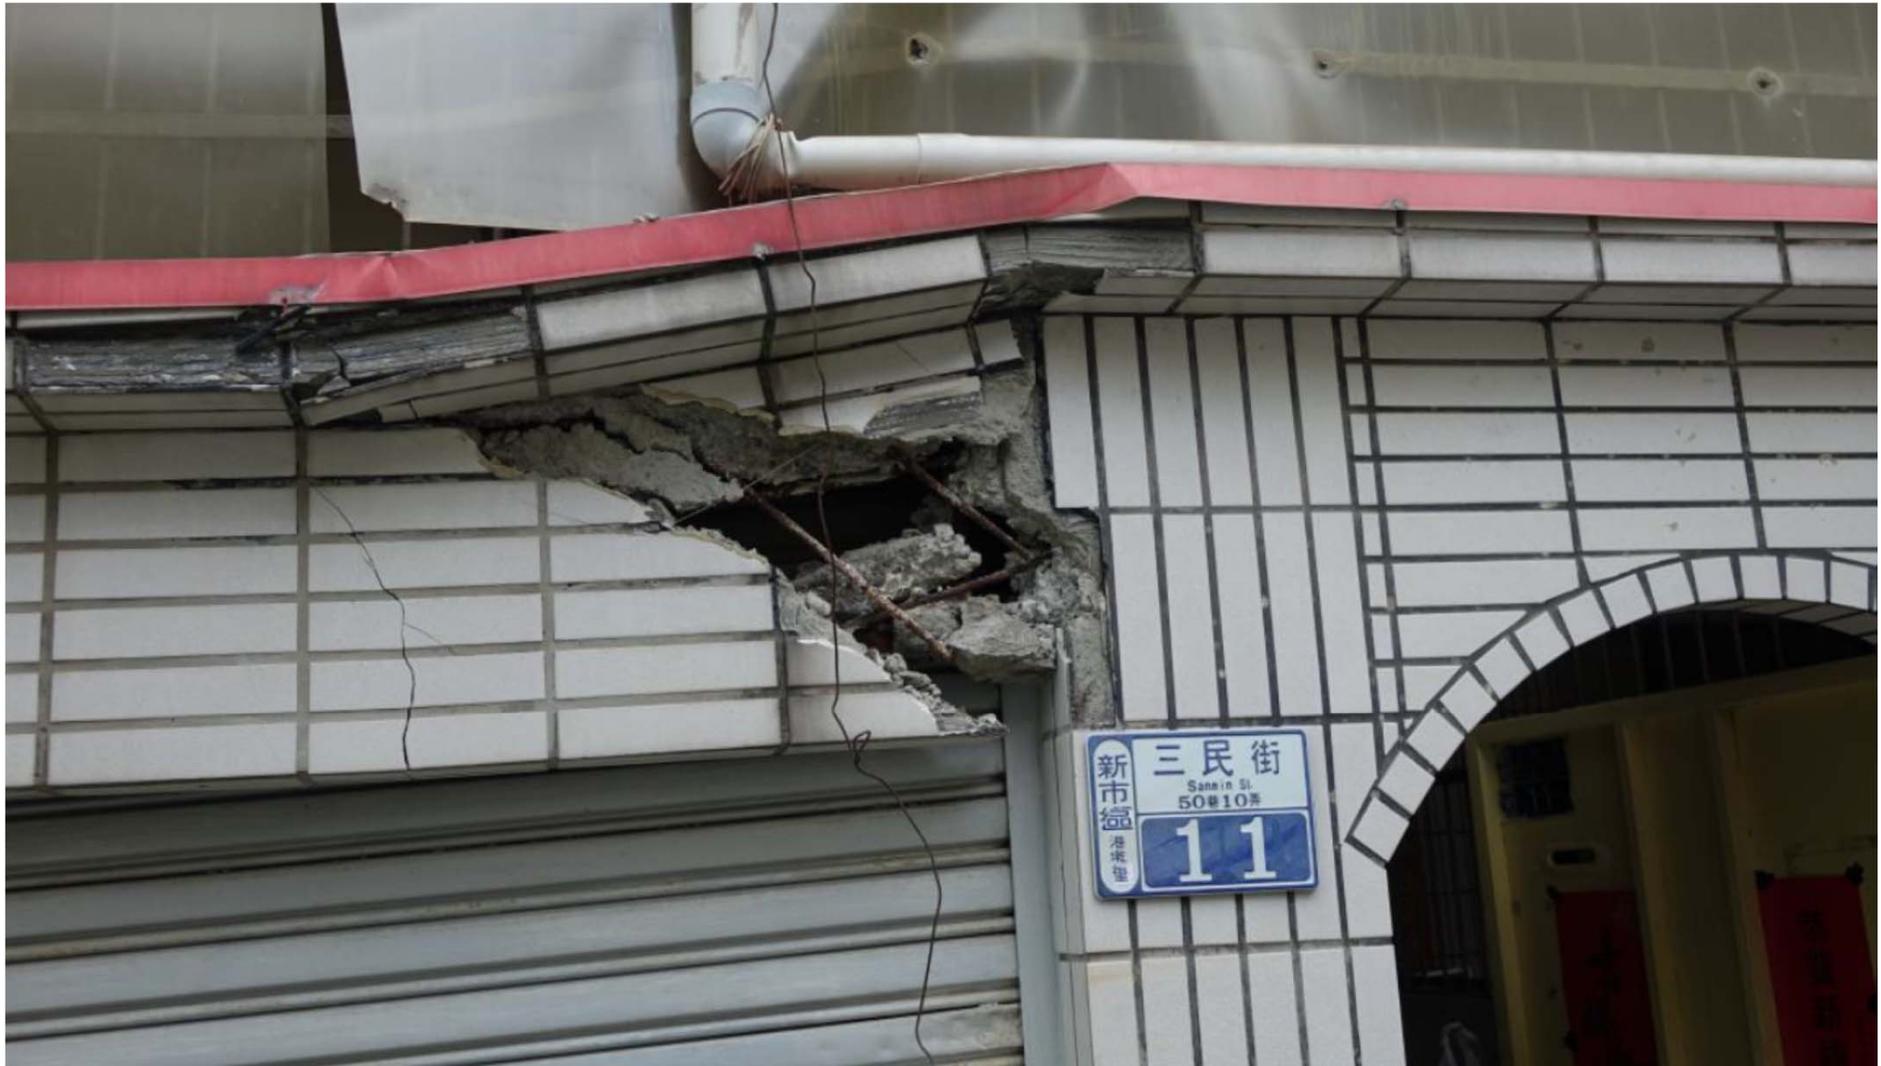
# Crack of Beam due to Differential Settlement

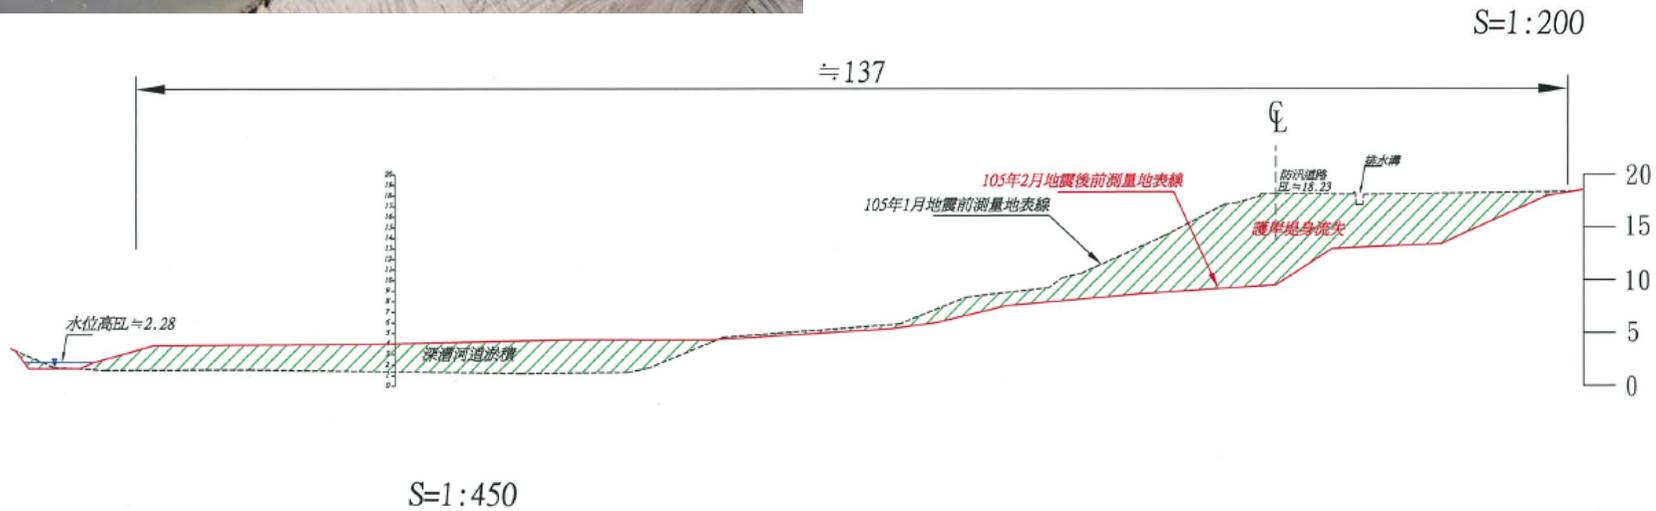
# Slide at A Site

- Flow slides caused by soil liquefaction?
- The soil formations of the three sites are mainly ML and CL soil layers
- whether the cohesive soils have the possibility to cause large-scale flow slides or not?
- The seepage of ground water at the scarps of the slides are clearly observed after earthquake
- The underlying soils below the concrete slab for protecting the slope of revetment may be eroded away
- The concrete slab may be thrown far away due to strong seismic motion
