5th IASPEI / IAEE International Symposium: Effects of Surface Geology on Seismic Motion

# Soil Liquefaction Issues in Meinong Earthquake

August 15-17, 2016

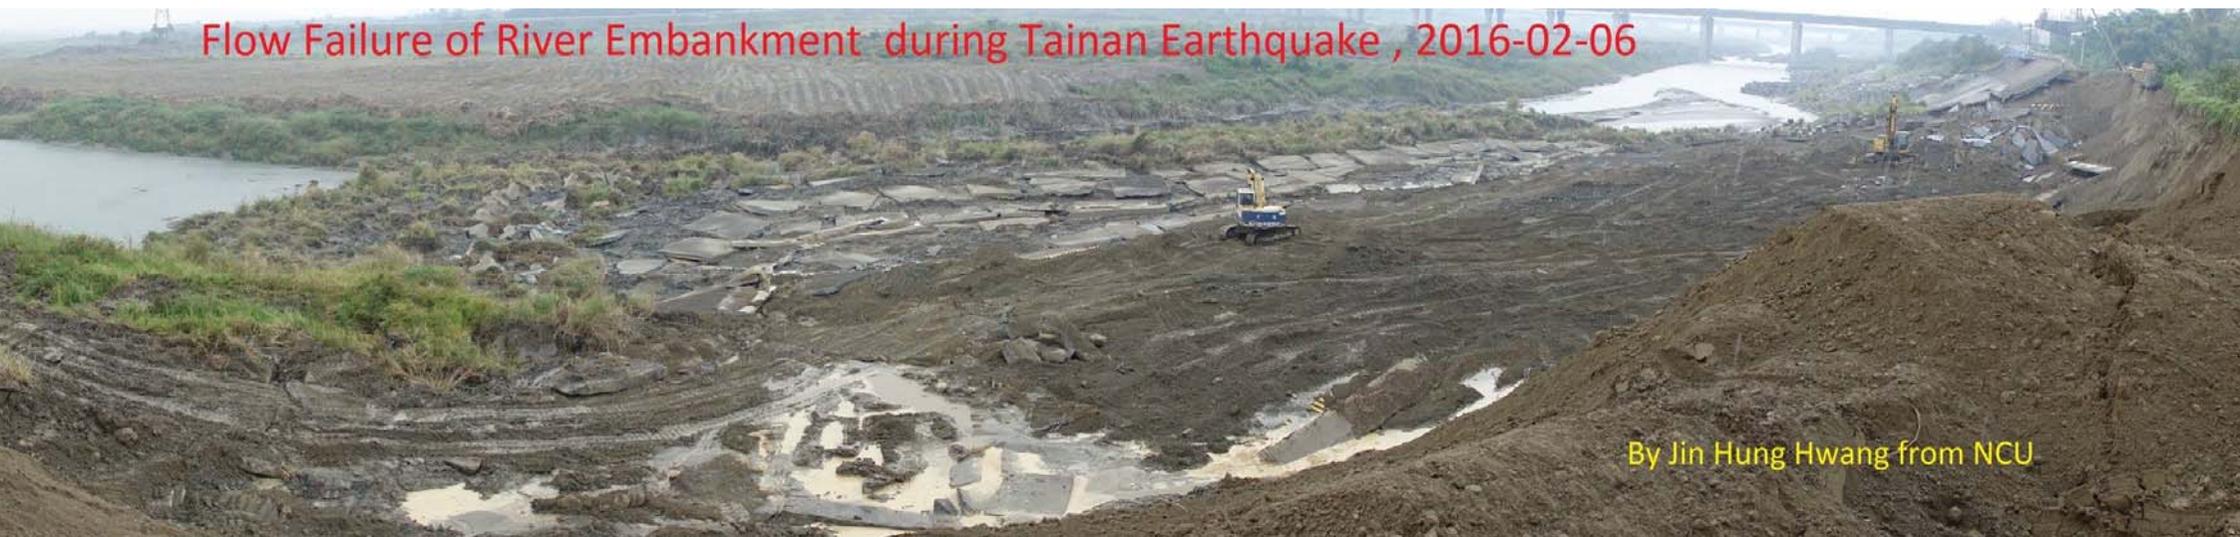
# Panoramic View of the Slide at Site B

Flow Failure of River Embankment during Tainan Earthquake , 2016-02-06

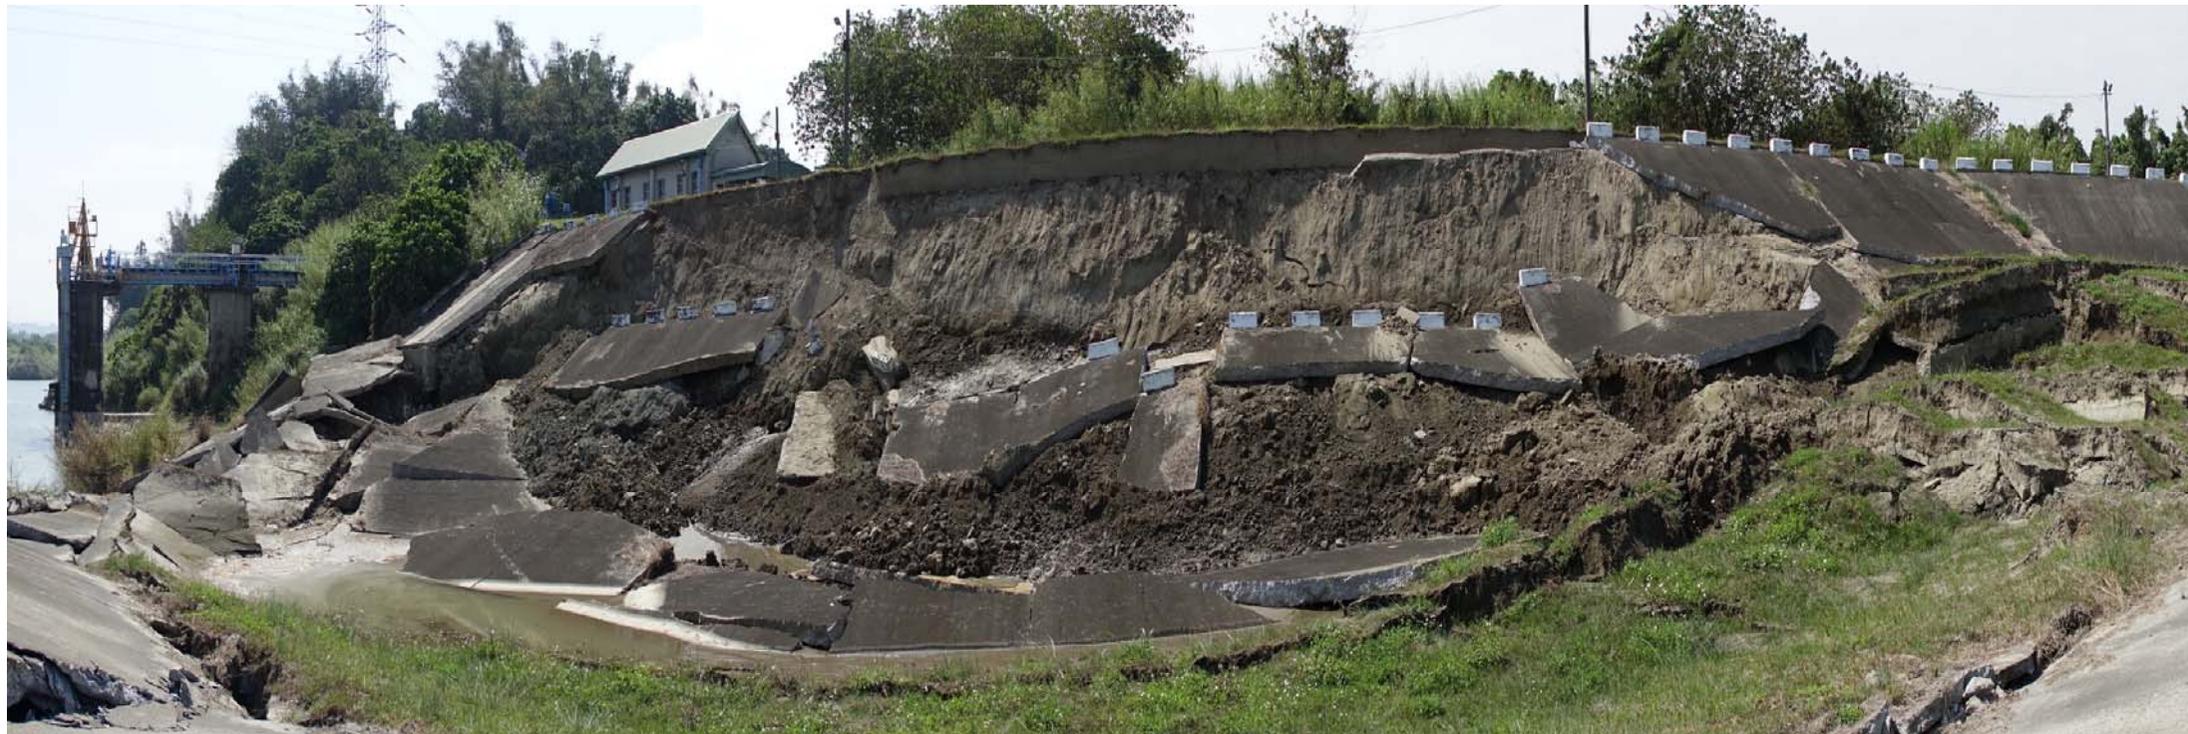
# Panoramic View of the Revetment Slide at Yufeng Weir

- The seepage of ground water was clearly observed at the scarp.
- It was guessed the underlying sandy soils below the concrete slab was eroded away and deposited at the toe of the revetment.
- The saturated sandy soils at the toe of revetment liquefied during the earthquake and caused the slide of the lower slope and then induced the slide of the upper slope.
- this slide is intuitively considered as the flow slide caused by soil liquefaction. However, future study is necessary to confirm this slide was really triggered by soil liquefaction.
