Verification of seismic assessment and retrofit using building data from the 2016 Meinong Earthquake

Tsung-Chih Chiou
Associate Researcher, NCREE

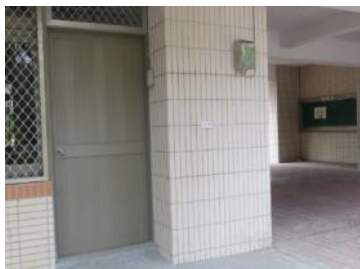
No structural damage

Retrofitted by RC wing wall in 2011

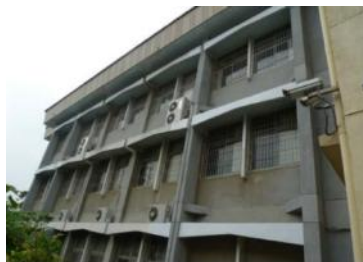
Retrofitted by RC wing wall in 2011

No structural damage

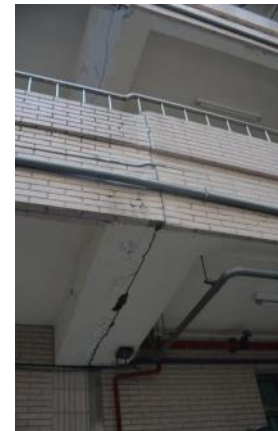
Expansion joints

Retrofitted by RC jacketing column in 2014

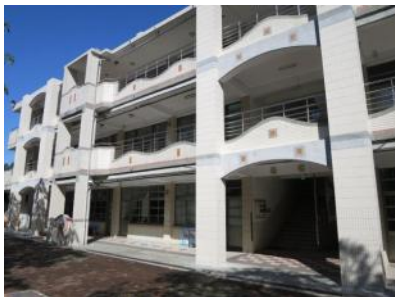
No structural damage

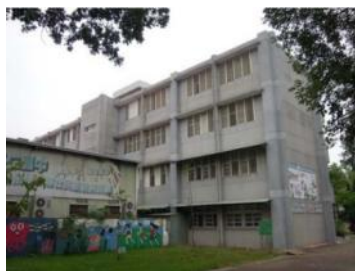
Retrofitted by RC jacketing column and wing wall in 2011

No structural damage

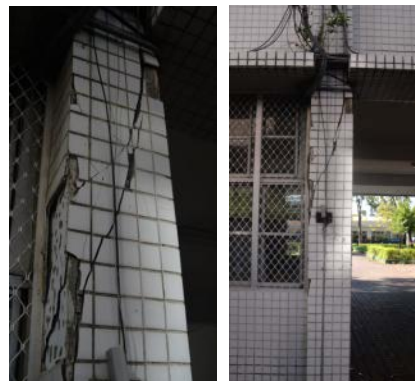
Nanhua District Office

CDR=0.706
Stand by funding

In the first floor, there was one column with shear failure, others were with minor cracks.

Classified as **dangerous building**
Entrance forbidden

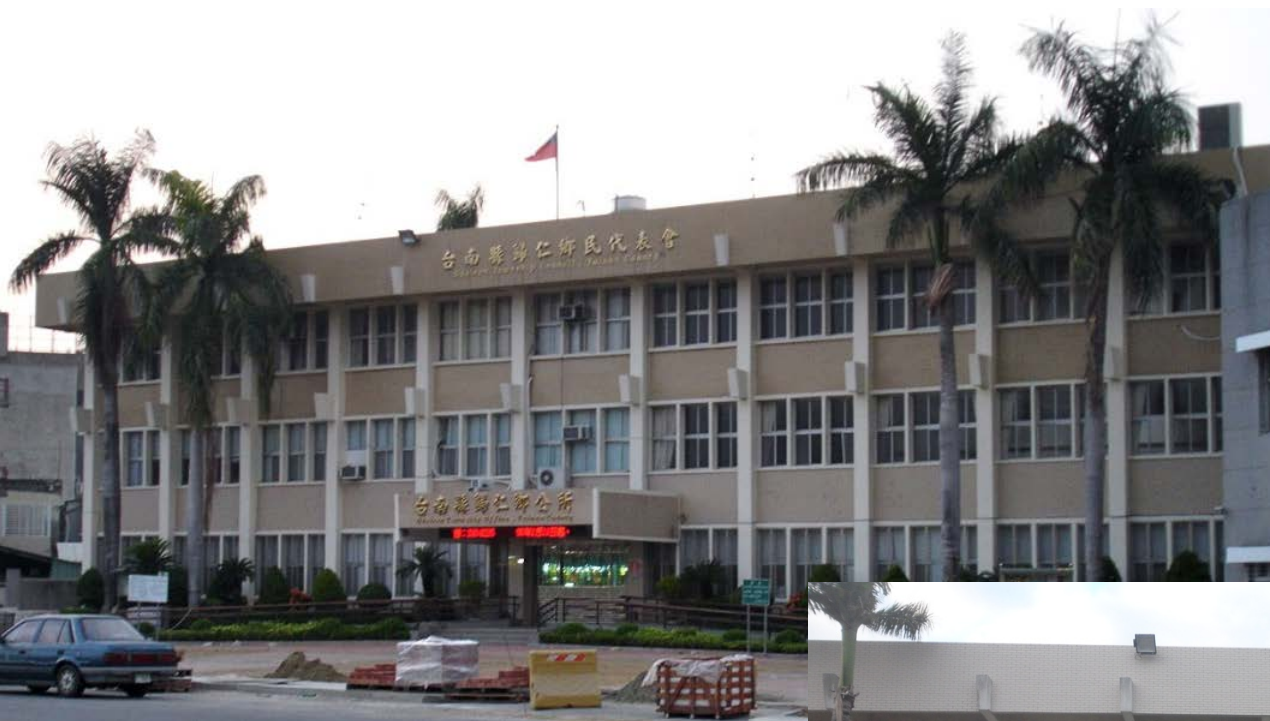
Gueiren District Office

**No damage;
Operational;
As emergency
response center**

**Retrofitted with
RC shear wall**

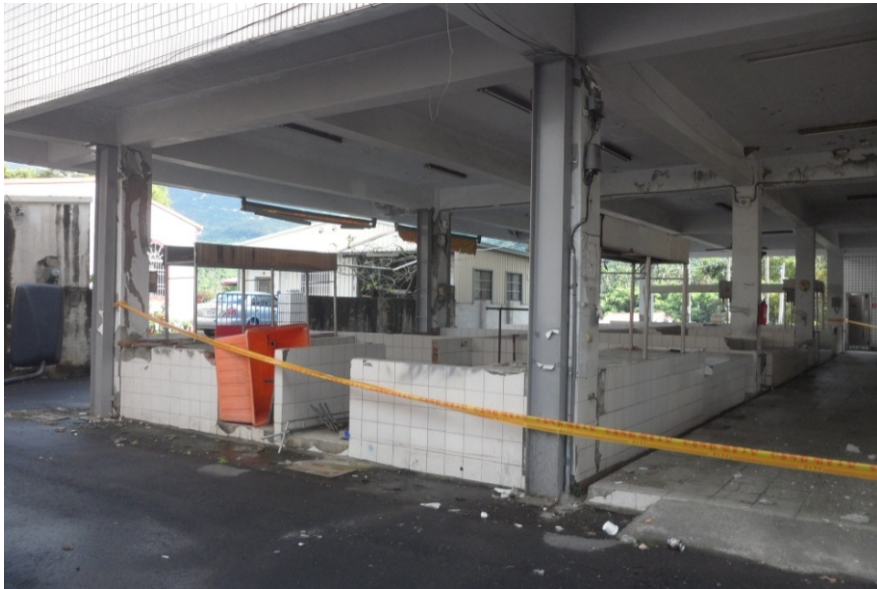
After 2010.03.04 earthquake, Nanhua Market shored with steel columns.

In 2016 Meinong earthquake, Damaged but not collapsed!

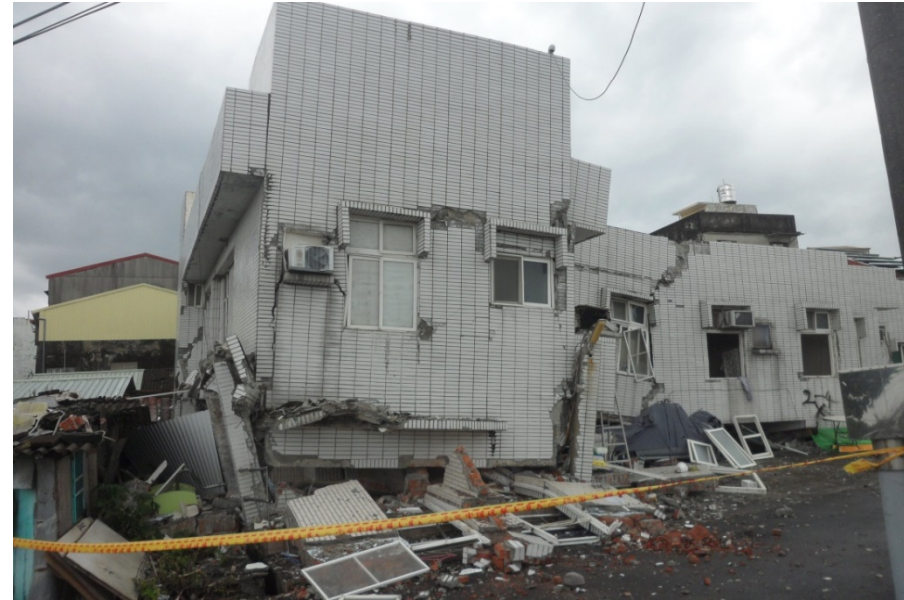
Shanshang Market didn't conduct any partial retrofit.

In 2016 Meinong earthquake, totally collapsed!
