Damage and Restoration of Drinking Water Systems Caused by 0206 Tainan Earthquake and Future Mitigation Measures

Nan-Tzer Hu

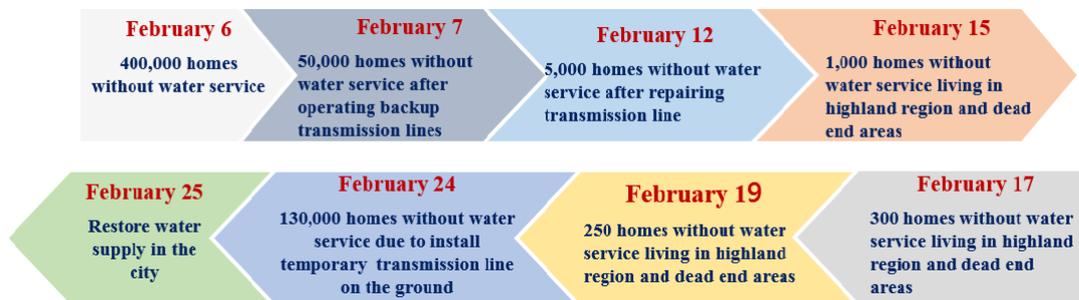
The disaster has left 400,000 homes without water service. TWC dispatched several emergency repairing teams corporate with outsourcing contractors to repair leaky pipeline and buried new pipes, gradually reduced the number of households affected by the water-supply outage due to the earthquake until on the February 25th morning to restore water supply. Fig.1 shows restoration of water supply system in 0206 Earthquake in 2016.

Fig.1 Restoration of water supply system in 0206 Earthquake in 2016

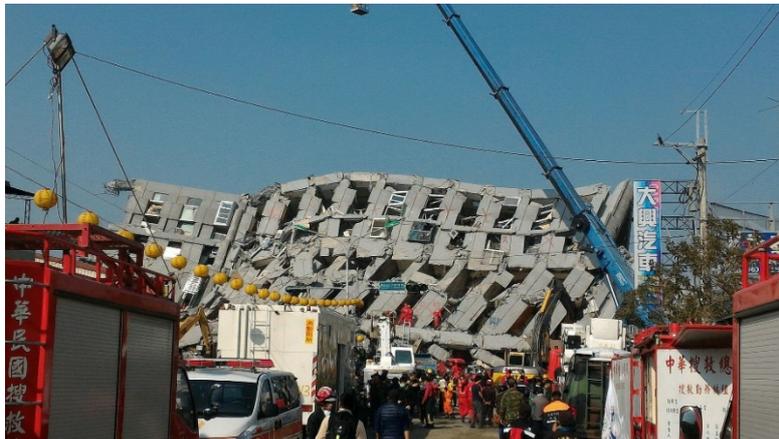
1. Due to the earthquake, Tainan Water Supply System had been seriously damaged, it needed time to restore water supply system gradually after repairing damaged water infrastructure , especially the damaged 2,000mm(in diameter) transmission line which was located under the collapsed 17-story Weiguan Jinlong Building (see Fig.2). TWC used backup 1,750 mm transmission line to transfer water and laying 1,350 mm emergency temporary transmission pipe on the ground (see Fig.3 and Fig.5) by reducing pressure to supply water. Owing that the total volume of water is insufficient and water pressure is low, the consumers living in highland region and dead end areas are still suffering water shortage problem.

Fig.2 The collapsed 17-story Weiguan Jinlong residential building

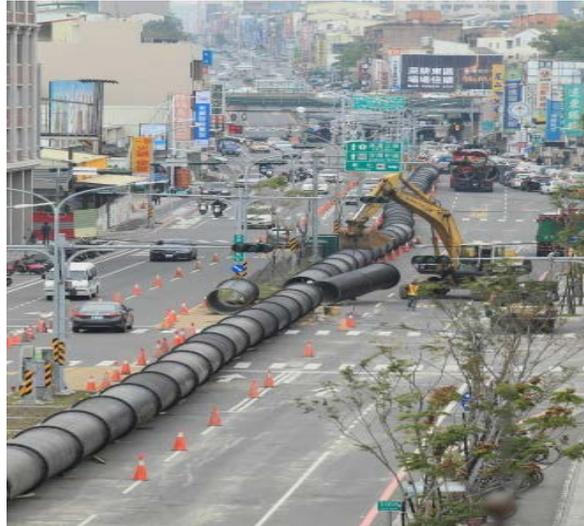
Fig.3 1,350 mm emergency temporary transmission pipe on the ground

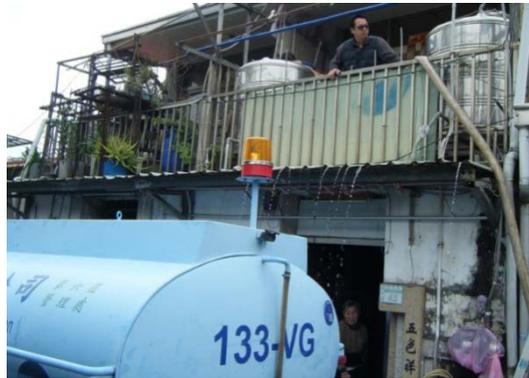
Fig.4 Water tanker injected water into pipeline for supplying water to consumer's water tank

3. Dead end areas : By using Water tanker or Fire-fighting truck injected water into pipeline for supplying water to consumer's water tank(see Fig.4).

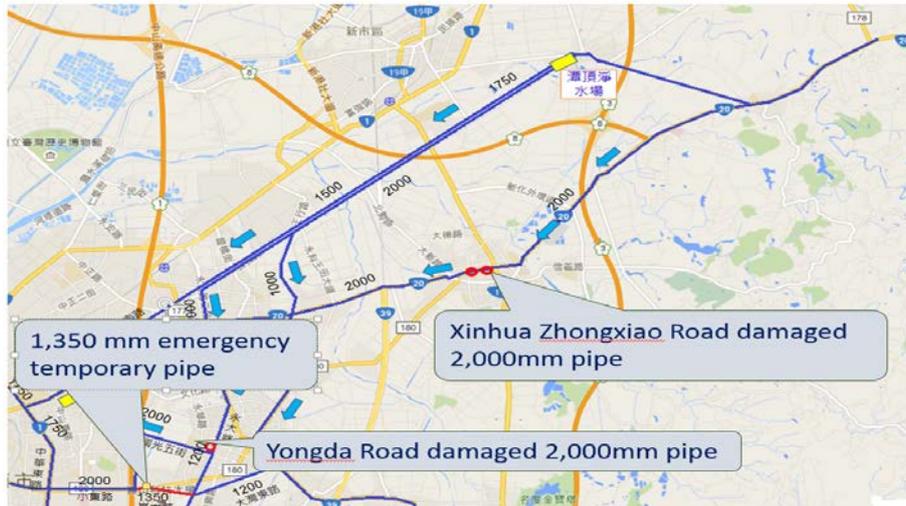
1. After inspection, there were about 7,948 cases of reporting water interruption, and about 4,710 leaky pipes (72 cases are larger than 300mm in diameter). The repairing teams cooperated with outsourcing contractors were dispatched immediately to fix leaky pipes.
2. Yongda Road damaged 2,000mm (in diameter) pipe:
After the Tainan City Government has cleaned up the collapsed Weiguan Jinlong Building, Repairing teams of TWC rushed to repair the pipe and completed at 24:00 on February 24th then restore water supply.
3. Xinhua Zhongxiao Road damaged 2,000mm (in diameter) pipe :
The damaged pipe was constructed by pipe jacking method and was under 8 meters from the ground, total length of 1,200 meters. After inspection it was found there were 7 cracks in the pipe. It was repaired at 00 : 30 on February 24th.
Location of damaged 2,000mm pipe and

Fig.5 Location of damaged 2,000mm pipe and 1,350 mm temporary pipe
