# **Damage Analysis of Air Valves of Drinking Water Pipeline in the 2016 Kumamoto Earthquake**

Taichiro Inui, Mitsuyasu Tamase and Masakatsu Miyajima

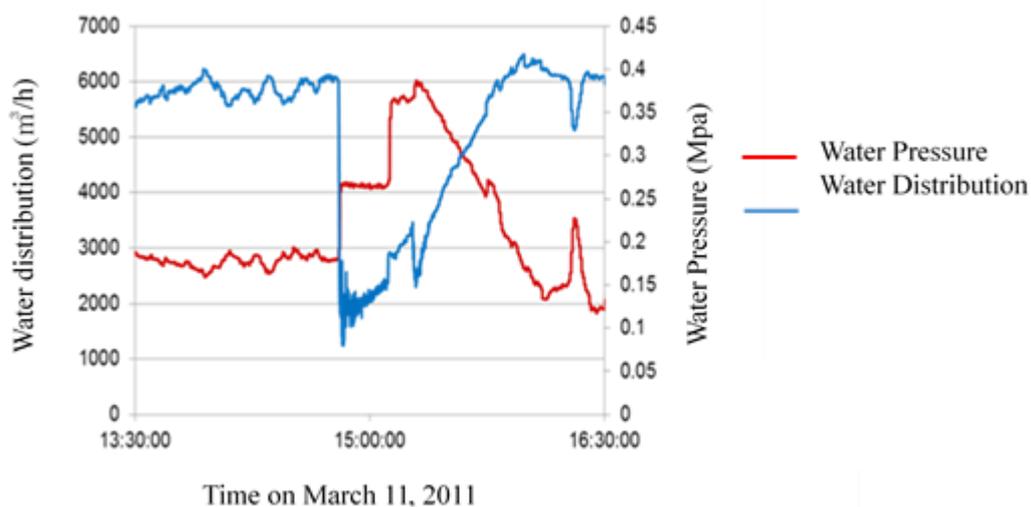
The 2011 Tohoku earthquake of magnitude 9.0 occurred on 11th March 2011, off the Ojika peninsula of Miyagi prefecture. Even in areas where direct damage such as rupture of water pipes did not occur in this earthquake, abnormal behaviors of the water distribution system such as rapid flow rate increase and water pressure decrease occurred immediately after the earthquake, and cases where the water supply system remarkably deteriorated a lot of it was seen. Changes in the water distribution and water pressure at the western part of Saitama City during the 2011 Tohoku earthquake are shown in Figure 1. The red line shows the change in the water distribution, the blue line shows the change in the water pressure. The water distribution rapidly increases around 14:46 when the earthquake occurred, and the water pressure is decreasing. Such abnormal behaviors have been reported in Tokyo and Osaka so far. Also, in the 2011 Tohoku earthquake a lot of damage to the air valve was reported, causing many leakage damage. An air valve is a valve having a function of automatically sucking and exhausting the air accumulated in the pipe and is installed in places where air bubbles are likely to occur, such as a continuous downward slope of a water distribution pipe and a convex portion of a pipe. Also, it is said that it is desirable that a few are installed for 1 km of water distribution pipe, even if it is not a place where air bubbles are likely to occur. Such water cutoff caused by damage to air valve may cause secondary disasters such as hindrance to firefighting activities in a large scale earthquake that may cause a fire from houses or the like. Even in the 2016 Kumamoto earthquake that occurred in April 2016, similar damage to air valves and other valves was reported. Table 1 shows the number of damaged places and damage rates of pipes and valves in the 2016 Kumamoto earthquake. It is known that damage rate to valves such as air valves is not small compared with damage of water pipes in the 2016 Kumamoto earthquake. Therefore, in order to investigate the actual condition of the air valve damage and to investigate the cause, this research will be conducted from the viewpoint of the form of the air valve, the difference of the surrounding situation, the characteristics of the seismic motion and the ground property.

Figure 1. Changes in water distribution and water pressure at the western part of Saitama City during the 2011 Tohoku earthquake [1]

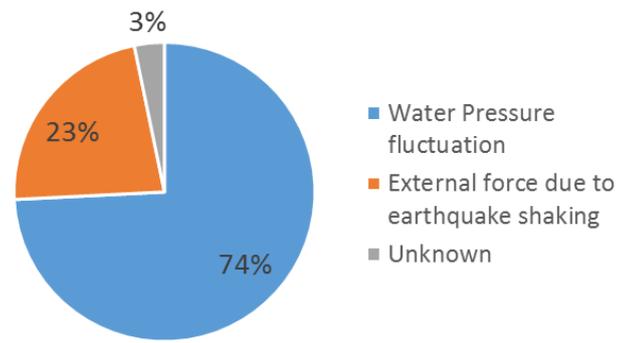
Figure 3 shows the structure of the air valve, and Figures 4 and 5 show the broken part and factor of the air valve, respectively. Concerning on the damaged part, the floating valve body (Photo 1) had the most damage and then the float valve body (Photo 2). The floating valve body / float valve body is a part for efficiently exhausting the air contained in the water in the pipeline. As mechanism, when the air contained in the water in the pipeline accumulates in the air valve, as the water level drops, the floating valve body / float valve body descends, the air hole valve seat is opened, and the air is exhausted. When the exhaust is completed, the float valve body rises and the air hole closes. This movement is automatically repeated to discharge the air in the pipeline. In addition, the float valve body guide / cover are also a part susceptible to the influence of water pressure fluctuation, and it is thought that it was influenced this time as well. On the other hand, the flange joint part (Photo 3), which was damaged next to the floating valve body and the float valve body, is in contact with the outside at the part which plays a role of connecting the water pipe and the air valve, and is not affected by the water pressure fluctuation. Therefore, this damage is considered to be caused by aged deterioration and direct external force caused by earthquake vibration. According to Figure 6, the damage of the flange joint portion occupies about 15% of the whole and is the third most damaged portion.

Figure 5. Factor of damage to air valve

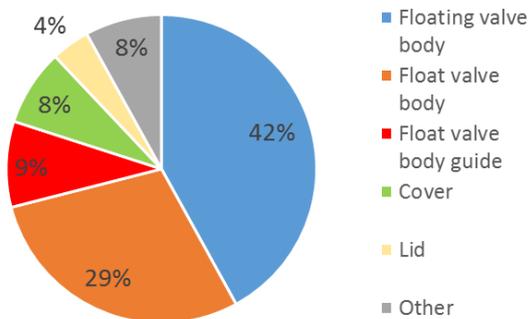
Figures 6 and 7 show the breakage points for each damage factor. Figure 6 indicates that the damages to the floating valve body and the float valve body account for 70% or more of the total in the case of breakage due to water pressure fluctuation in the pipe. In addition, Figure 7 explains that the breakage of the flange joint portion accounts for 70% by the damage due to external force to the valve body. As a result, measures against sudden changes in water pressure to the floating valve body and the float valve body are of utmost importance as countermeasures against earthquakes. On the other hand, countermeasures against earthquake shaking are, however, indispensable for the part in contact with the outside such as the flange joint part.

Figure 6. Damage parts due to water pressure variation in pipe

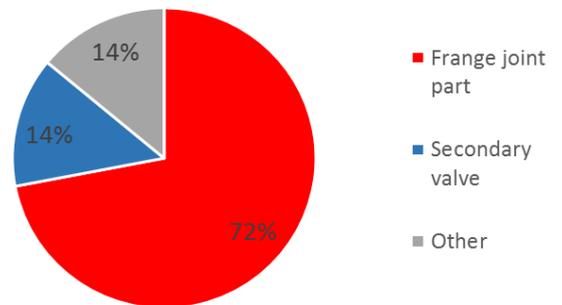
Figure 7. Damage parts due to external force applied to the valve body

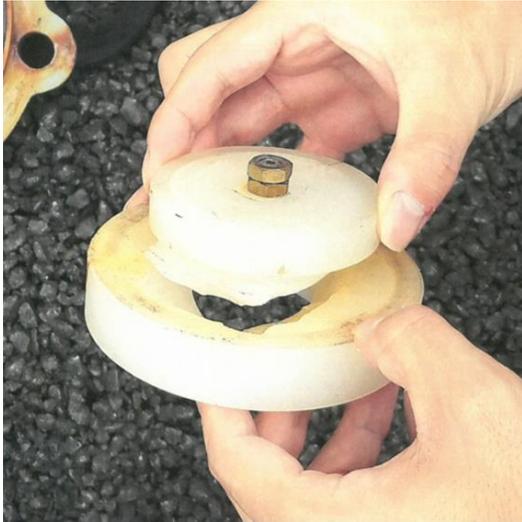
Photo 1. Damaged floating valve body

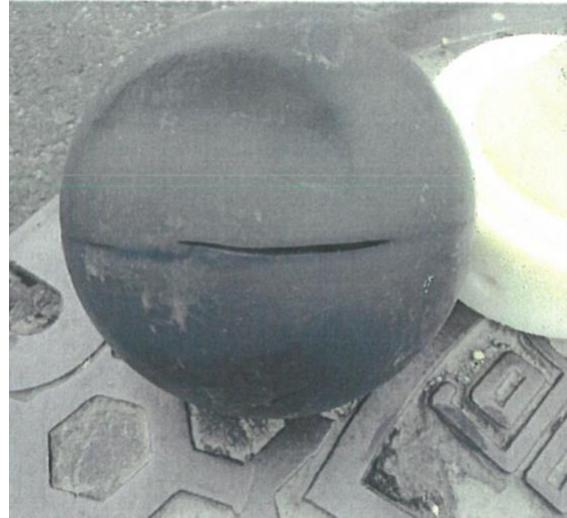
Photo 2. Damaged float valve body

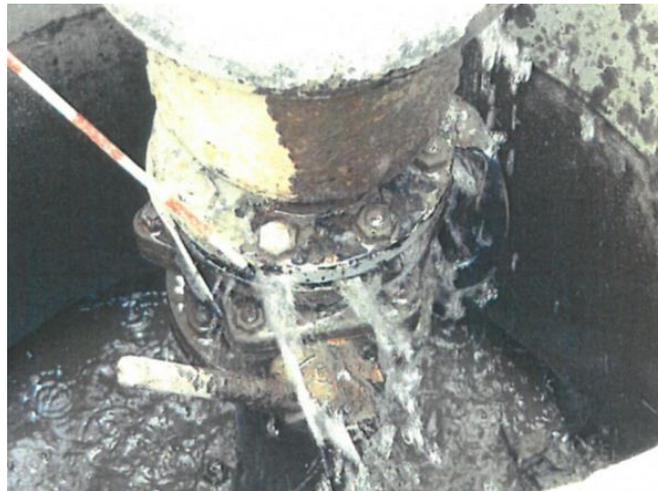
Photo 3. Leakage from flange joint

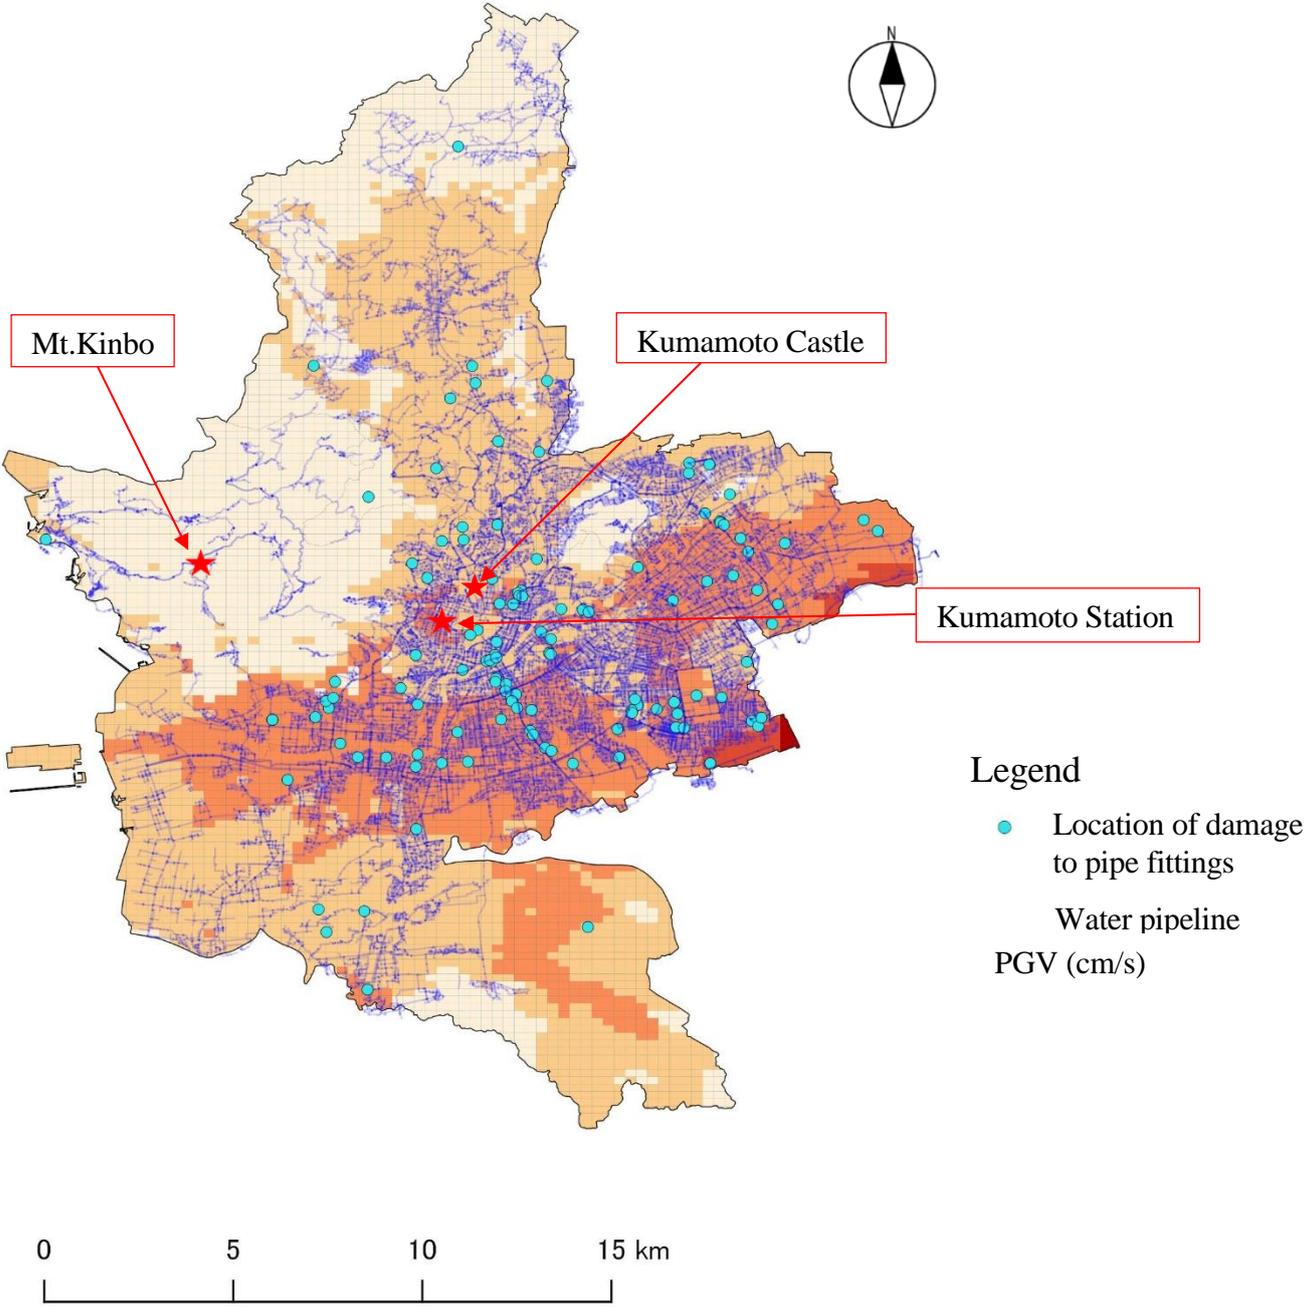
Figure 8 shows the distribution of the peak ground velocity (PGV) in the 2016 Kumamoto Earthquake and damage to pipe fittings. The relation between PGV and the damage to pipe fittings is discussed here. The damage to pipe fittings occurred almost entirely around the central and eastern parts of Kumamoto City. This figure suggests that more than half of them occurred in the area where PGV was 80 cm / s or more, but some damage occurred even in the area of PGV of 40 cm / s to 80 cm / s where PGV was relatively small. Figure 9 shows the number of damage to pipe fittings in each PGV range. This figure also indicates that the damage to pipe fitting occurred in the area where PGV is more than 80 cm / s. These figures clarify that the damage to pipe fittings concentrated in the central and eastern parts of the city where the distribution pipeline is dense, and in the region where PGV was large. However, it was found that some damage to pipe fittings occurred even in the areas where PGV was relatively small. These areas are sparse distribution of pipelines in case of Kumamoto City. Therefore, it is the magnitude of the seismic vibration affects

fittings damage, but it is possible that factors other than seismic vibration affect pipe fittings and cause damage and leakage even if the seismic vibration is small.

Figure 8. Distribution of PGV and damage to pipe fittings
