Damage Analysis of Air Valves of Drinking Water Pipeline in the 2016 Kumamoto Earthquake

Taichiro Inui, Mitsuyasu Tamase and Masakatsu Miyajima

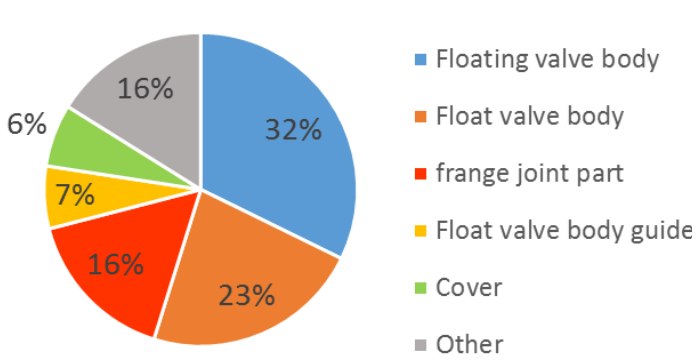
Figure 3 shows the structure of the air valve, and Figures 4 and 5 show the broken part and factor of the air valve, respectively. Concerning on the damaged part, the floating valve body (Photo 1) had the most damage and then the float valve body (Photo 2). The floating valve body / float valve body is a part for efficiently exhausting the air contained in the water in the pipeline. As mechanism, when the air contained in the water in the pipeline accumulates in the air valve, as the water level drops, the floating valve body / float valve body descends, the air hole valve seat is opened, and the air is exhausted. When the exhaust is completed, the float valve body rises and the air hole closes. This movement is automatically repeated to discharge the air in the pipeline. In addition, the float valve body guide / cover are also a part susceptible to the influence of water pressure fluctuation, and it is thought that it was influenced this time as well. On the other hand, the flange joint part (Photo 3), which was damaged next to the floating valve body and the float valve body, is in contact with the outside at the part which plays a role of connecting the water pipe and the air valve, and is not affected by the water pressure fluctuation. Therefore, this damage is considered to be caused by aged deterioration and direct external force caused by earthquake vibration. According to Figure 6, the damage of the flange joint portion occupies about 15% of the whole and is the third most damaged portion.

Figure 4. Broken part of air valve

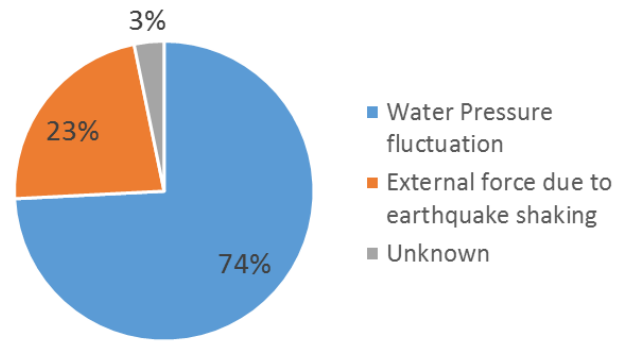
Figure 5. Factor of damage to air valve

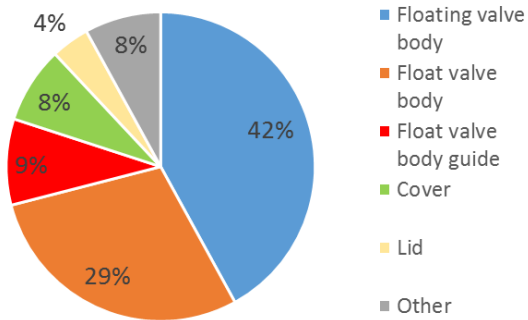
Figures 6 and 7 show the breakage points for each damage factor. Figure 6 indicates that the damages to the floating valve body and the float valve body account for 70% or more of the total in the case of breakage due to water pressure fluctuation in the pipe. In addition, Figure 7 explains that the breakage of the flange joint portion accounts for 70% by the damage due to external force to the valve body. As a result, measures against sudden changes in water pressure to the floating valve body and the float valve body are of utmost importance as countermeasures against earthquakes. On the other hand, countermeasures against earthquake shaking are, however, indispensable for the part in contact with the outside such as the flange joint part.

Figure 6. Damage parts due to water pressure variation in pipe

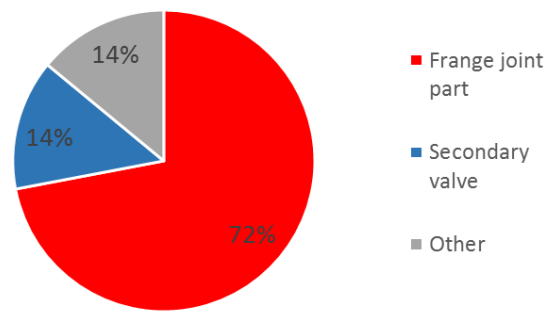
Figure 7. Damage parts due to external force applied to the valve body

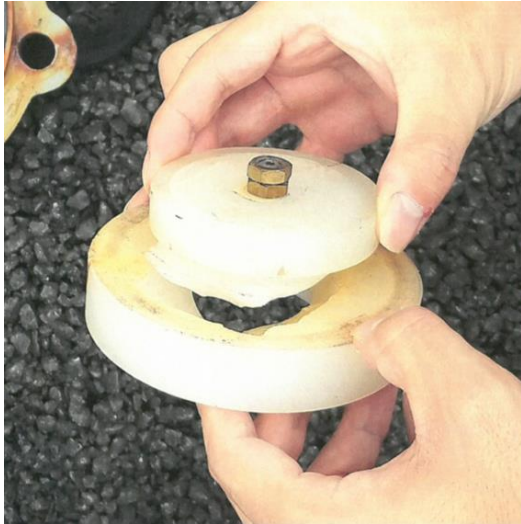
Photo 1. Damaged floating valve body

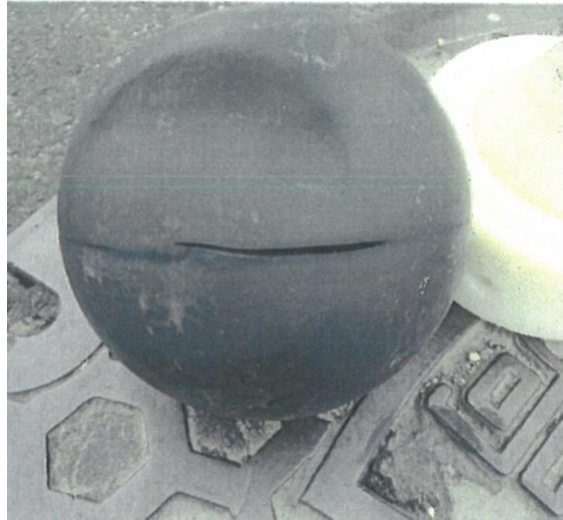
Photo 2. Damaged float valve body

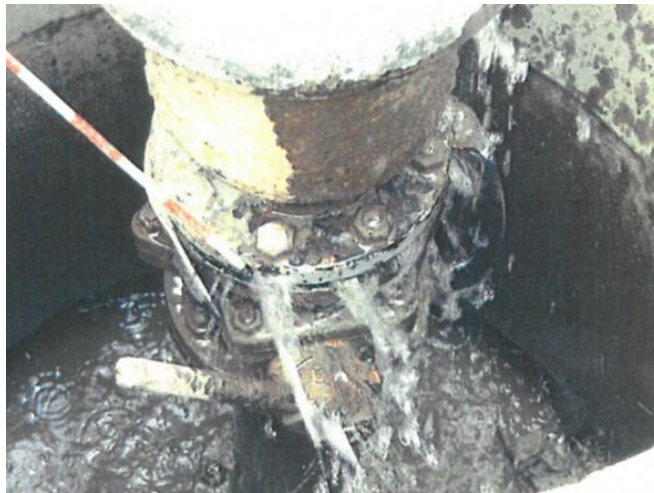
Photo 3. Leakage from flange joint

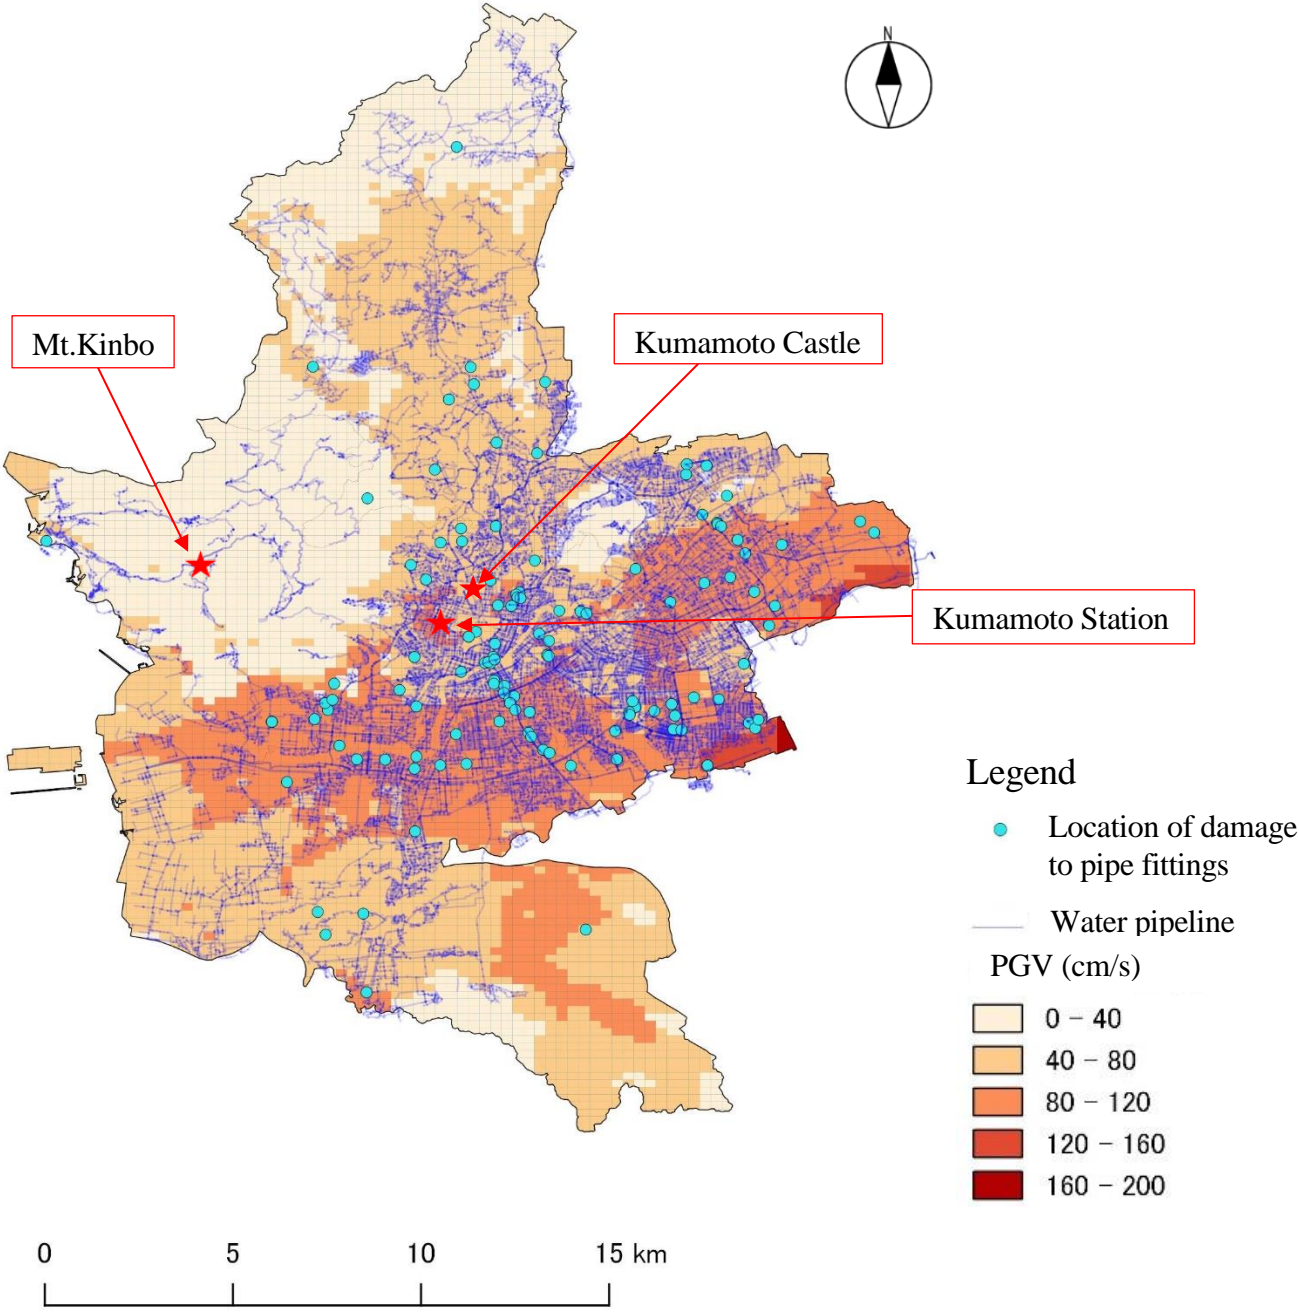
Figure 8 shows the distribution of the peak ground velocity (PGV) in the 2016 Kumamoto Earthquake and damage to pipe fittings. The relation between PGV and the damage to pipe fittings is discussed here. The damage to pipe fittings occurred almost entirely around the central and eastern parts of Kumamoto City. This figure suggests that more than half of them occurred in the area where PGV was 80 cm / s or more, but some damage occurred even in the area of PGV of 40 cm / s to 80 cm / s where PGV was relatively small. Figure 9 shows the number of damage to pipe fittings in each PGV range. This figure also indicates that the damage to pipe fitting occurred in the area where PGV is more than 80 cm / s. These figures clarify that the damage to pipe fittings concentrated in the central and eastern parts of the city where the distribution pipeline is dense, and in the region where PGV was large. However, it was found that some damage to pipe fittings occurred even in the areas where PGV was relatively small. These areas are sparse distribution of pipelines in case of Kumamoto City. Therefore, it is the magnitude of the seismic vibration affects

fittings damage, but it is possible that factors other than seismic vibration affect pipe fittings and cause damage and leakage even if the seismic vibration is small.

Figure 8. Distribution of PGV and damage to pipe fittings
