Lessons Learned from Damage to Drinking Water Supply System in the 2016 Kumamoto Earthquake in Japan

Masakatsu Miyajima

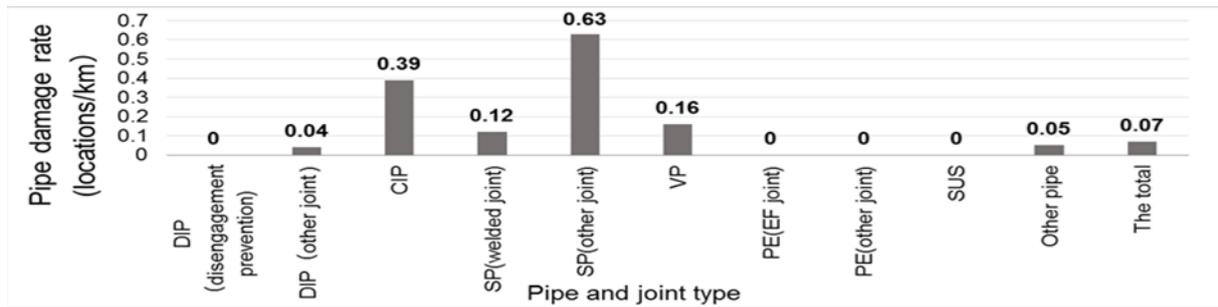
The piping length of drinking water supply in Kumamoto City is 3,238 km. The total number of pipe damages was 233, therefore, the damage rate was 0.07 per kilometer. As Figure 1 shows, the number of damage by pipe material was 0.63/km for SV (other joint), 0.39/km for CIP, 0.16/km for VP, 0.12/km for SP (welded joint), and 0.04/km for DIP (other joint).

Figure 1. Pipe damage tare by pipe material in Kumamoto City

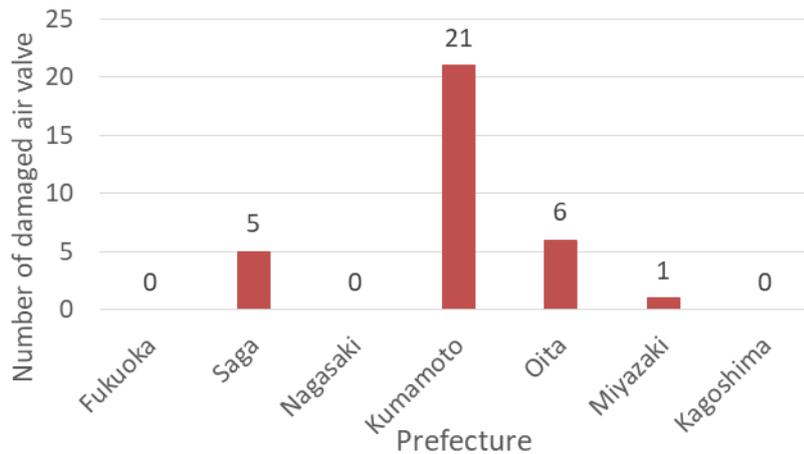
Table III shows the number of locations of damage and damage rates of pipes and valves in Kumamoto City. This table indicates that damage to valves such as air valves was not small compared with damage to pipes in the 2016 Kumamoto earthquake. The number of damage to air valves in each prefecture in the 2016 Kumamoto earthquake is shown in Figure 2. This figure explains that the damage was concentrated in Kumamoto Prefecture and Oita Prefecture where the epicenter was located and near. On the other hand, air valve damage has also occurred in areas relatively far from the epicenter such as Saga City in Saga Prefecture and Nobeoka City in Miyazaki Prefecture. It seems that the damage was caused by not only strong ground motion but also abrupt increase of water pressure in a pipe. The cause of abrupt increase of water pressure in a pipe just after an earthquake should be clarified.

Figure 2. Number of damage to air valve in each prefecture
