Napa Water System Earthquake Response: like fine wine, the right blend of self-help and mutual aid

Joy Eldredge, Water General Manager

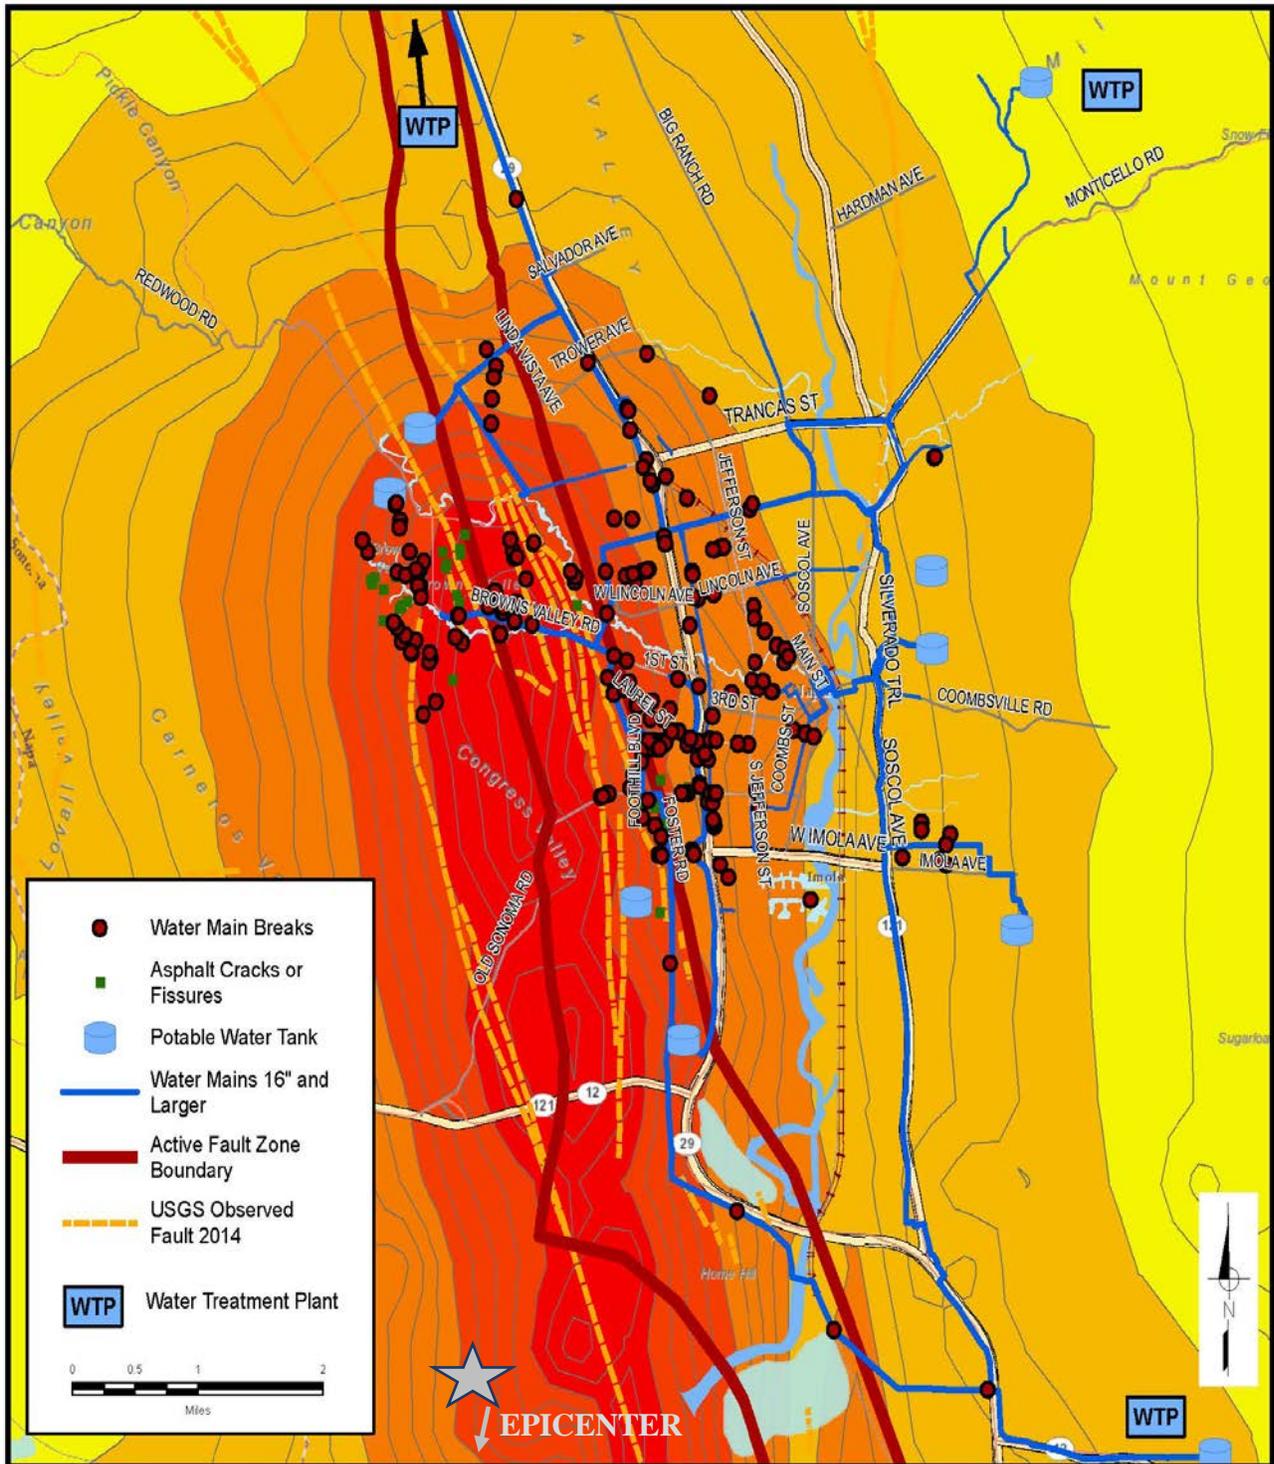
At 0320, pacific time, on August 24, 2014, a 6.0 magnitude earthquake occurred near the city Napa, California. The West Napa fault caused the earthquake and although the epicenter was 8 miles southwest of City of Napa, the shake maps indicate the energy radiated northwest along the fault and numerous surface faults were identified by staff and citizens alike to the west of downtown Napa as shown in Figure 2 [1]. As a result, the City of Napa's water system was most directly affected by the event when compared to utilities of neighboring systems.

Figure 2. Epicenter of August 24, 2014 Event, Shake Intensity Map, West Napa Fault (Dashed) and Surface Faults (Green) and Water Storage Tanks (Blue)[1].
