Lessons Learned from Damage to Drinking Water Supply System in the 2016 Kumamoto Earthquake in Japan

> Masakatsu Miyajima Kanazawa University, Japan

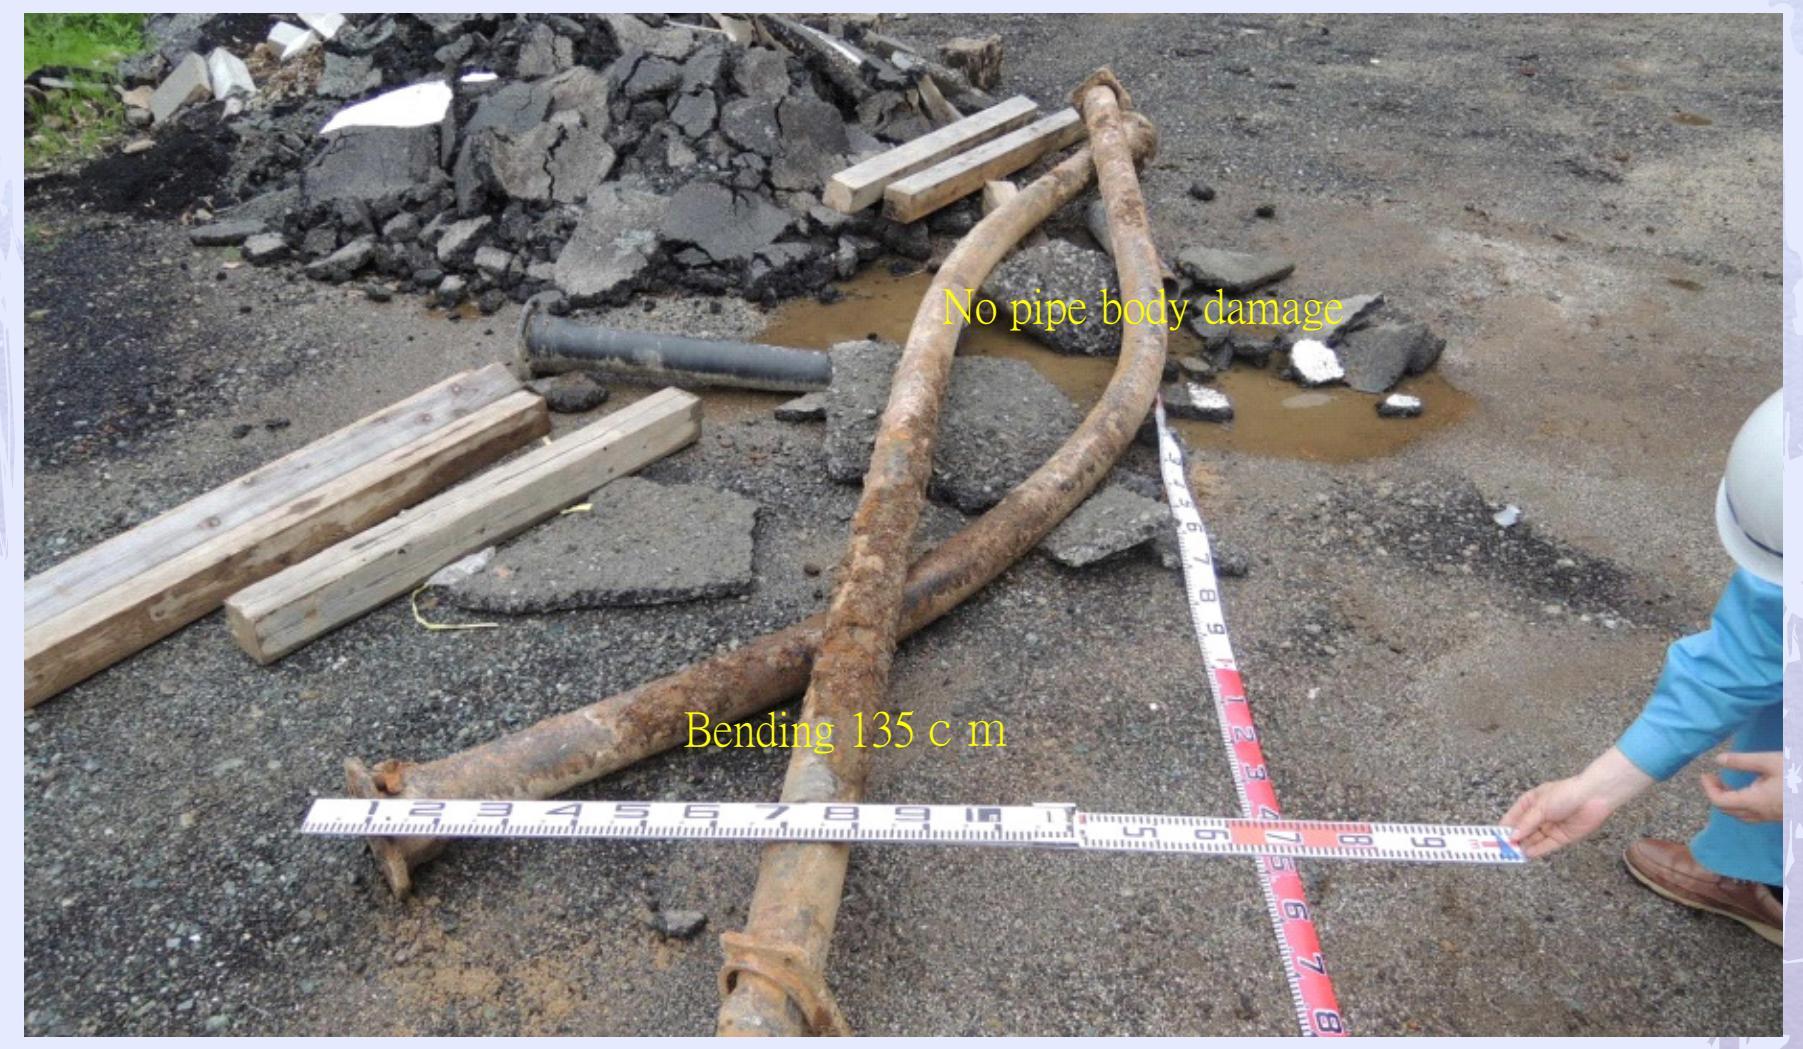
Horizontal displacement 2.0n

DIP (K-type) φ 100

Pipe bending and joint slip-out

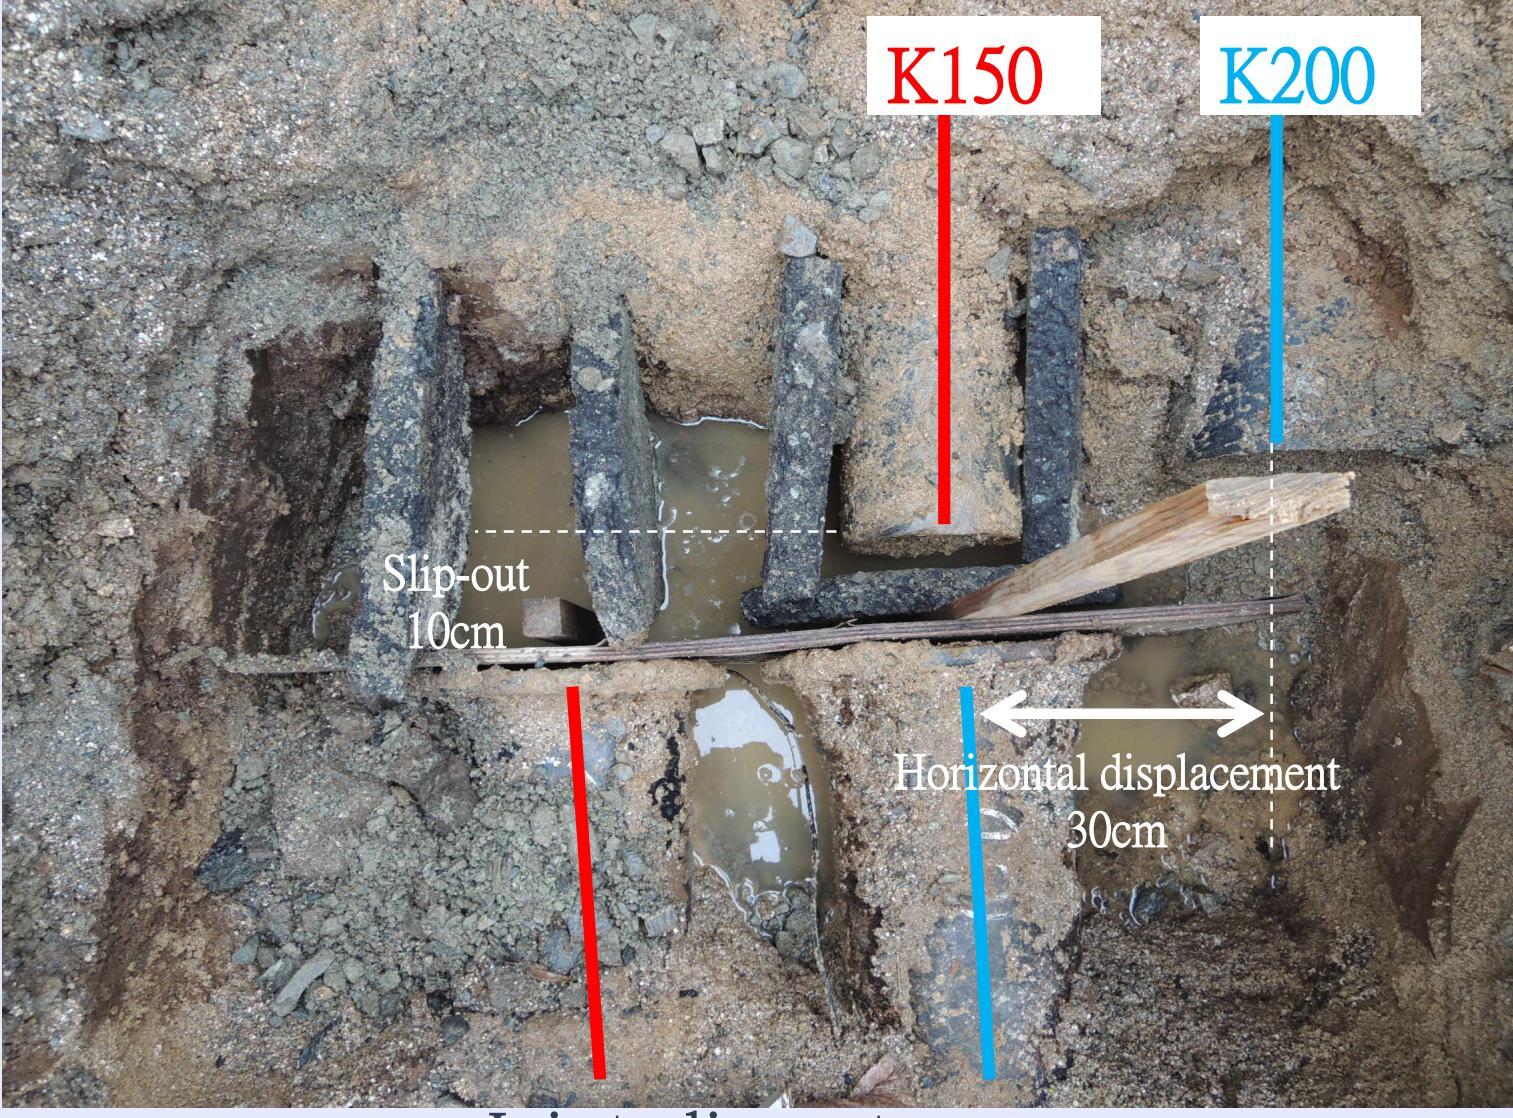
DIP (K-type) φ 150 ' φ 200

Joint slip-out

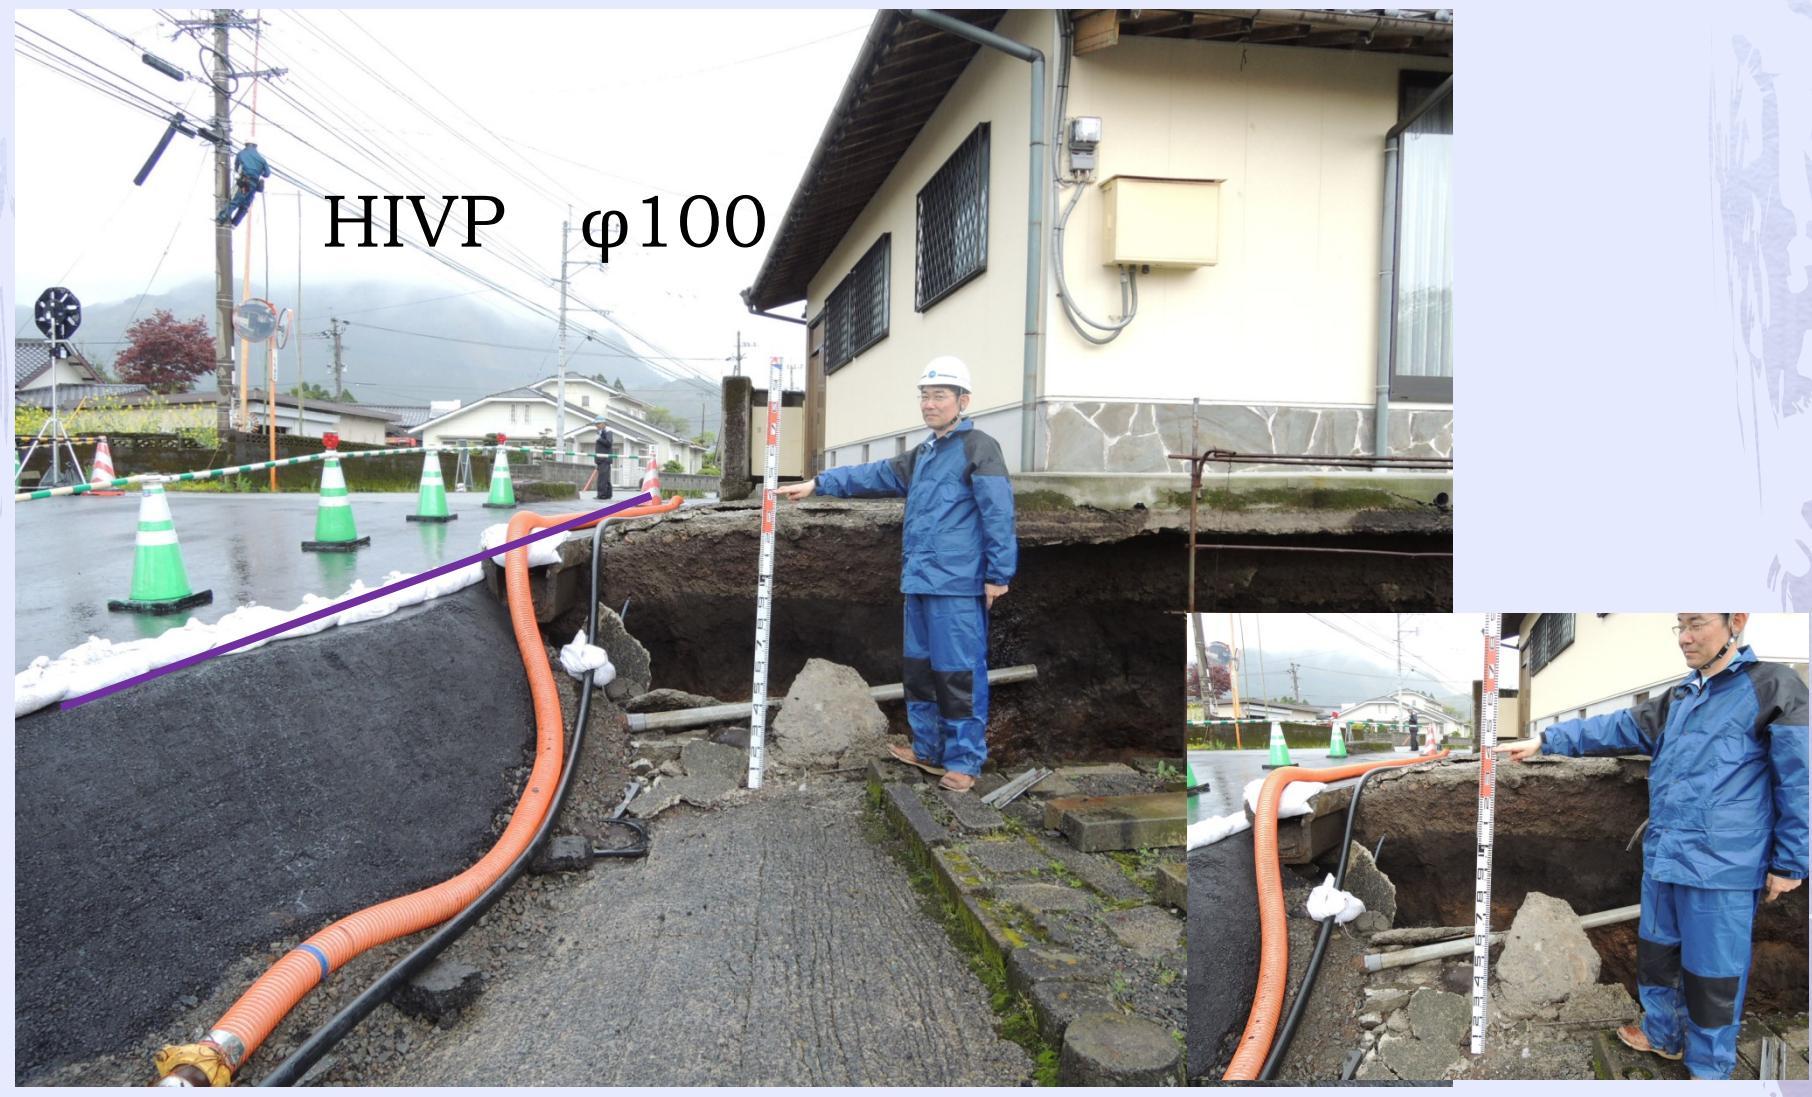
HIVP $\varphi \ 1 \ 0 \ 0$ at normal fault

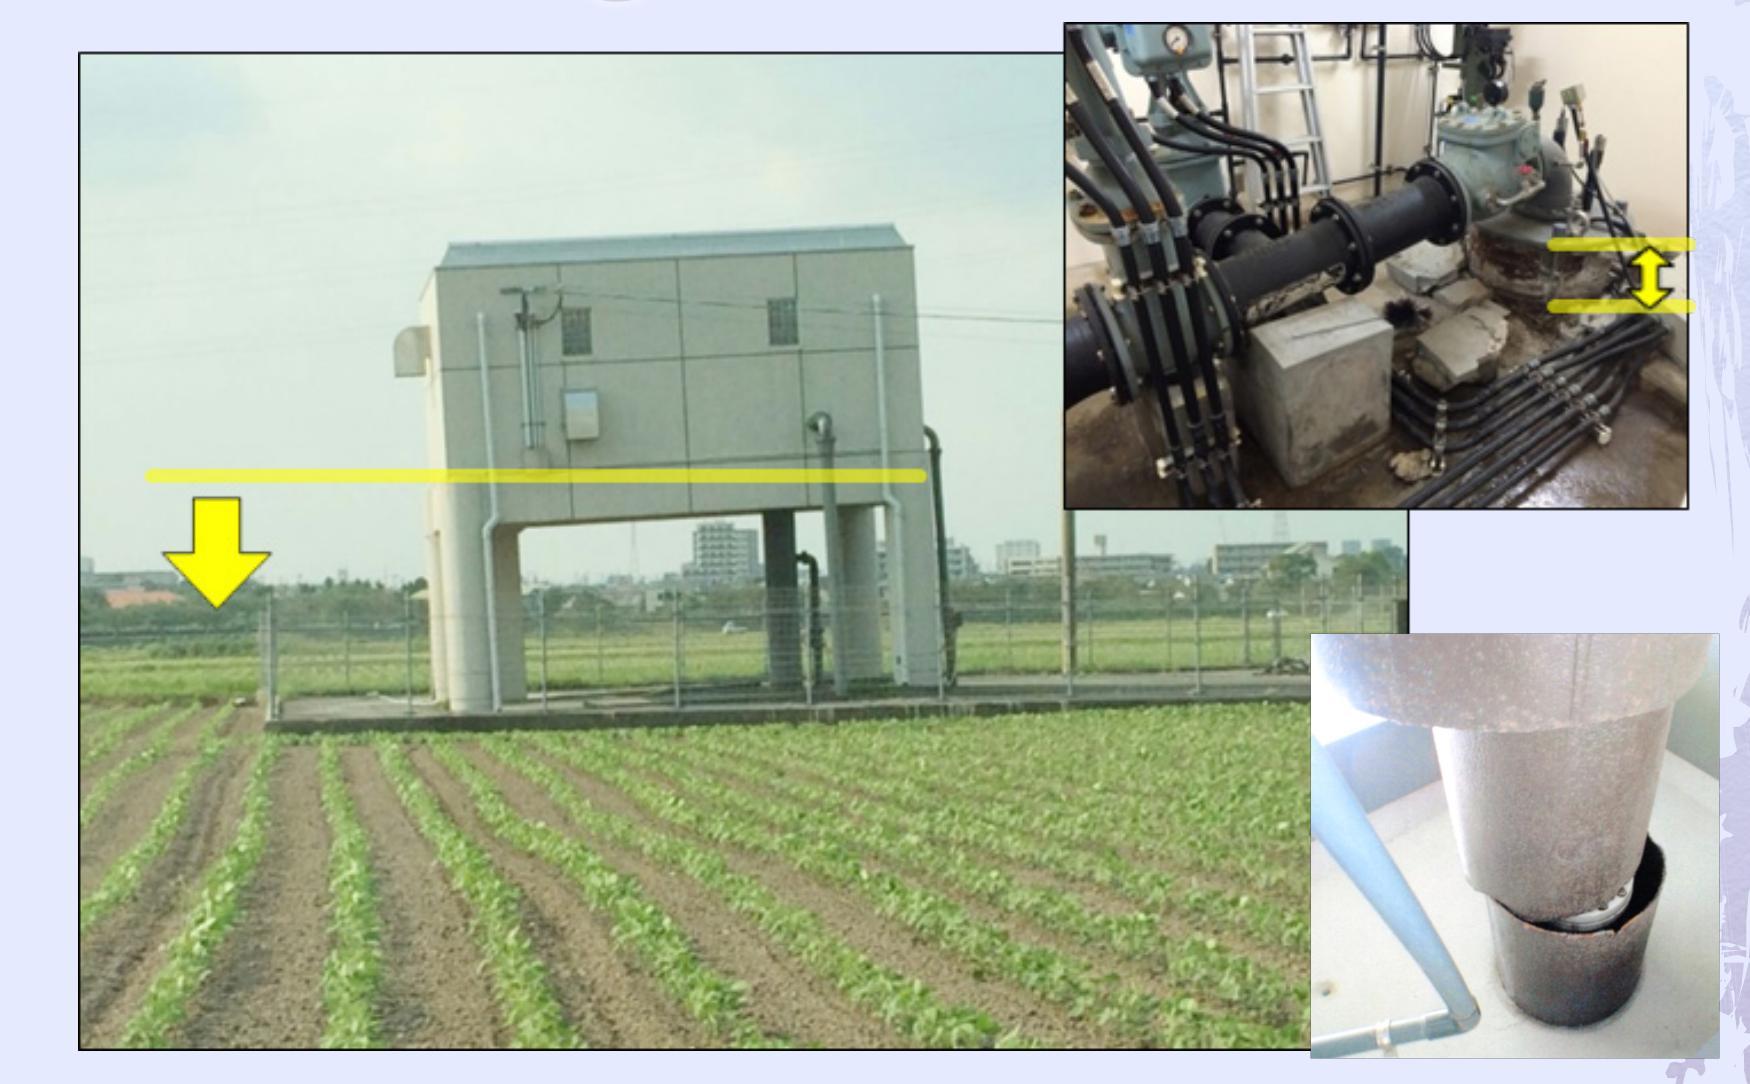
Damage to intake well

Suspension of water supply at all household (about 326,000) due to turbidity

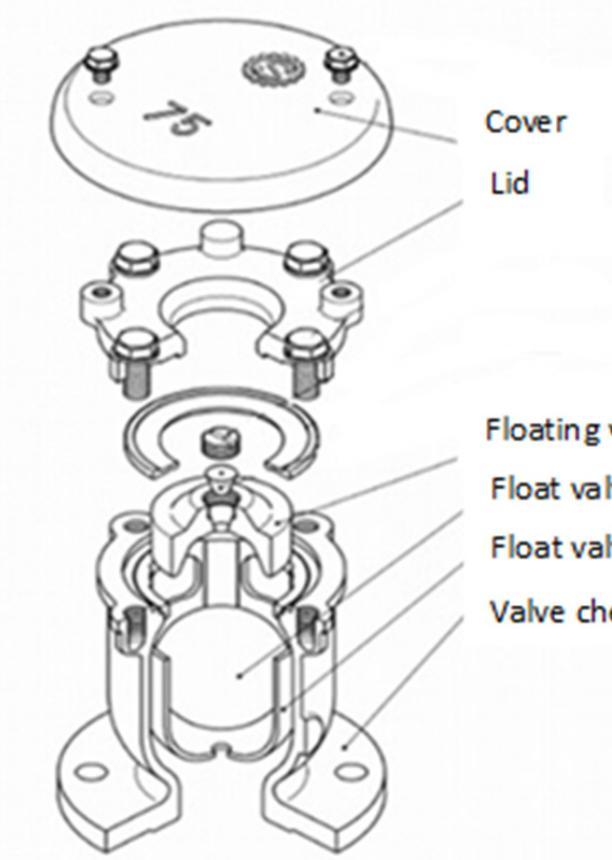
Damage to valve

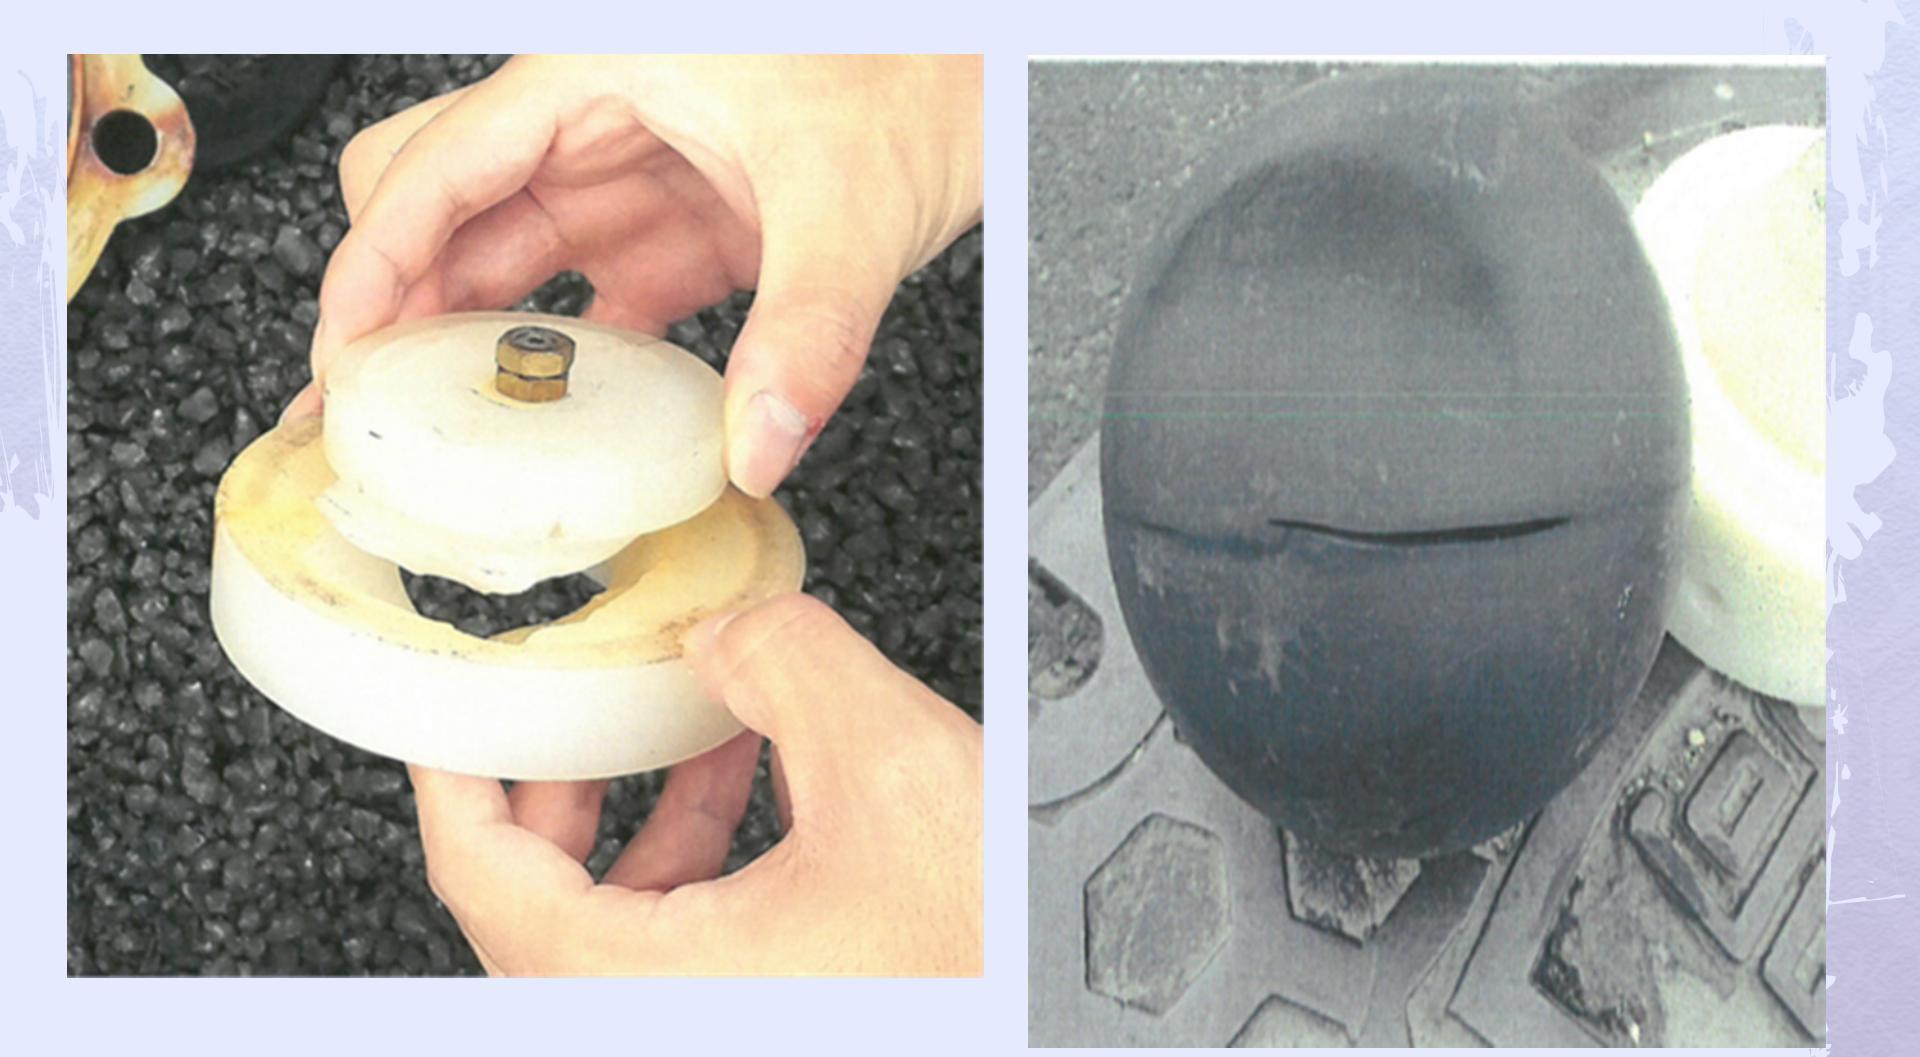
Damage to valve
