Japanese Lessons on RC building collapse and importance of beam-column joint

H. Shiohara, PhD. FACI

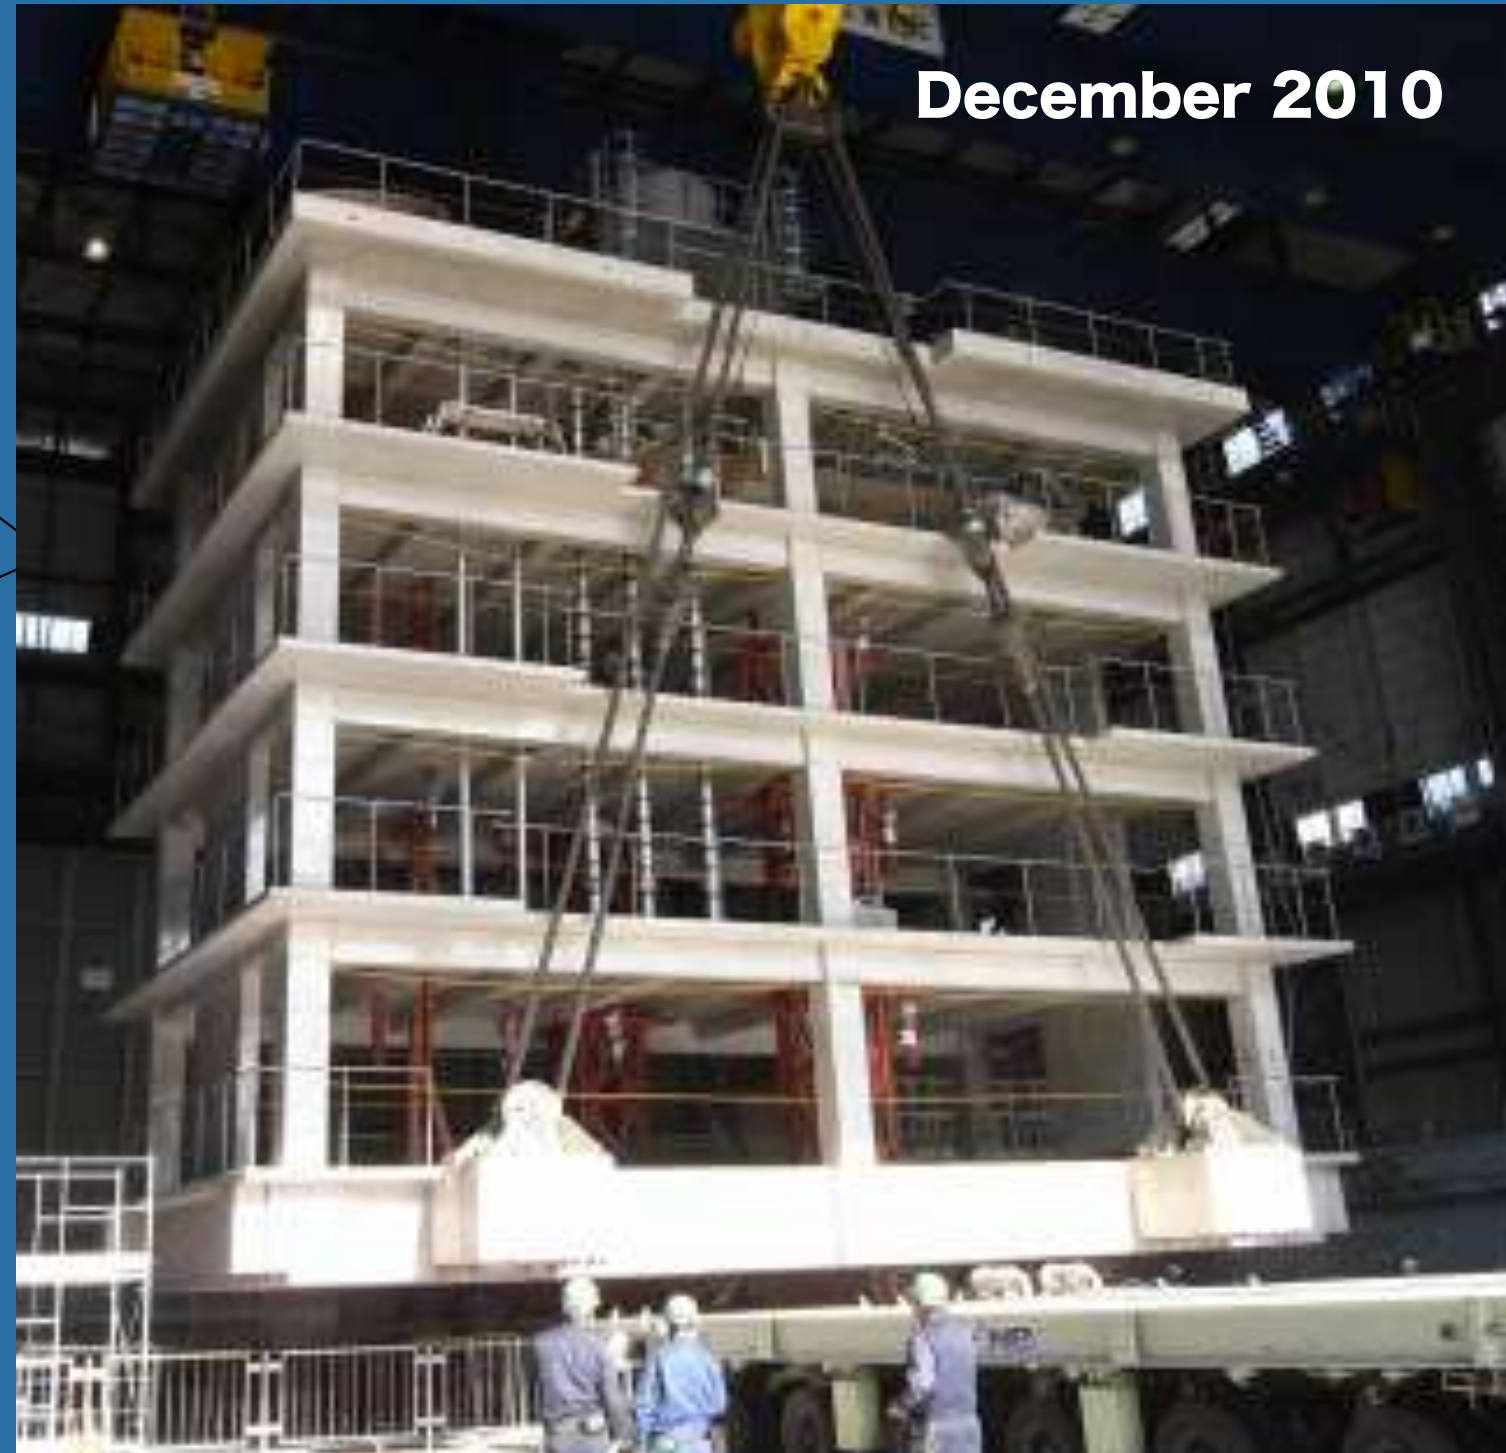
E-Defense 3D Shaking Table

National Research Institute for Earth
Science and Disaster Prevention
Miki, Hyogo Prefecture, Japan

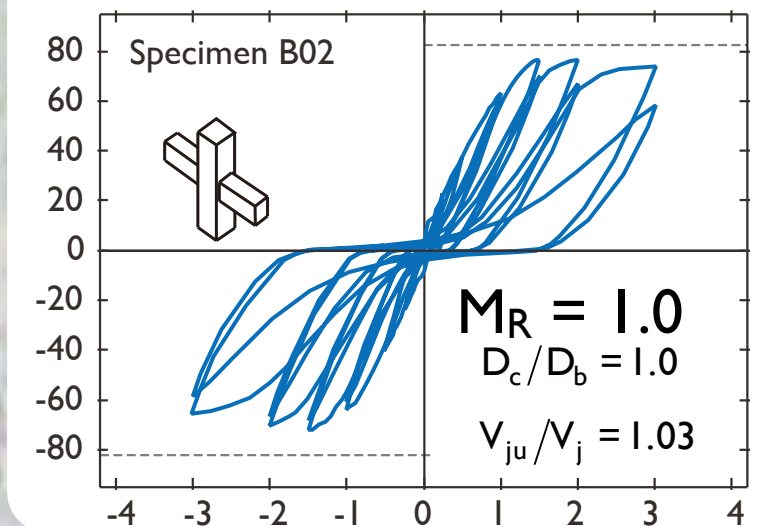
This test confirmed joint hinging at JMA Kobe 100%

Beam-column joint conformed to
Japanese seismic provisions

Joint Hinging

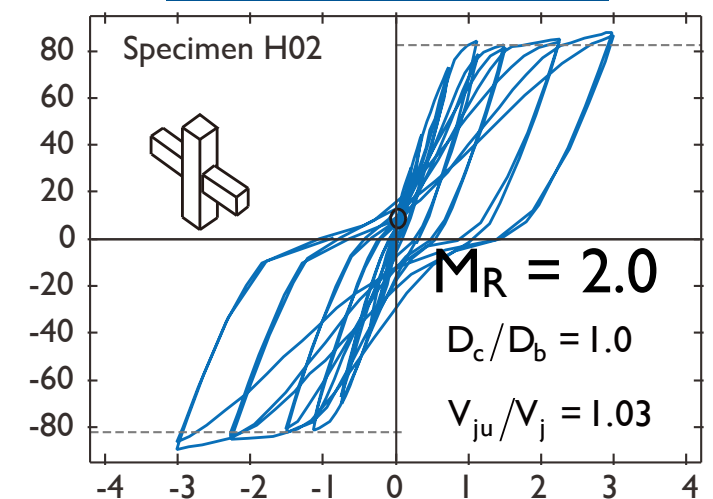
Beam Hinging

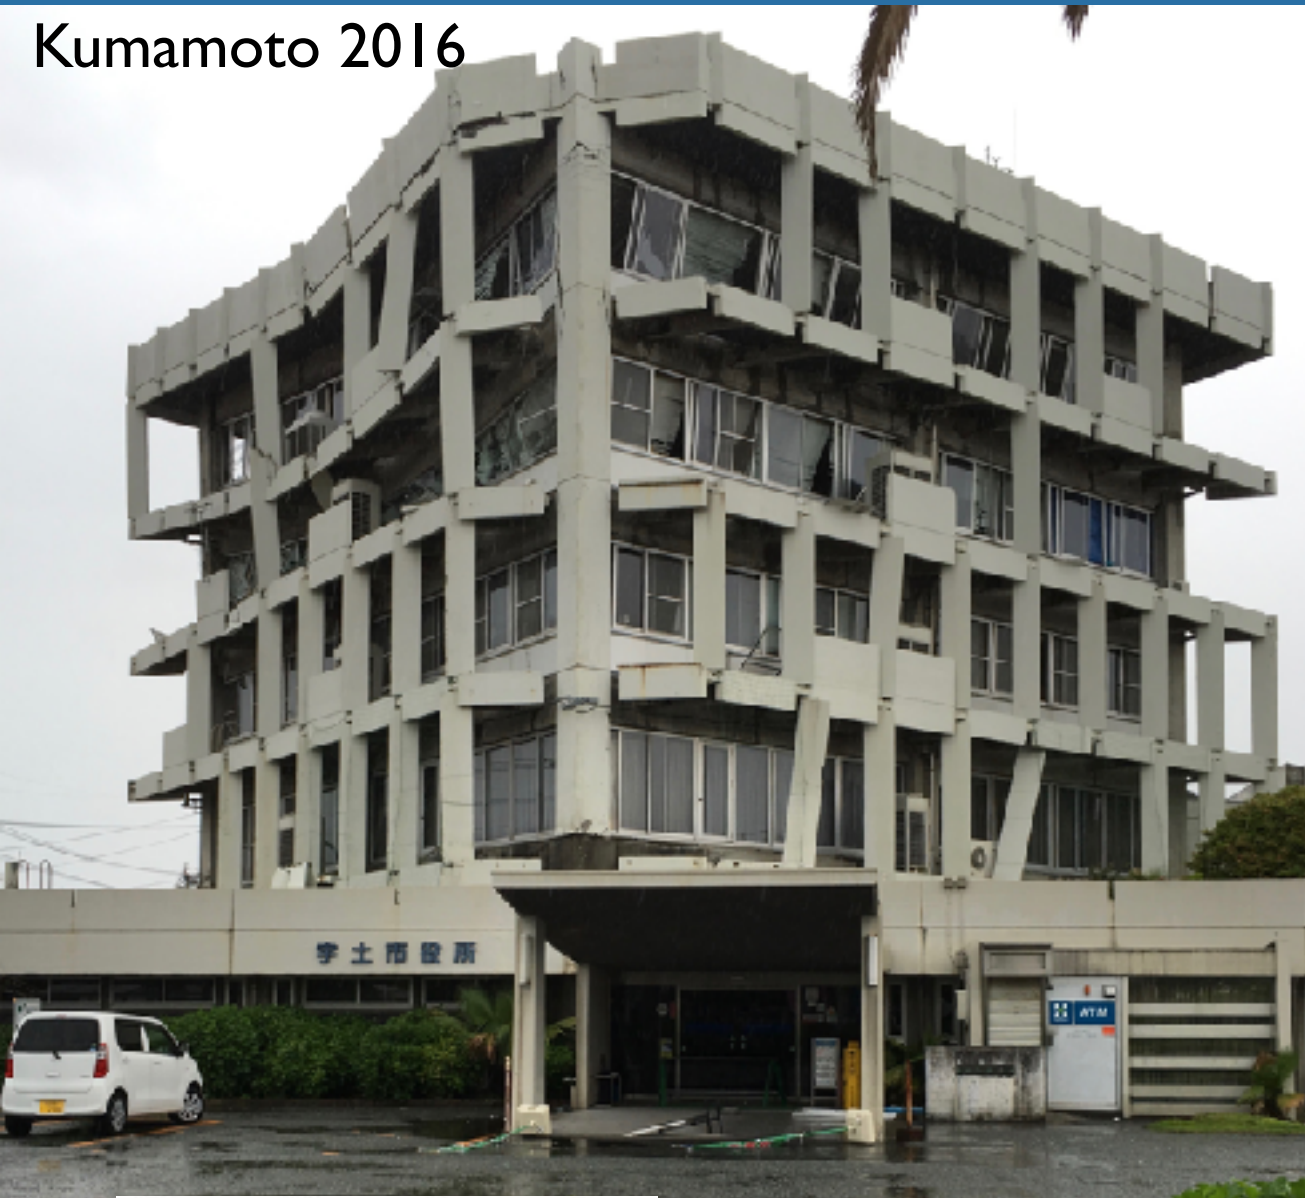
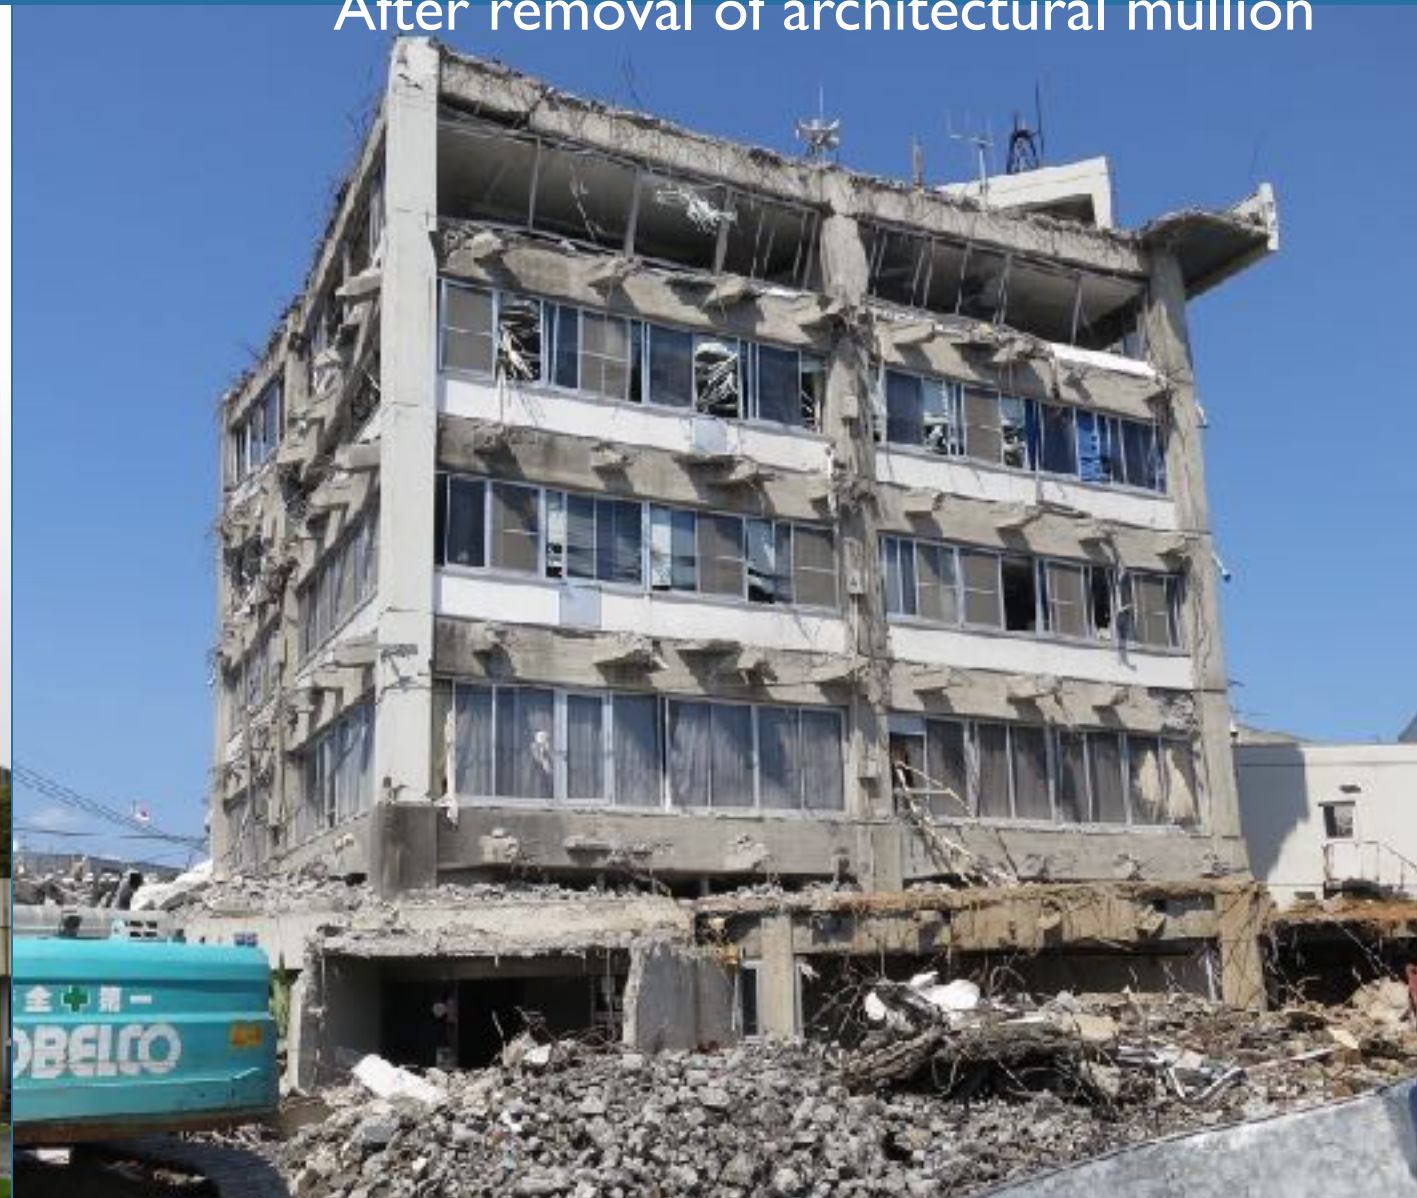
After removal of architectural mullion

Uto Municipal Building collapsed by 2016 Kumamoto earthquake, Kumamoto, Japan, built in the 1970's, but probably satisfied the current seismic provisions for beam-column joint of Japan. Detailed investigation is underway.
