The Effectiveness of the Dispatch of Support Staff to Small Waterworks

Takuya KUDO¹, Yoshihito HIGUCHI²

This paper reports on the dispatch of technical support staff to Shichigahama following the Great East Japan Earthquake (GEJE) of 2011.

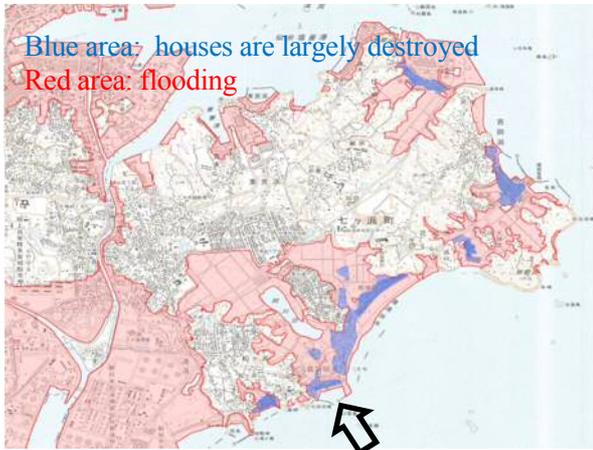
The earthquake damage was not serious in Shichigahama but its lowland areas were hit by a huge tsunami. The tsunami caused significant loss of life and damage to the infrastructure such as the waterworks. Figure 2 depicts the area hit by the tsunami. Picture 1 and Picture 2 show the impacts of the tsunami.

Figure 2. Flooded area due to the tsunami[4]
(the black arrow denotes the angle of Picture 1.)

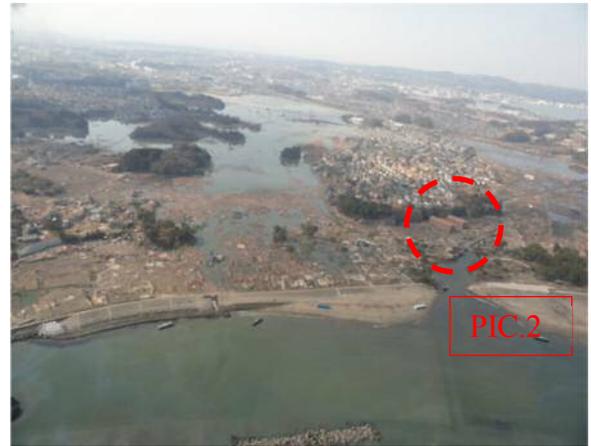
Picture 1. Aerial photo of Shichigahama
(a few days after tsunami)

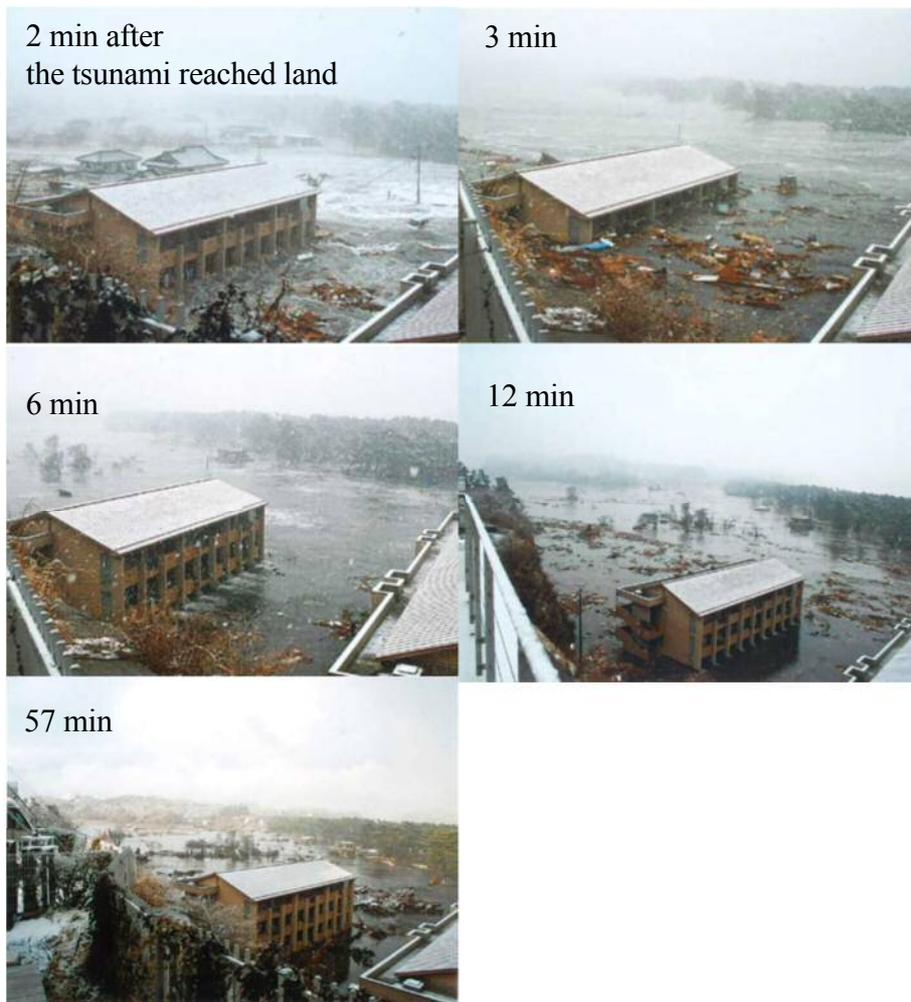
Picture 2. The town of Shichigahama after being hit by the tsunami

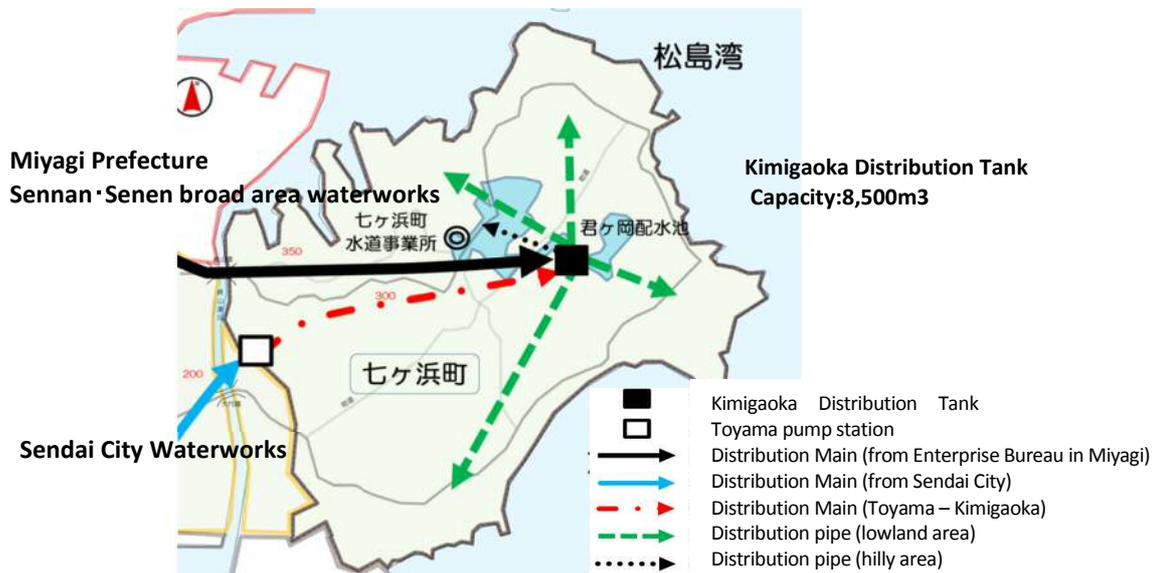
The Shichigahama waterworks does not have its own purification plant and therefore depends on a supply of water from other waterworks entities, Sendai City and the Enterprise Bureau in Miyagi into the Kimigaoka distribution tank. (In Japan, municipalities are mandated to manage their water supply on their own so municipalities usually have their own purification plants. In case a municipality without its own purification plant, like Shichigahama, the municipality buys water from other waterworks entities.) Figure 3 shows Shichigahama's water distribution system.

Figure 3. The distribution system in Shichigahama

As previously explained, as Shichigahama does not have its own purification plant, its waterworks was completely cut off when the distribution main pipe from Enterprise Bureau in Miyagi was broken by the earthquake. The distribution pipes in Shichigahama were also damaged by the earthquake. In particular, the air valve and the water pipe bridge were severely damaged in the coastal area. It took 35 days to fix the water failure in the distribution main from the Enterprise Bureau in Miyagi but the coastal area remained out of service because there were no houses remaining to service.

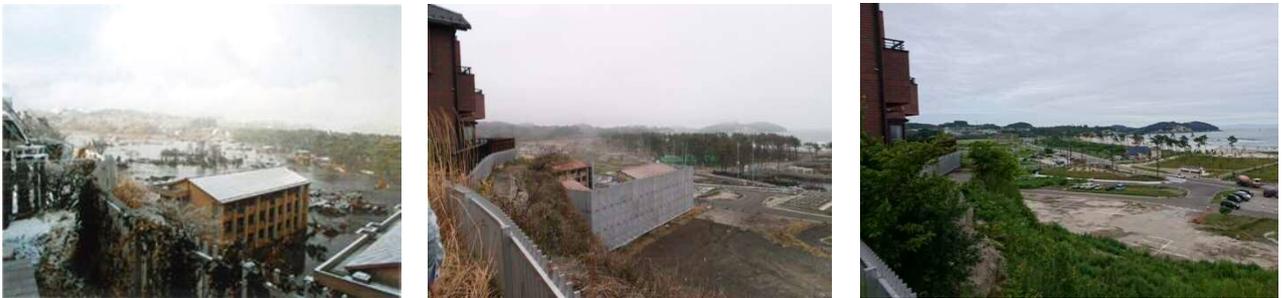
In the model project, the town of Shichigahama focused on the hydrological estimation in hilly areas by considering the collective relocation of the residents from coasts areas. Applying the model project make the reconstruction of the town very smooth compared to the reconstruction efforts of other waterworks entities as shown by Picture 4 and Picture 5.

Picture 4. Shichigahama public housing in 2011, 2013, and 2017(from left to right)

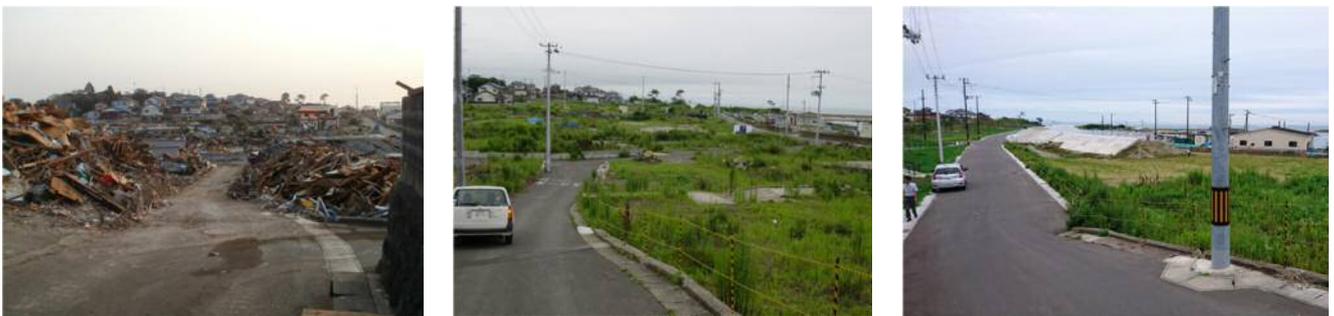
Picture 5. Shobuta-hama beach(south area of Shichigahama) in 2011, 2013, and 2017(from left to right)
