# Verification of Design Method of Pipeline Crossing Fault with Earthquake Resistant Ductile Iron Pipe using Large-scale Split-box Test

## ABSTRACT

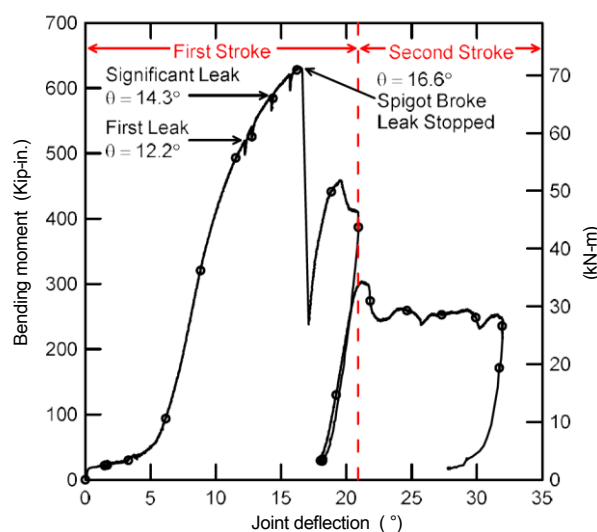
Figure 6. Bending moment versus joint deflection

The bending moment versus joint deflection relationship is shown in Figure 6. The bending moments owing to the pipe, water, and spreader beam weights are included in the bending moment versus the deflection calculations. Figure 7 shows the pipe specimen during and after the test. The results are as follows.

- (1) No leakage occurred at  $8^\circ$ , which is the performance limit of GX-type joint.
- (2) No leakage occurred at  $12^\circ$ , which is 1.5 times the performance limit of GX-type joint.

- (3) The first leakage of approximately 0.4 l/min (0.1 gal/min) was observed at the deflection of  $12.2^\circ$ , corresponding to a small fluctuation in the pressure as shown in Figure 6.

- (4) At the deflection of  $14.3^\circ$ , the pressure reduced to 410 kPa (60 psi), and the pipe leaked at a significant leakage rate of approximately 26.5 l/min (7 gal/min).

- (5) The leakage stopped at the deflection of  $16.6^\circ$ , after which the pressure stabilized with very small pressure fluctuations.
- (6) The test was stopped when the joint reached the joint deflection of  $32^\circ$ , as shown in the figure. The pipe was unloaded, thereby reducing the deflection to  $29.2^\circ$  after which the pipe was depressurized.

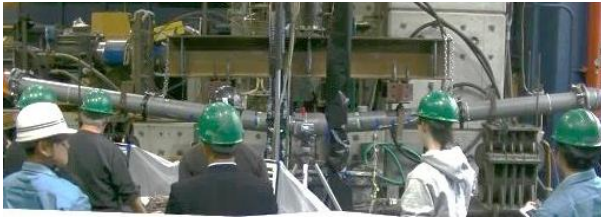
Figure 7. Bending specimen during and after the test

[12.2°]

[32°]

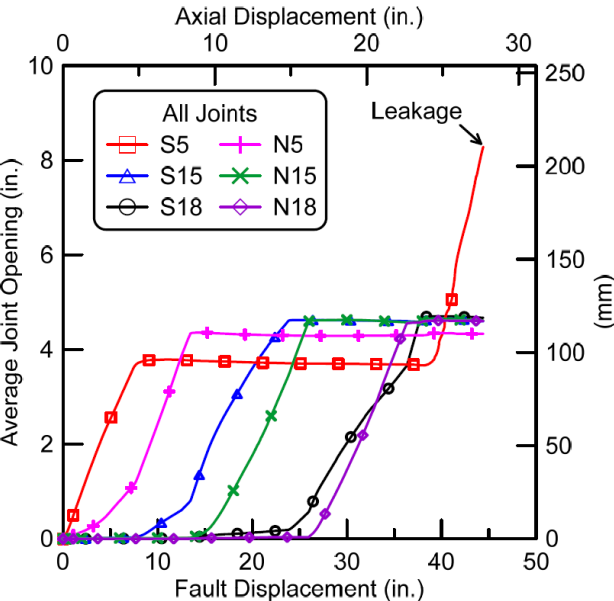
Figure 12. Amount of joint extension

Figure 12 shows the amount of joint extension versus fault displacement. Figure 13 shows the joint deflection versus fault displacement. The results are as follows.

- (1) After the joints S5 and N5 located near the fault began to extend to their limits, the joints S15, N15, S18, and N18 on both sides of S5 and N5 began to extend to absorb the ground displacement. The behavior of the chain structure pipeline was observed.
- (2) When the fault displacement was 0.96 m, all the joints in the boxes were fully extended. No leakage occurred in this step.
- (3) When even larger displacement that exceeded the performance limit of the ERDIP was applied to the fully extended pipeline, joint S5 began to pull out. However, no leakage occurred immediately.
- (4) When the fault displacement was 1.13 m, the amount of extension of joint S5 reached 210 mm. At this time, the end of the spigot passed the rubber gasket and leakage occurred.
