Damage Analysis of Air Valves of Drinking Water Pipeline in the 2016 Kumamoto Earthquake

T. Inui, Kanazawa University, Japan

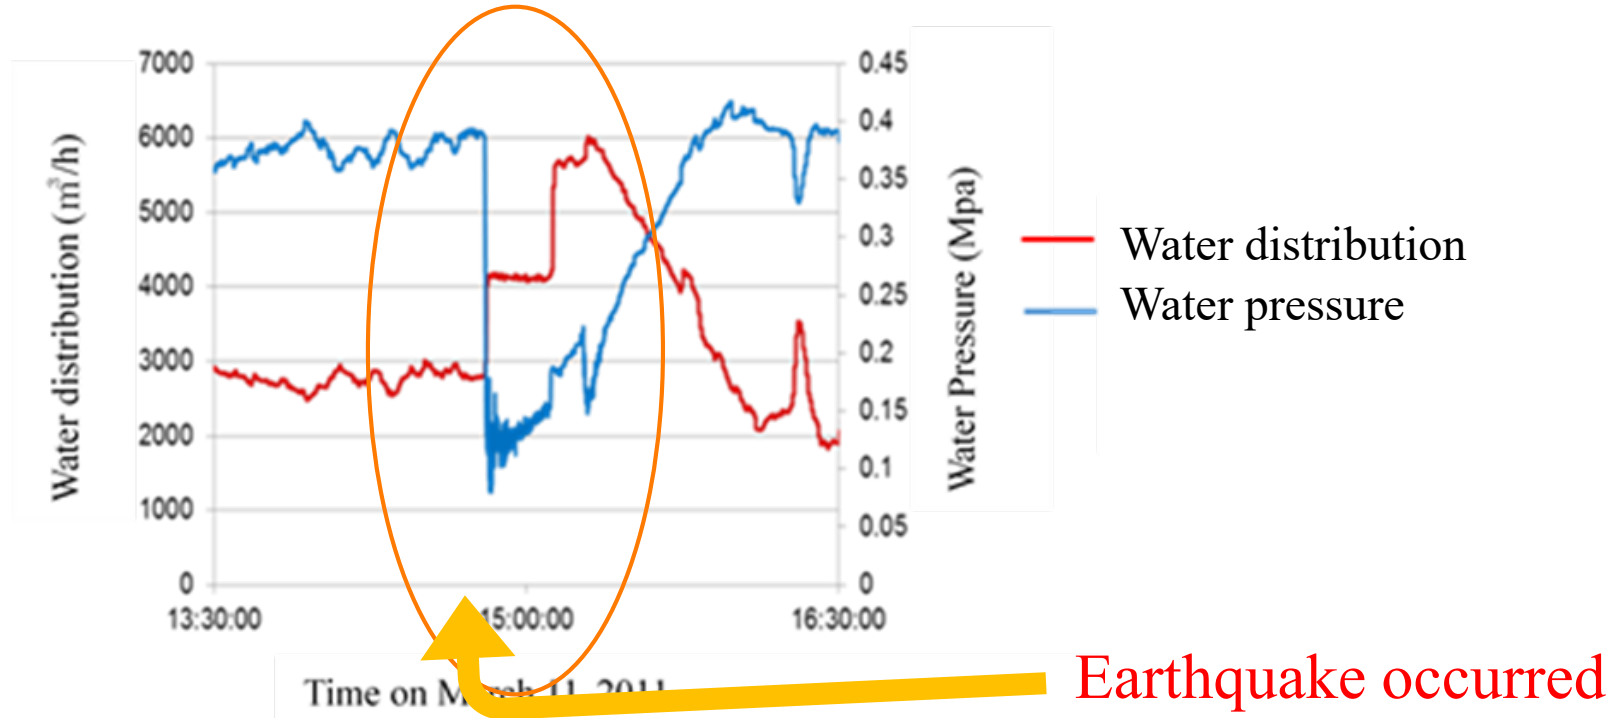
- ▶ Rapid increase in flow rate
- ▶ Rapid water pressure drop

Abnormal behavior of water distribution system occurred.

Changes in water distribution and water pressure
at the western part of Saitama City during the 2011 Tohoku earthquake

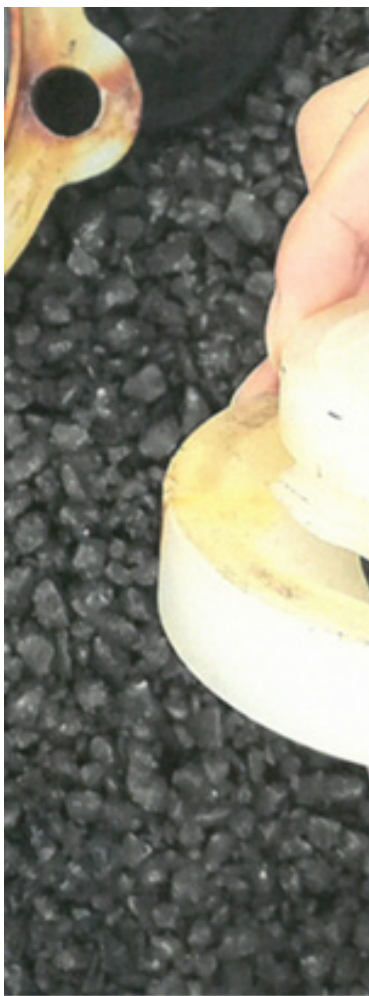
Damaged floating valve body

- ▶ Measures against sudden changes in water pressure to the floating valve body and the float valve body are of utmost importance as countermeasures against earthquakes.
- ▶ Countermeasures against earthquake shaking are, however, indispensable for the part in contact with the outside such as the flange joint part.

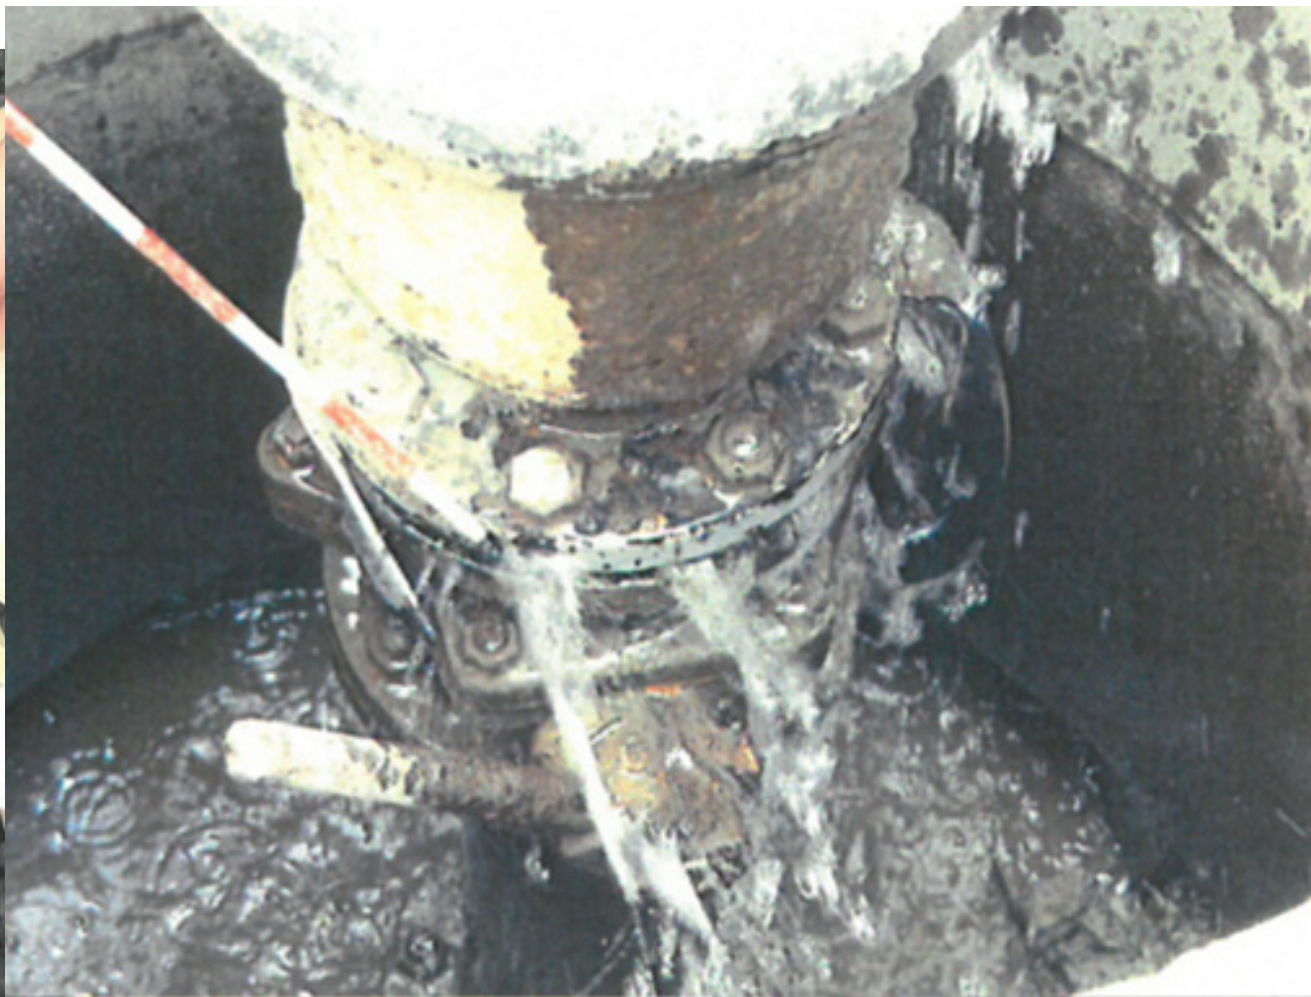
Leakage from flange joint

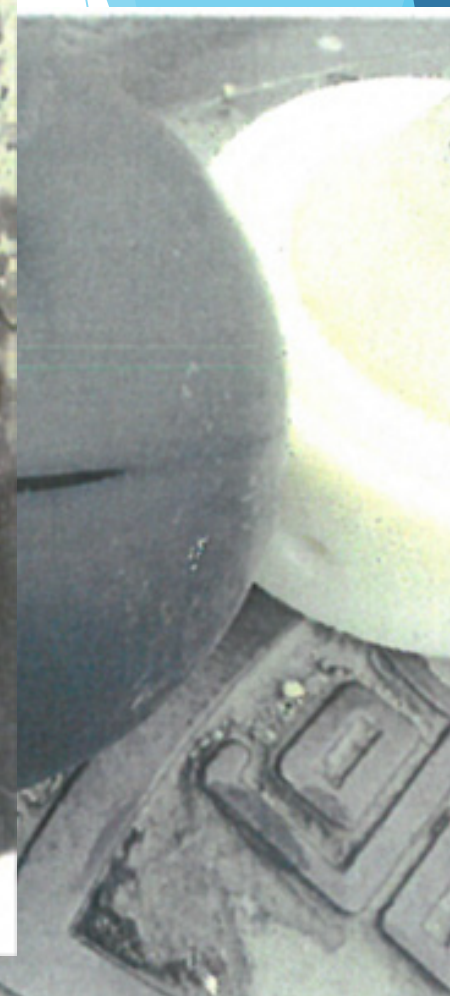
Damaged float valve body

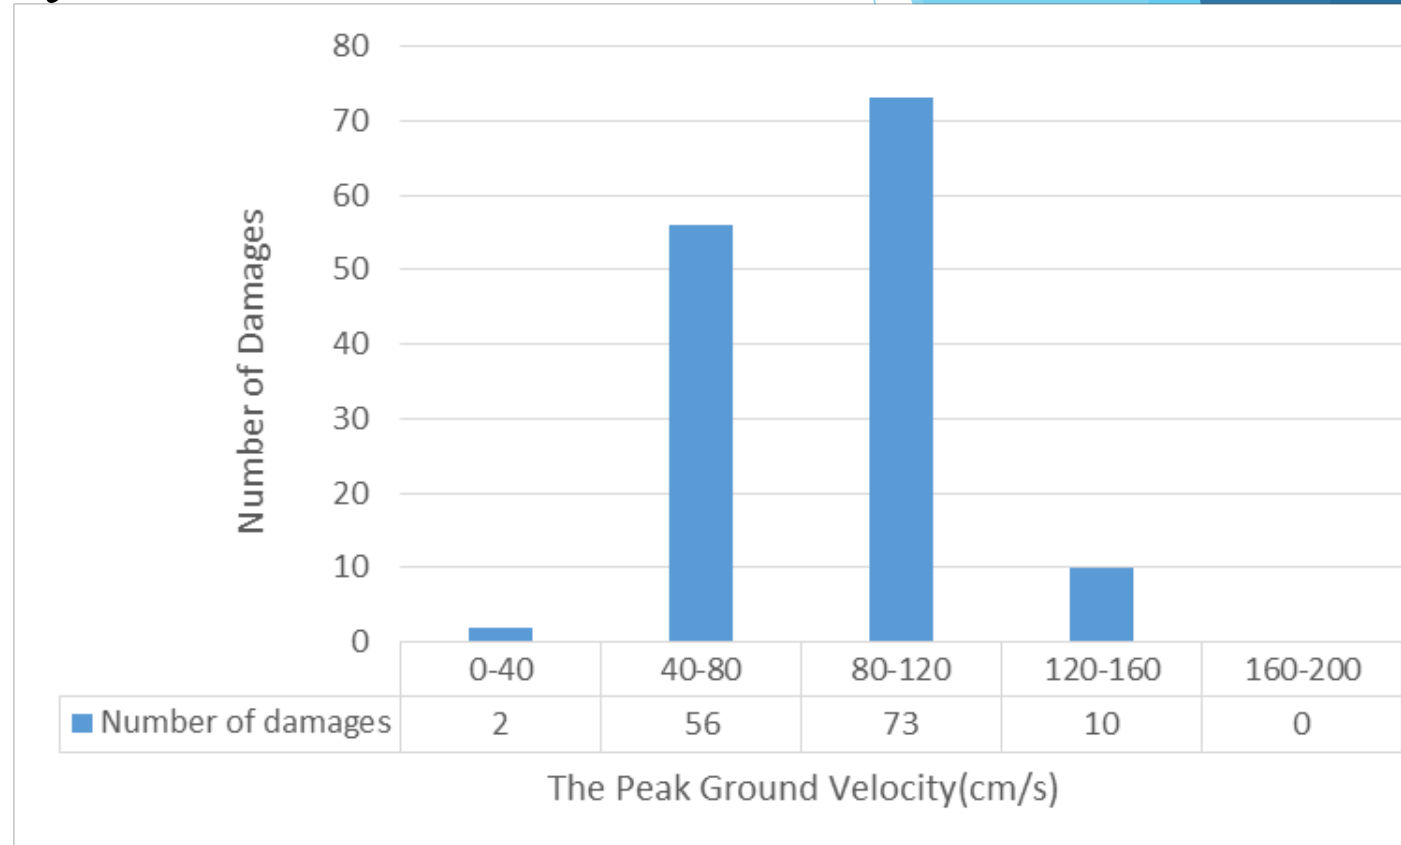
- ◆ Number of damage to fitting in each PGV range
 - ▶ There are many damage at the point where the PGV is 80 cm / s or more.
 - ▶ Damages in the area of 40 to 80 cm / s also increased to more than 50 cases
 - ▶ Damage was also confirmed at less than 40 cm / s although only 2 cases were damaged.

Number of damage to fitting in each PGV range
