NETWORKED HYBRID TESTING OF A FULL SCALE RCS COMPOSITE FRAME

Chui-Hsin Chen, Wen-Chi Lai, and Keh-Chyuan Tsai
National Center for Research on Earthquake Engineering, Taiwan,
chchen@ncree.gov.tw, r90521215@ms90.ntu.edu.tw, kctsai@ncree.gov.tw

Paul Cordova and Greg G. Deierlein
J.A. Blume Earthquake Engrg. Center, Stanford University
cordova@stanford.edu, ggd@stanford.edu

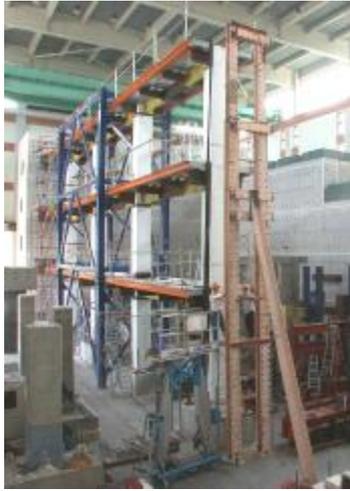
Photo 1 Large-scale, three-story, three-bay RCS moment frame

The large-scale, 3-story RCS frame shown in Fig. 1 and Photo 1 is employed in this experimental research. The typical bay width of 7000mm and typical story height of 4000mm have been found common in Taiwan and US building configuration. The 2150 mm wide concrete slab is adopted to develop the composite action of the beams. Measuring 12 meters tall and 21 meters long, the frame is among the largest frame tests of its type ever conducted. The three-story prototype structure is designed for a highly seismic location either in Taiwan or California. Prior to the frame test, a series of subassembly tests have been completed in the structural laboratory in NCREE and some recommendations have been concluded (Tsai and Chen 2002, Cheng and Cian 2002, Chen and Lin 2002) for the design of frame specimen. Meanwhile, this experiment also provides the impetus to explore international collaboration and data archiving envisioned for the Networked Earthquake Engineering Simulation (NEES) initiatives and the Internet-based Simulations for Earthquake Engineering (ISEE) (Hsieh et al. 2002, Yang et al. 2002) launched recently in USA and Taiwan, respectively.

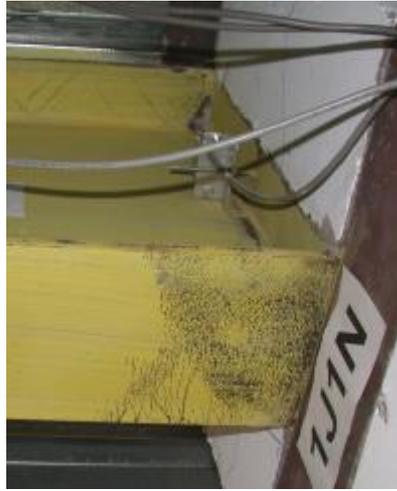
Photo 2 White wash flaking at the beam bottom flange (CC50/50 45 sec)

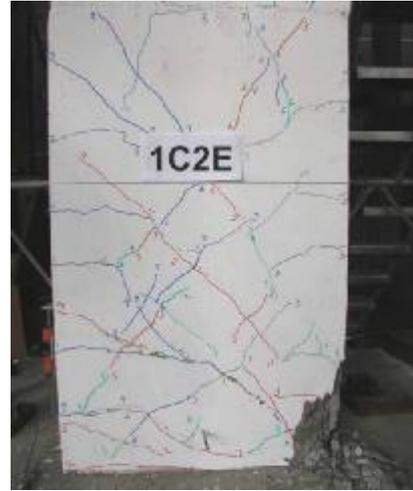
Photo 3 Concrete spalling in the column bottom ends in the first story (1st LP10/50x0.8 39.96 sec)

At the 5.74 second time step, some of the beam flanges on the first and third floors locally buckled. None of the beams on the second floor were found buckled. In the end of this time history, severe concrete spalling shown in Photo 3 was found in the column bottom ends in the first story.

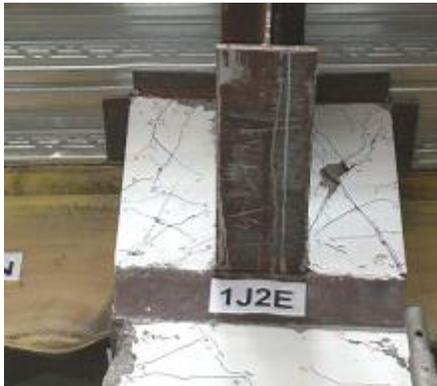
Photo 4 Shear failure and bearing failure of beam-column connection in the first story (CC2/50 27.96 sec)

first story were crashed due to bearing failure. Columns in the second story were found crashed in the bottom ends along with the crash of the concrete slab around them. Some columns in the second story were found damaged on the top and plastic hinge appeared there. At the step of 27.96 second, the test was stopped because the roof displacement has reached the preset limit (about the stroke capacity) of the actuators. In the end, the column bottom ends in the first story were crashed so drastically that the stirrups of the columns were exposed. At the same time, all the beam-to-column panel joints in the first story were found damaged with shear failure and bearing failure as illustrated in Photo 4. On the second floor, bearing failure was found under the steel band plate, and the beam splice plates yielded slightly.

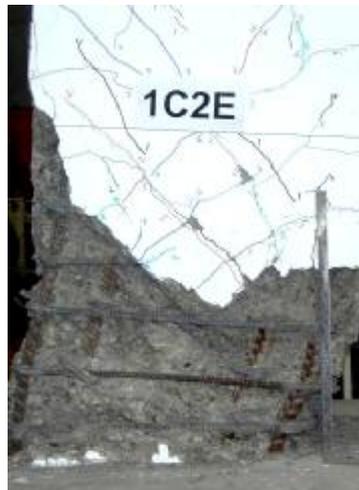
Photo 5 Buckling of main bars in the column bottom end in the first story (Pushover)

After the final pushover test to reach a roof lateral drift of about 1.0 meter, main bars in column bottom ends in the first story were severely buckled (see Photo 5), and the plastic hinges were evidently formed in the range of about a column-depth high from the top of the footings. Moreover, a beam splice plate at one first floor beam bottom flange also fractured as shown in Photo 6. The damage conditions on the second and the third floors were evidently more severe than those found after all the pseudo-dynamic tests.

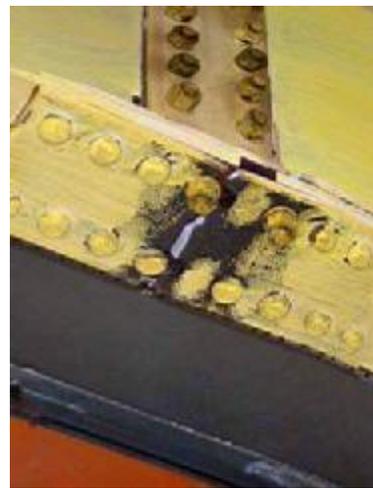
Photo 6 Fracture of beam splice steel plate (Pushover)
