5th IASPEI / IAEE International Symposium: Effects of Surface Geology on Seismic Motion

# Soil Liquefaction Issues in Meinong Earthquake

August 15-17, 2016

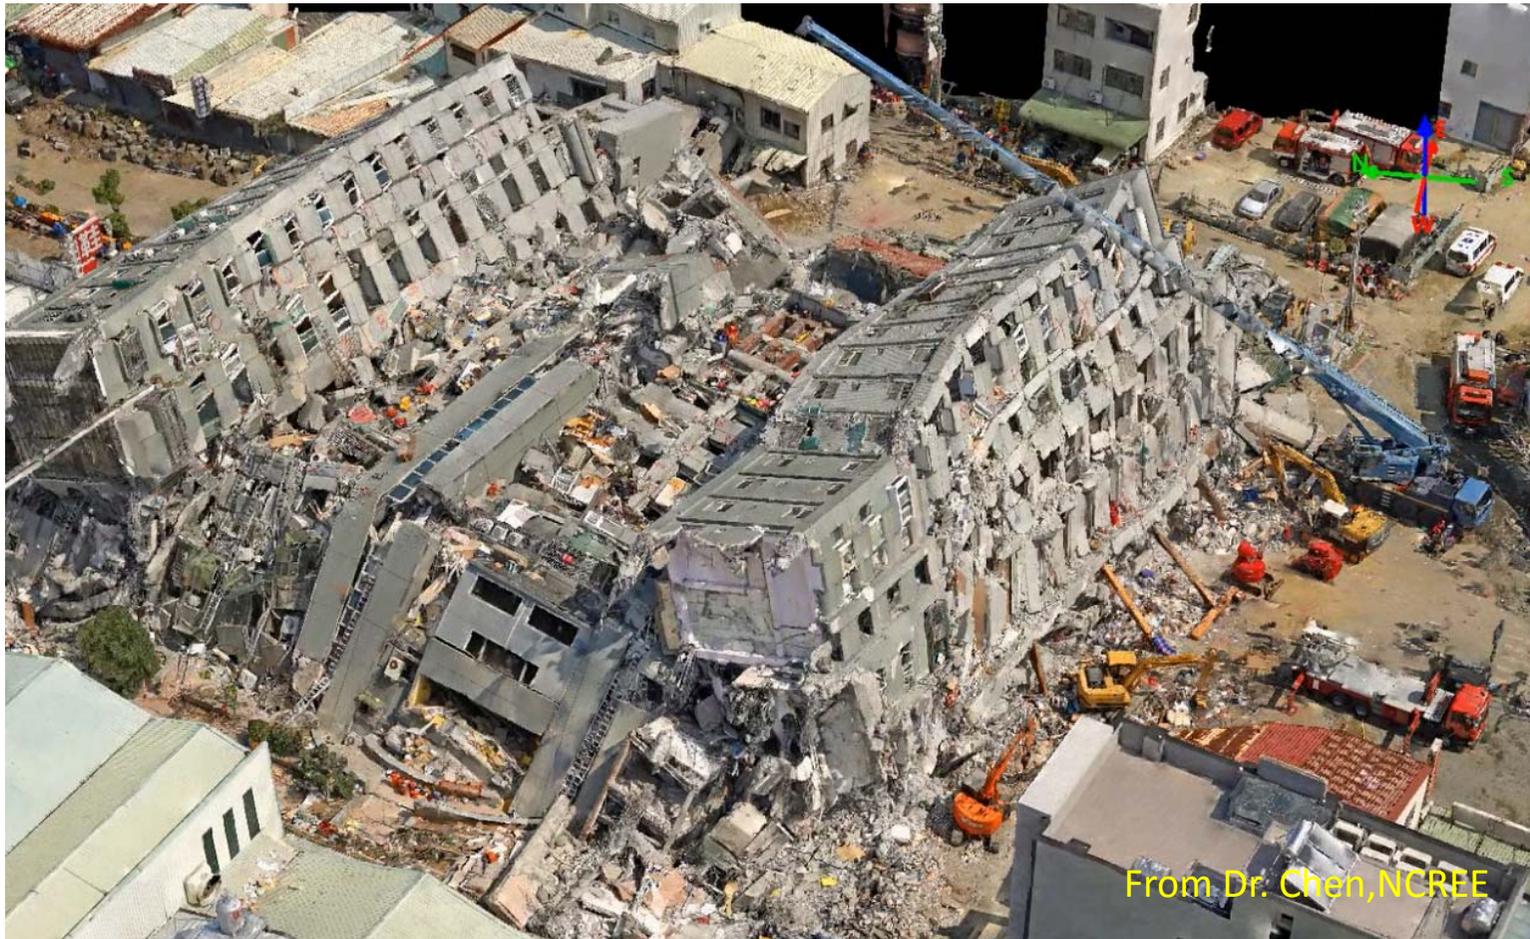
# Collapse of 16-Story Wei Guan Building

115 death

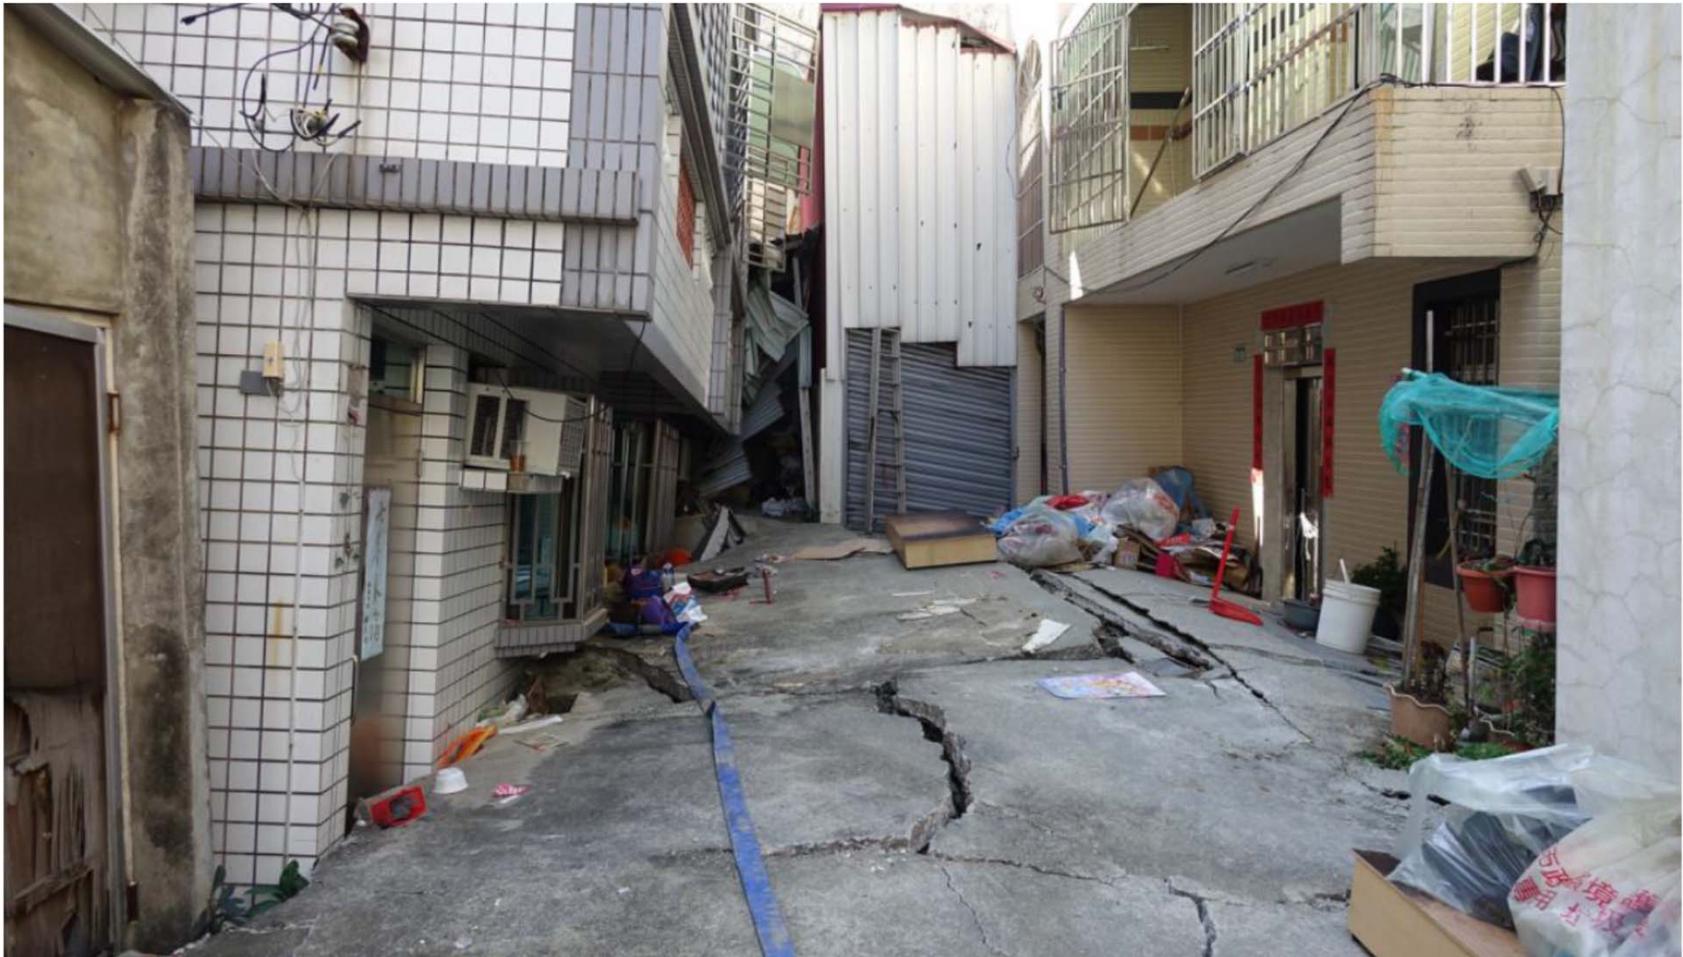
# Soil Liquefaction

severe damage to buildings

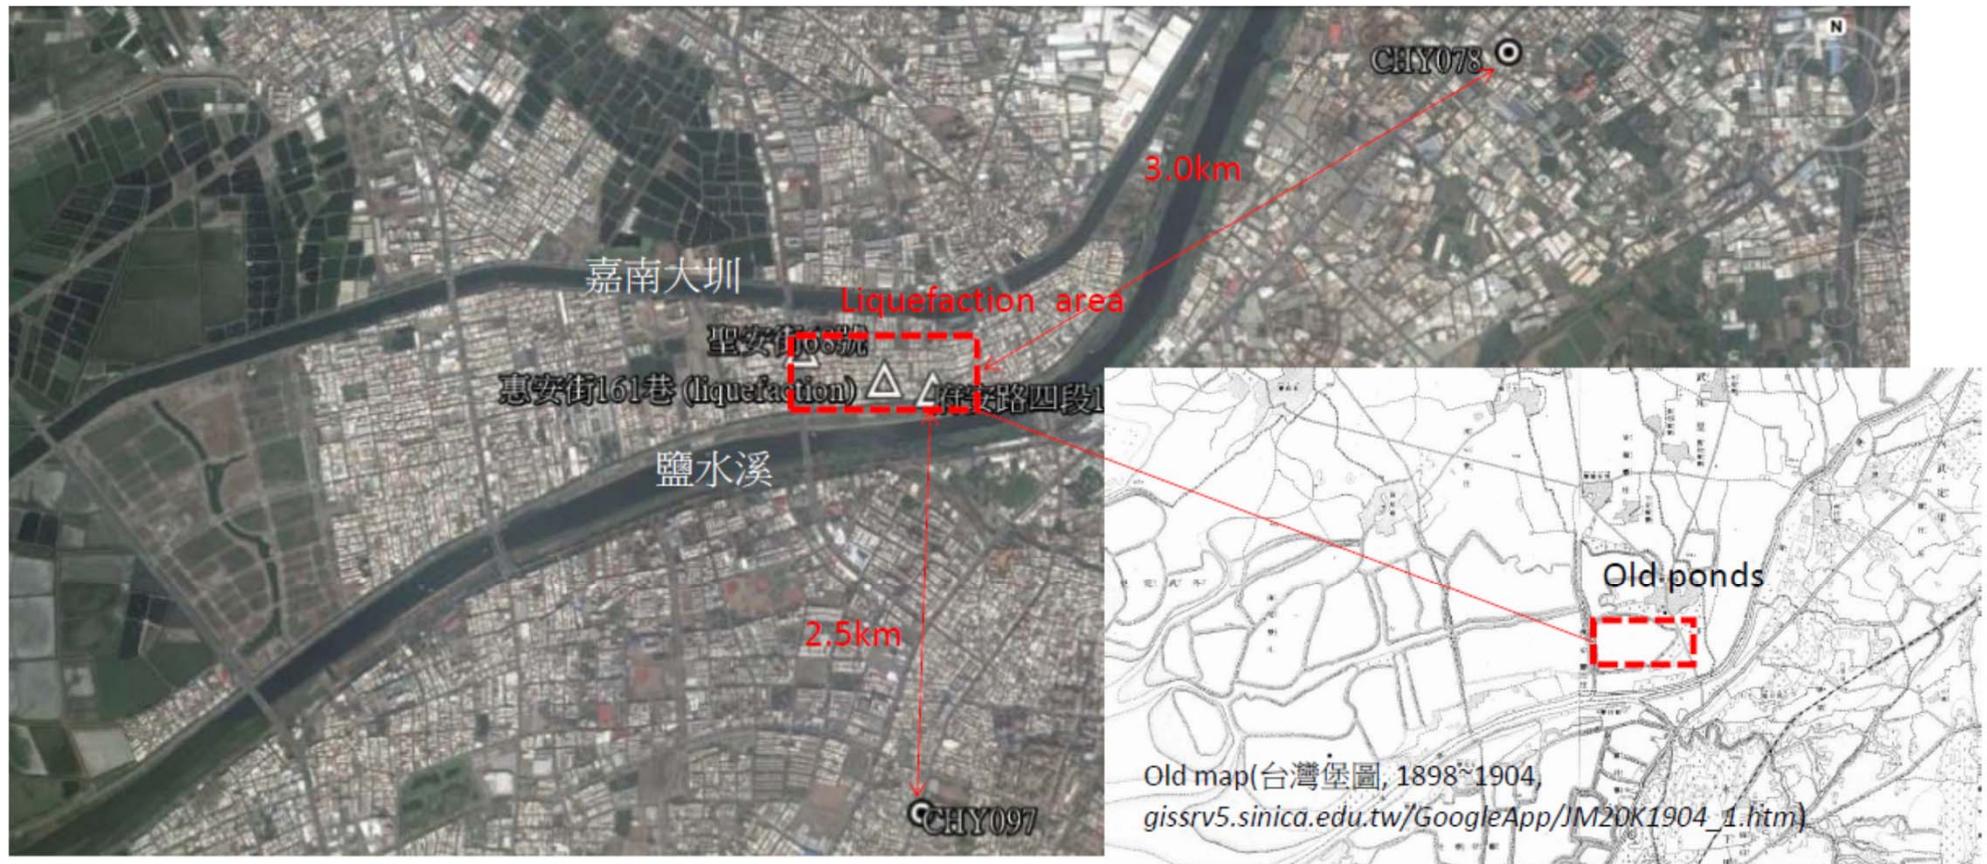
# Damage Conditions of Huian Street (Annan)

Location	Index	Description
Annan	GF1	The settlement of this area ranged from 10~20cm mainly occurred at and around the building. The differential settlement caused cracks between the building and road, meanwhile, the pipeline at the interface was destroyed.
Annan	GF2	
Annan	GF3	The building in this area seriously settled (40~90cm) and tilted (1~7 degrees). The road heaved much and had extensive sand boiling.
Sinshih	GF1	The settlement of building is minor due to soil liquefaction.
Sinshih	GF2	The maximum settlement of column was about 10cm. the maximum tilt of building is about 1 degree. Boiling sand deposited in the kitchen and ditch behind the building. The first floor slab heaved and cracked. The edge of road cracked and damaged the water pipeline.
Sinshih	GF3	The area was fishpond before. The three-story building here is a two span frame structure in long direction with a garage add-on in front of house. Due to soil liquefaction, the column seriously settled and caused the indoor first floor slab heaving and cracking much. The sand/mud boiling was obvious inside the house. Fire lanes heaved and sand deposited in the ditch. The road in front of building heaved and the pipeline was damaged. The sand boiling could be observed everywhere.

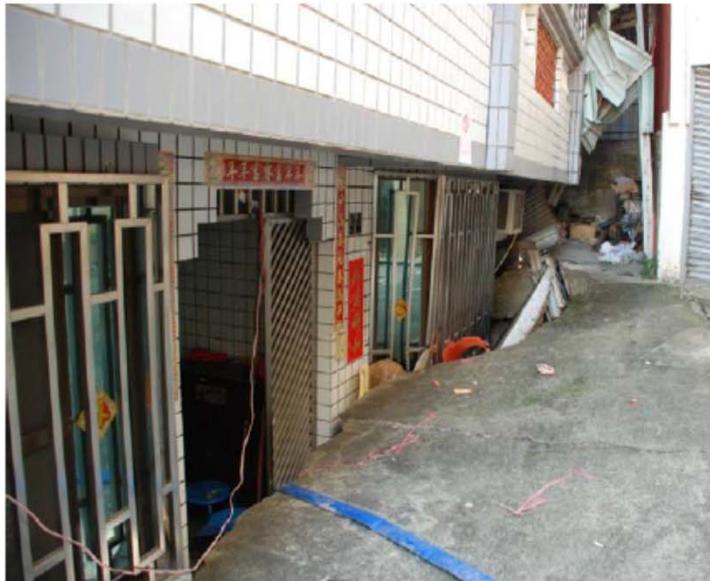
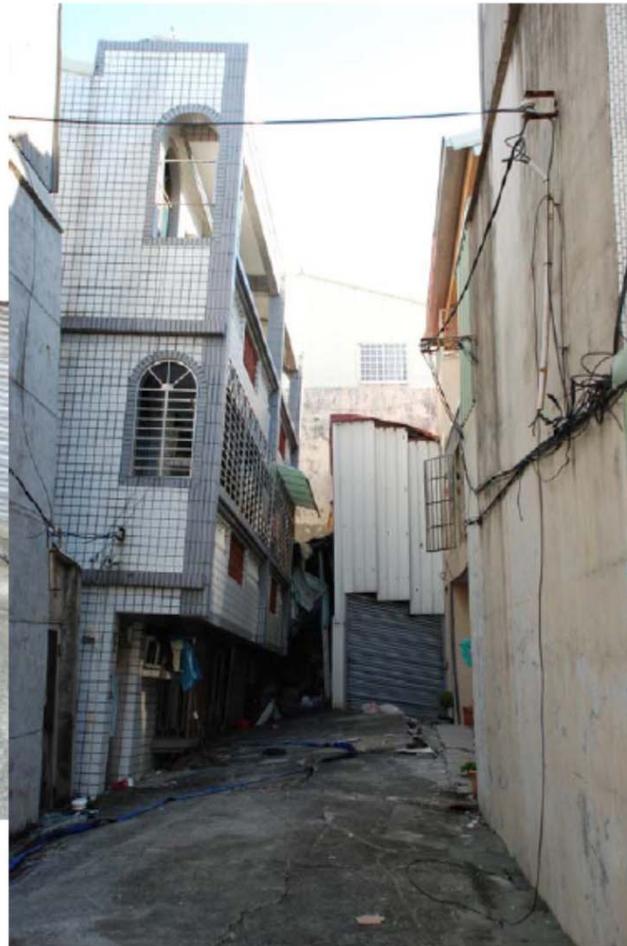
No.8

**3-story RC Building**

Settlement: 90cm  
Tilt angle: 3 deg. Clockwise in EW  
4 deg. Clockwise in NS

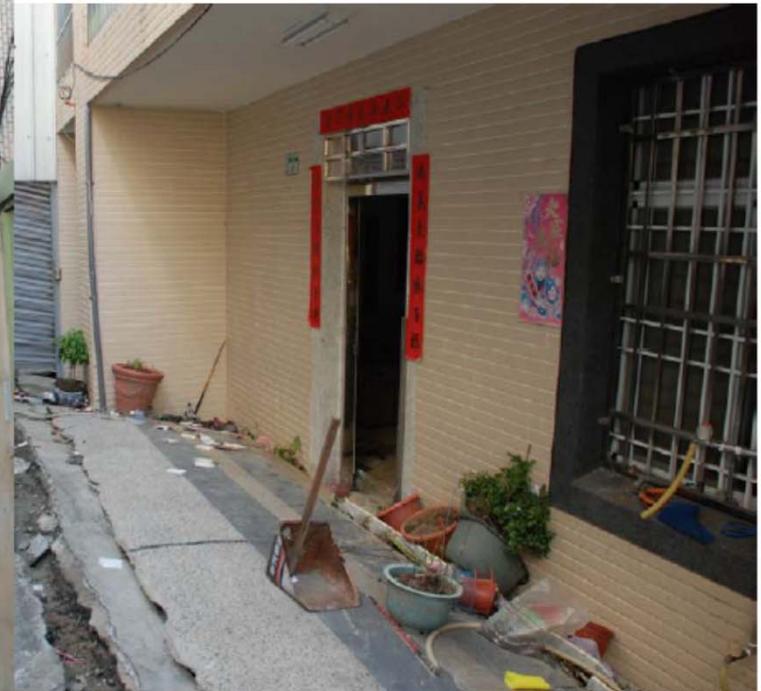
No.6

Settlement: 60cm  
Tilt angle: 2 deg. Clockwise in EW  
2 deg. Clockwise in NS

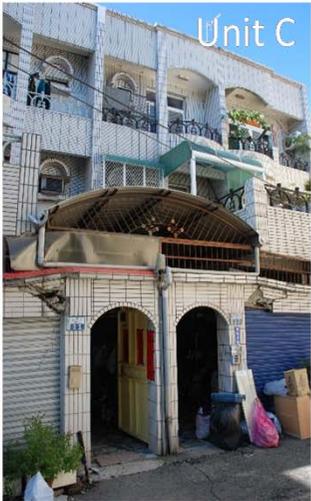
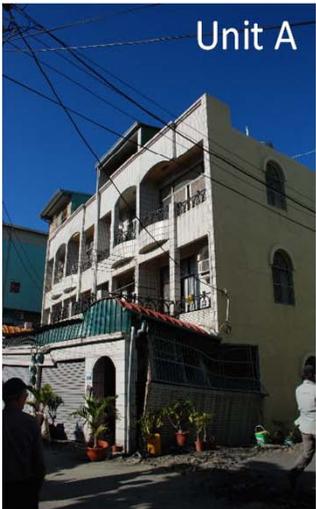
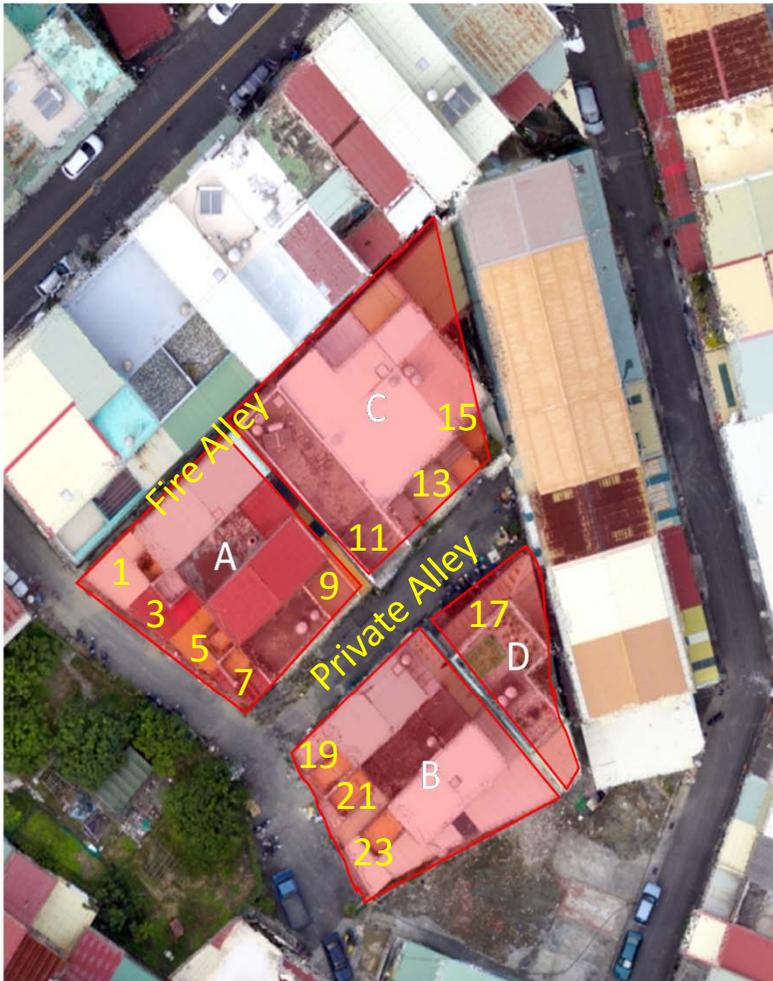
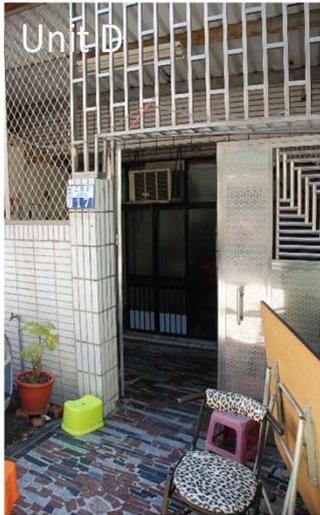
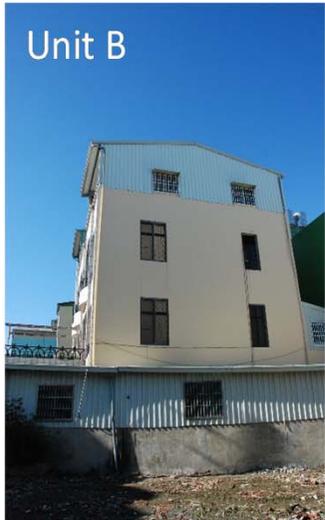
# GF3 Buildings at Sanmin St., Sinshih District

Wenhe St.	GF2	The settlement of building was a few of centimeters. The first floor slab and road pavement had minor cracks. Sand boiling took place nearby.
Wenhe St.	GF3	The maximum tilt and settlement of the building were 4 degrees and 20 cm respectively. It could be found the sand boiling on the surface of roads nearby.
Zhengjue St.	GF1	The degree of soil liquefaction was slight. The differential settlement of building caused brick wall cracked, window railings deformed, as well as road and floor slab cracked.

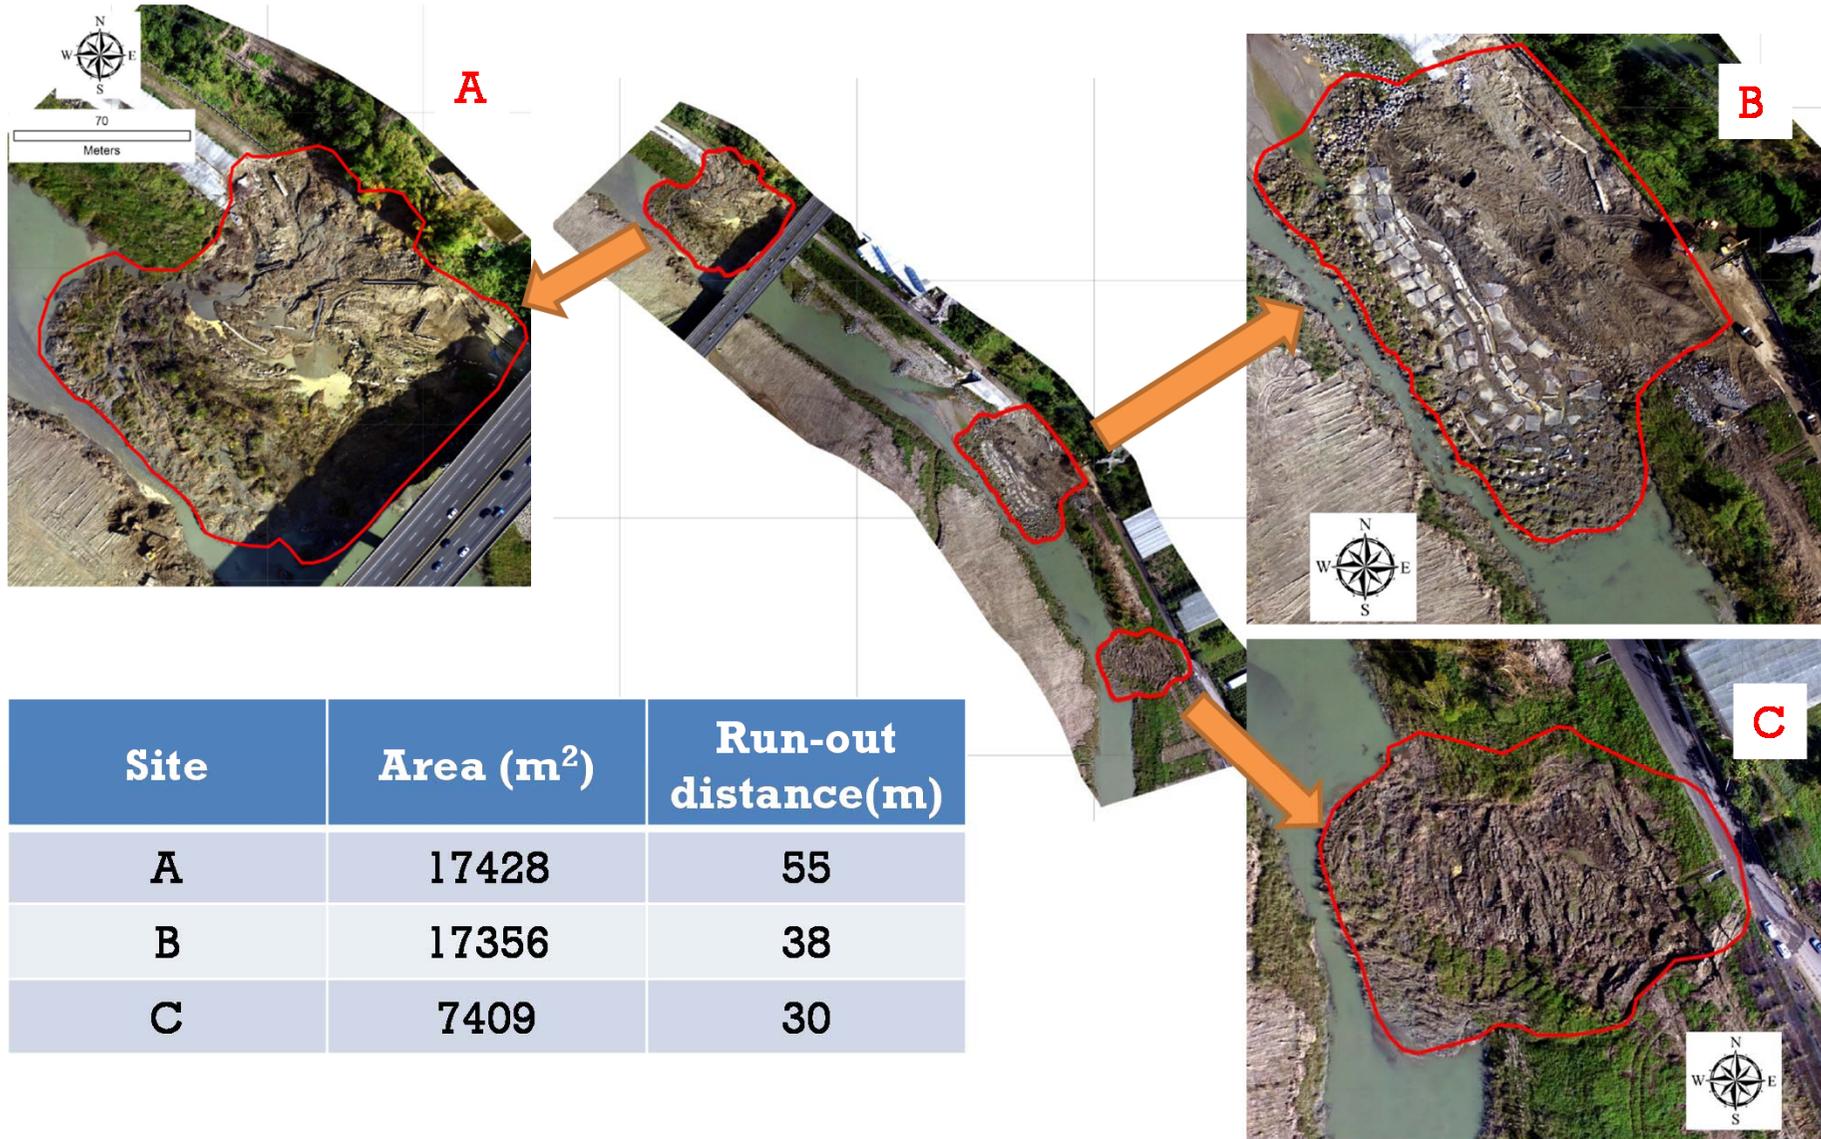
# Slides at Tsengwen River

- Height: 15m (Slope: 1:2 )
- 30cm unreinforced concrete slab
- Completed in 2011
- PGA about 287.5 gal

- Flow slides caused by soil liquefaction?
- The soil formations of the three sites are mainly ML and CL soil layers
- whether the cohesive soils have the possibility to cause large-scale flow slides or not?
- The seepage of ground water at the scarps of the slides are clearly observed after earthquake
- The underlying soils below the concrete slab for protecting the slope of revetment may be eroded away
- The concrete slab may be thrown far away due to strong seismic motion

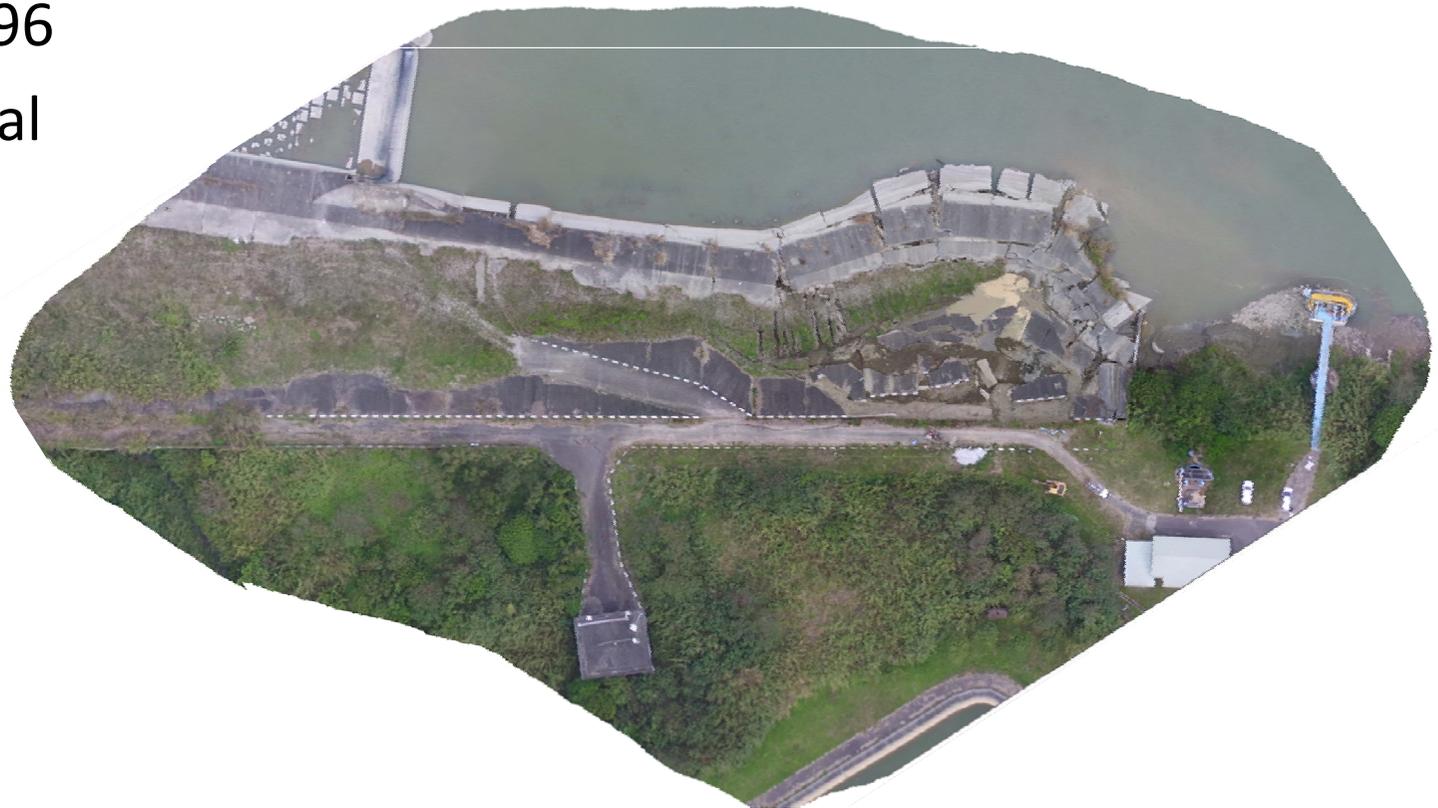
- Height: 19m (Slope: 1:2 and 1:1.5 )
- 30cm unreinforced concrete slab
- Completed in 1996
- PGA about 325 gal

Area (m <sup>2</sup> )	Run-out distance(m)
2854	45

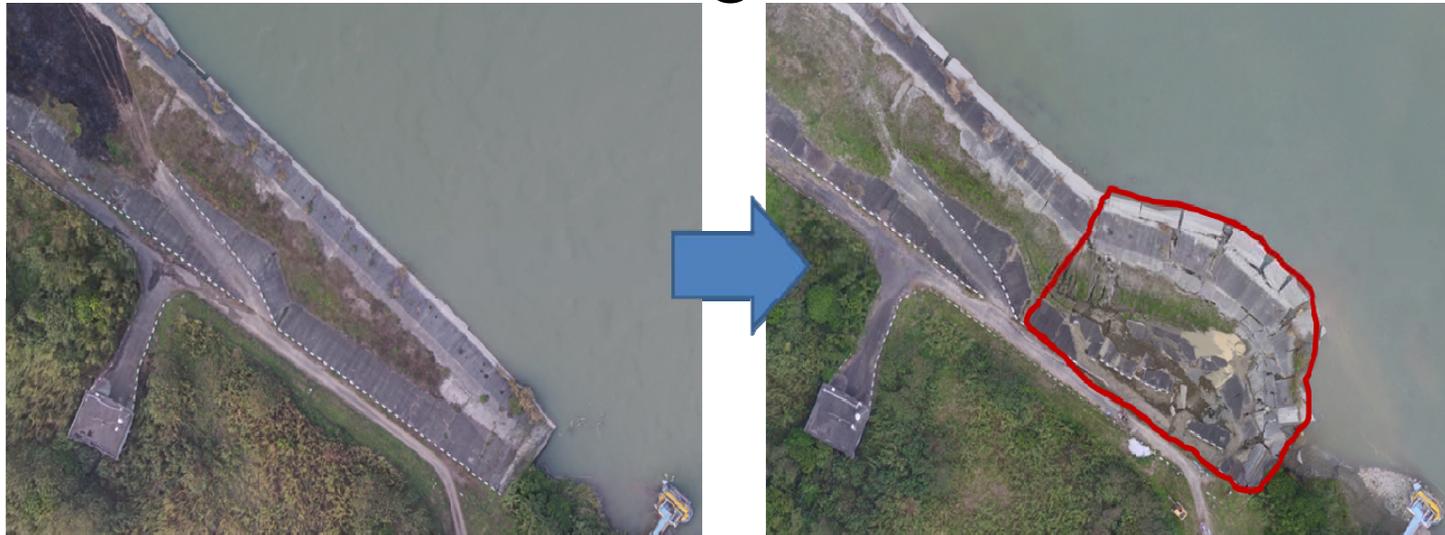
# UAV images and the cross sections of the damaged revetment

(a) UAV image before EQ

(b) UAV image after EQ

- The seepage of ground water was clearly observed at the scarp.
- It was guessed the underlying sandy soils below the concrete slab was eroded away and deposited at the toe of the revetment.
- The saturated sandy soils at the toe of revetment liquefied during the earthquake and caused the slide of the lower slope and then induced the slide of the upper slope.
- this slide is intuitively considered as the flow slide caused by soil liquefaction. However, future study is necessary to confirm this slide was really triggered by soil liquefaction.
