# **Damage Analysis of Air Valves of Drinking Water Pipeline in the 2016 Kumamoto Earthquake**

Taichiro Inui, Mitsuyasu Tamase and Masakatsu Miyajima

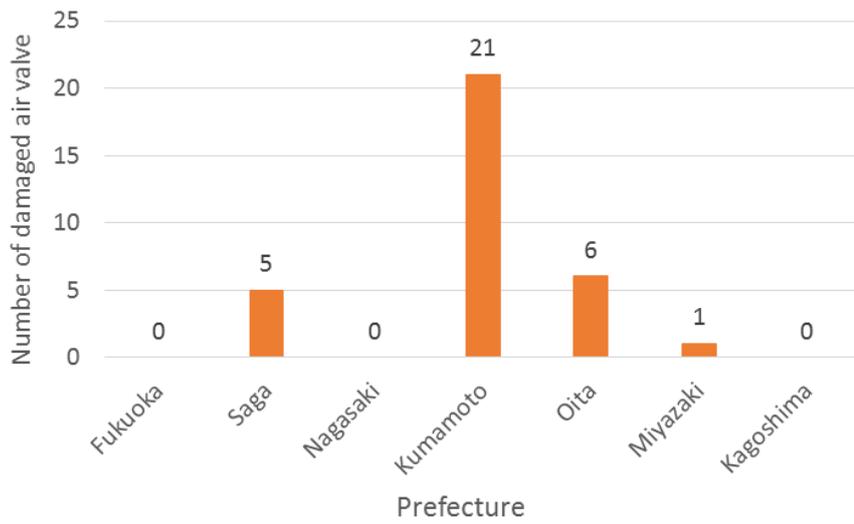
Figure 2. Number of damage to air valve in each prefecture

The number of damage to air valves in each prefecture in the 2016 Kumamoto earthquake is shown in Figure 2. According to Figure 2, it is understood that the damage was concentrated in Kumamoto Prefecture and Oita Prefecture where the epicenter is located. On the other hand, air valve damage has also occurred in areas relatively far from the epicenter such as Saga City in Saga Prefecture and Nobeoka City in Miyazaki Prefecture.

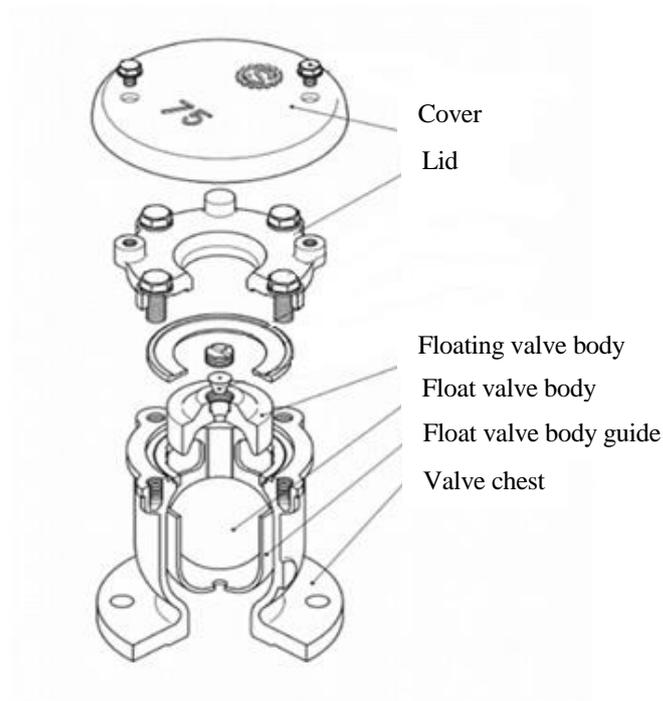
Figure 3. The structure of air valve [3]

Figure 3 shows the structure of the air valve, and Figures 4 and 5 show the broken part and factor of the air valve, respectively. Concerning on the damaged part, the floating valve body (Photo 1) had the most damage and then the float valve body (Photo 2). The floating valve body / float valve body is a part for efficiently exhausting the air contained in the water in the pipeline. As mechanism, when the air contained in the water in the pipeline accumulates in the air valve, as the water level drops, the floating valve body / float valve body descends, the air hole valve seat is opened, and the air is exhausted. When the exhaust is completed, the float valve body rises and the air hole closes. This movement is automatically repeated to discharge the air in the pipeline. In addition, the float valve body guide / cover are also a part susceptible to the influence of water pressure fluctuation, and it is thought that it was influenced this time as well. On the other hand, the flange joint part (Photo 3), which was damaged next to the floating valve body and the float valve body, is in contact with the outside at the part which plays a role of connecting the water pipe and the air valve, and is not affected by the water pressure fluctuation. Therefore, this damage is considered to be caused by aged deterioration and direct external force caused by earthquake vibration. According to Figure 6, the damage of the flange joint portion occupies about 15% of the whole and is the third most damaged portion.

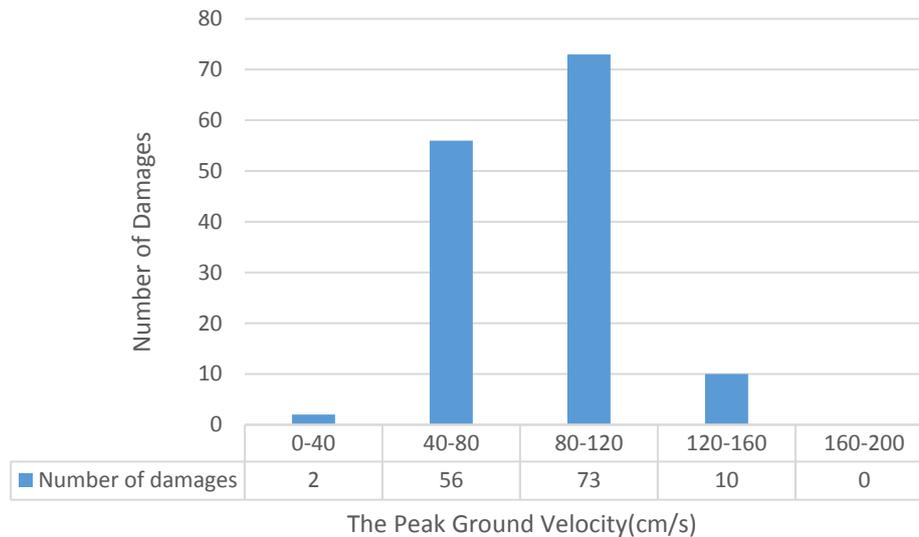
Figure 9. Number of damage to fitting in each PGV range

Figure 8 shows the distribution of the peak ground velocity (PGV) in the 2016 Kumamoto Earthquake and damage to pipe fittings. The relation between PGV and the damage to pipe fittings is discussed here. The damage to pipe fittings occurred almost entirely around the central and eastern parts of Kumamoto City. This figure suggests that more than half of them occurred in the area where PGV was 80 cm / s or more, but some damage occurred even in the area of PGV of 40 cm / s to 80 cm / s where PGV was relatively small. Figure 9 shows the number of damage to pipe fittings in each PGV range. This figure also indicates that the damage to pipe fitting occurred in the area where PGV is more than 80 cm / s. These figures clarify that the damage to pipe fittings concentrated in the central and eastern parts of the city where the distribution pipeline is dense, and in the region where PGV was large. However, it was found that some damage to pipe fittings occurred even in the areas where PGV was relatively small. These areas are sparse distribution of pipelines in case of Kumamoto City. Therefore, it is the magnitude of the seismic vibration affects

fittings damage, but it is possible that factors other than seismic vibration affect pipe fittings and cause damage and leakage even if the seismic vibration is small.
