Damage Analysis of Air Valves of Drinking Water Pipeline in the 2016 Kumamoto Earthquake

Taichiro Inui, Mitsuyasu Tamase and Masakatsu Miyajima

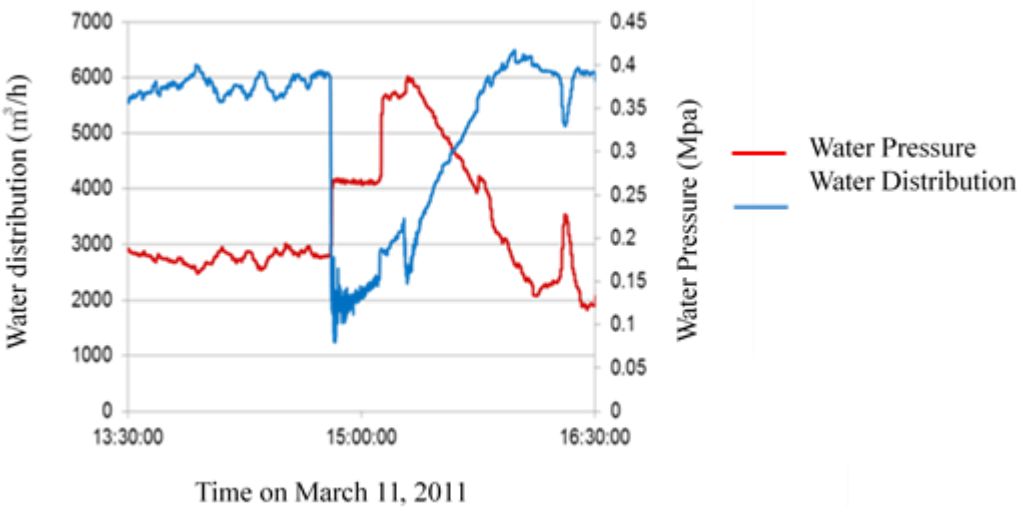
Figure 1. Changes in water distribution and water pressure at the western part of Saitama City during the 2011 Tohoku earthquake [1]

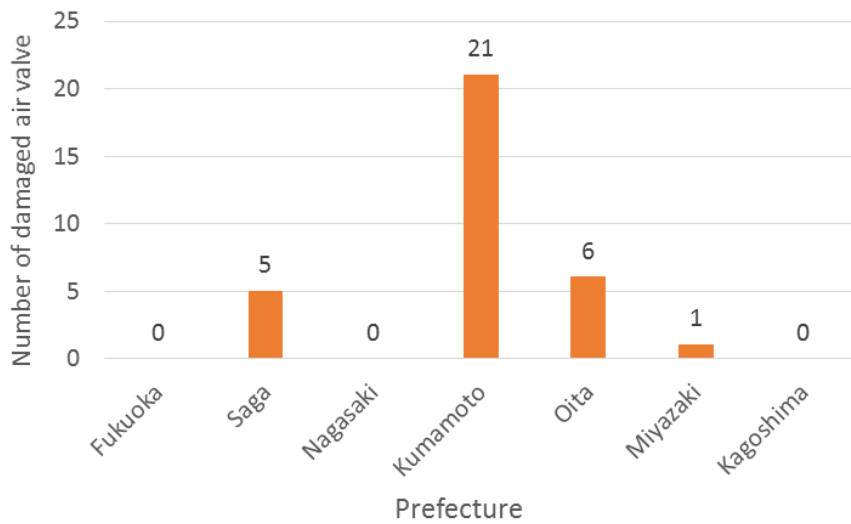
The number of damage to air valves in each prefecture in the 2016 Kumamoto earthquake is shown in Figure 2. According to Figure 2, it is understood that the damage was concentrated in Kumamoto Prefecture and Oita Prefecture where the epicenter is located. On the other hand, air valve damage has also occurred in areas relatively far from the epicenter such as Saga City in Saga Prefecture and Nobeoka City in Miyazaki Prefecture.

Figure 2. Number of damage to air valve in each prefecture

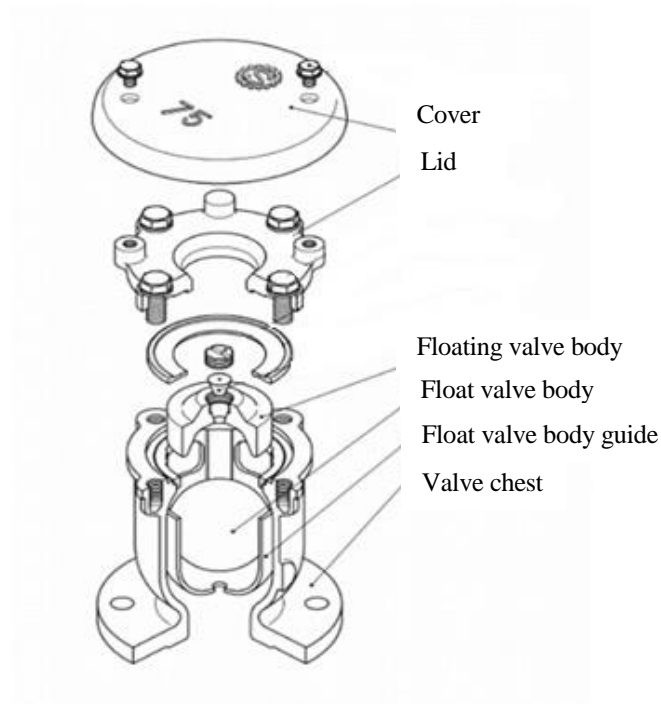
Figure 3. The structure of air valve [3]

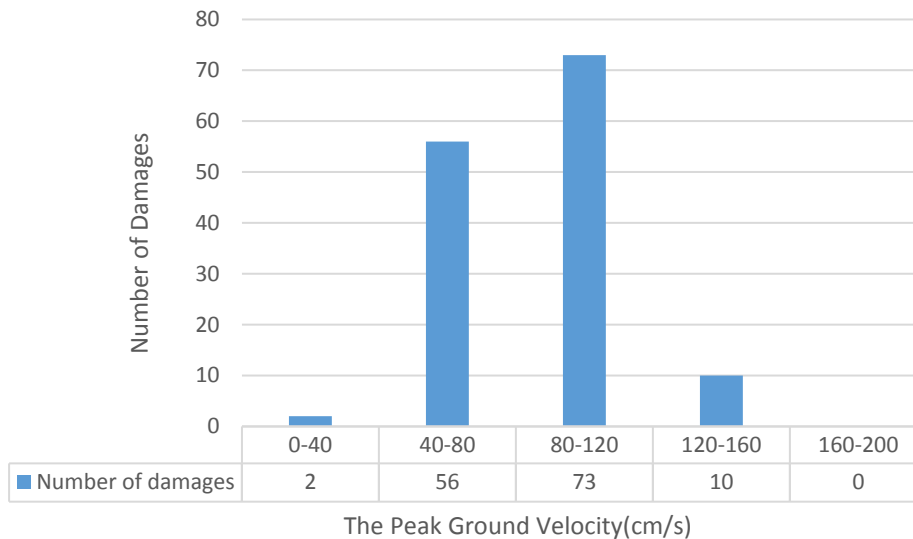
fittings damage, but it is possible that factors other than seismic vibration affect pipe fittings and cause damage and leakage even if the seismic vibration is small.

Figure 9. Number of damage to fitting in each PGV range
