Lessons Learned from Damage to Drinking Water Supply System in the 2016 Kumamoto Earthquake in Japan

> Masakatsu Miyajima Kanazawa University, Japan

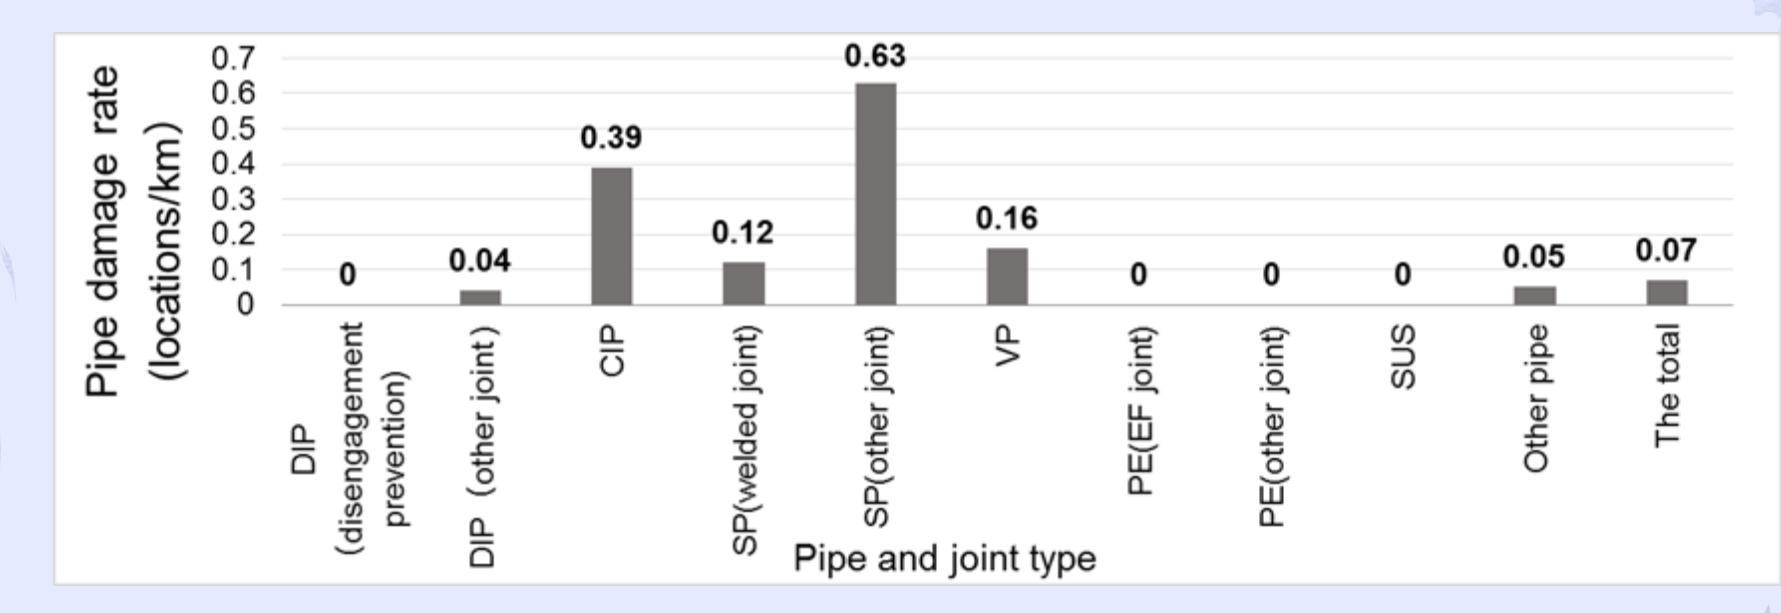
Damage rate of each pipe type

Pipe material	DIP (disengag ement preventio n)	DIP (other joint)	CIP	SP (welded joint) ^{*2}	SP (other joint) ^{* 3}	VP	PE (EF joint)	PE (other joint)	SUS	Other pipe
Pipe damage (no. of locations)	0	72	36	8	59	55	0	0	0	3
Pipe Installation length (km)	583	1882	92	68	93	346	97	8	5	63

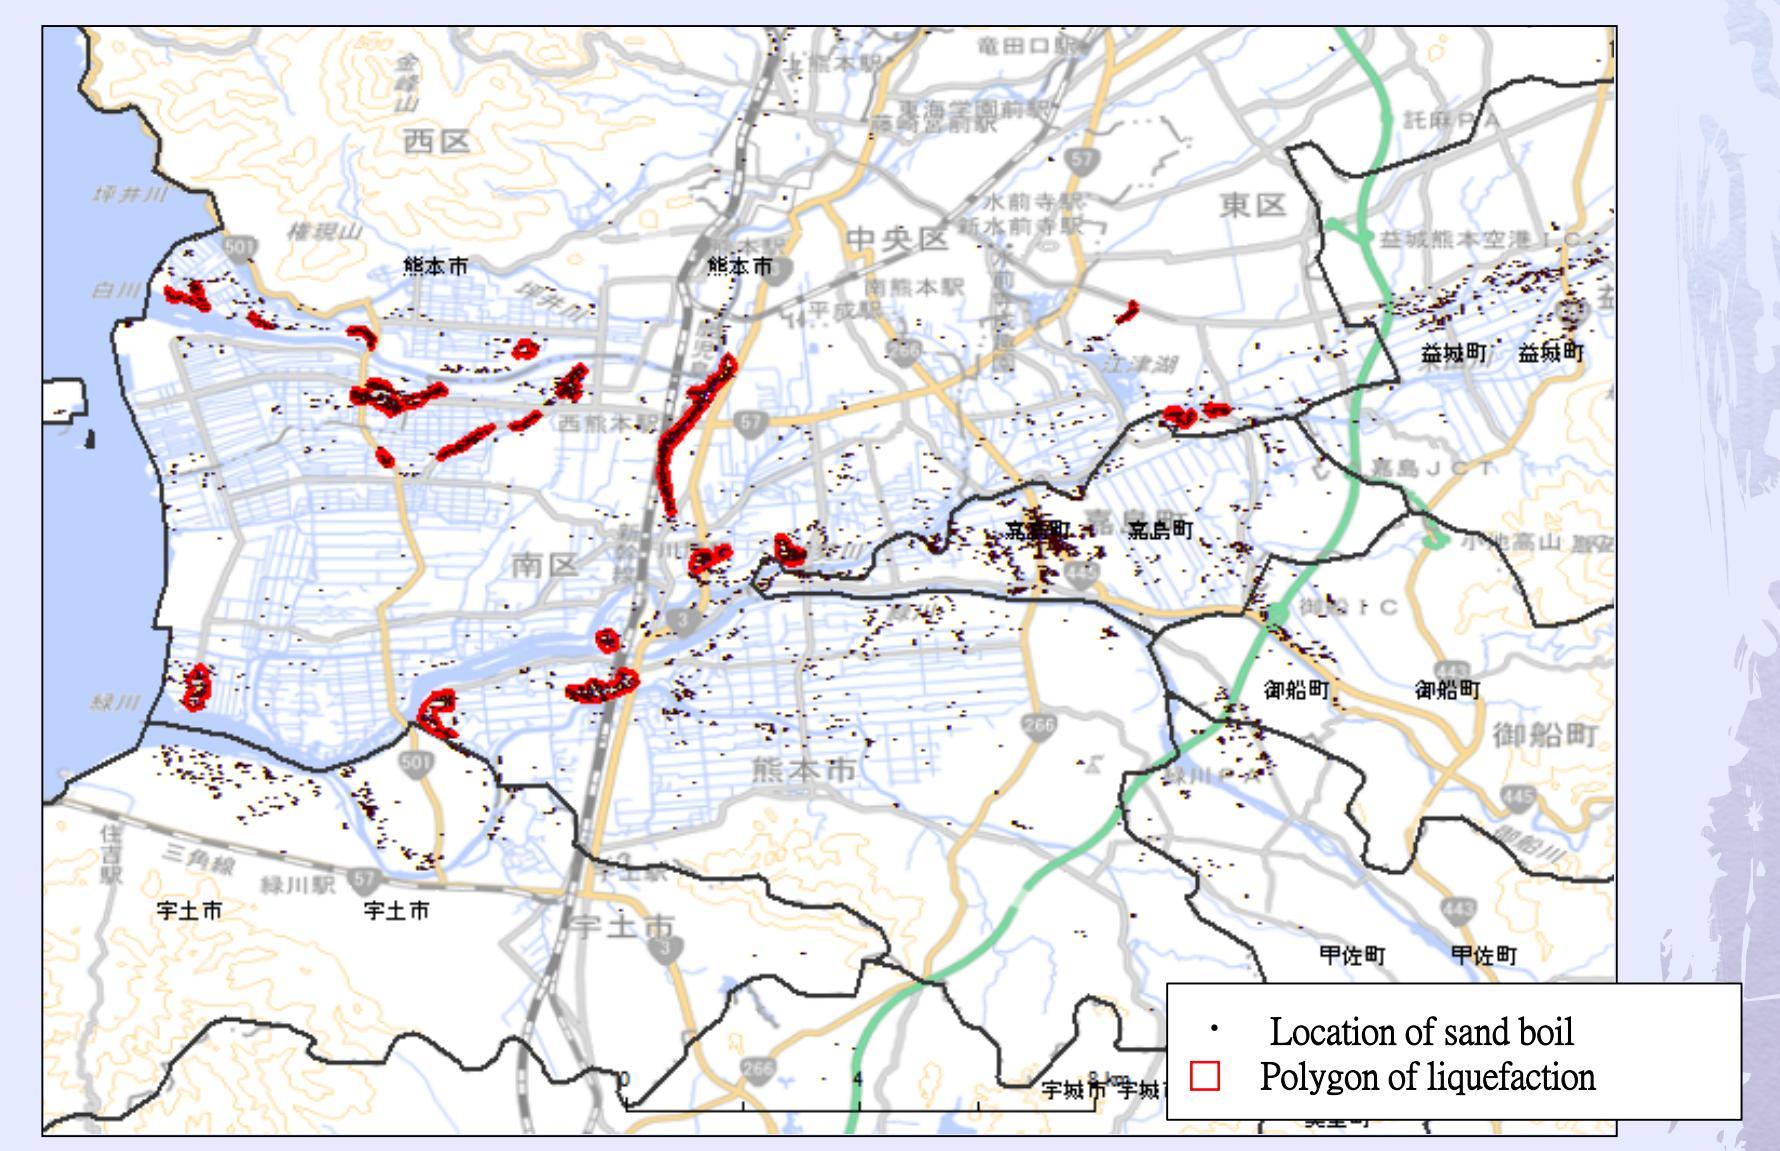
Liquefaction area in Kumamoto City

- Pipe length of liquefied area is about 0.8% of the total length in Kumamoto City. The damage rate of pipelines in liquefied area was however about ten times of that in non-liquefied area.
- The pipelines crossed a surface faulting suffered severe damage. The countermeasure for pipeline crossed a fault is necessary in the future.
- The damage to air valve was caused by not only strong ground motion but also abrupt decrease of water pressure in a pipe. The cause of abrupt decrease of water pressure in a pipe just after an earthquake should be clarified.

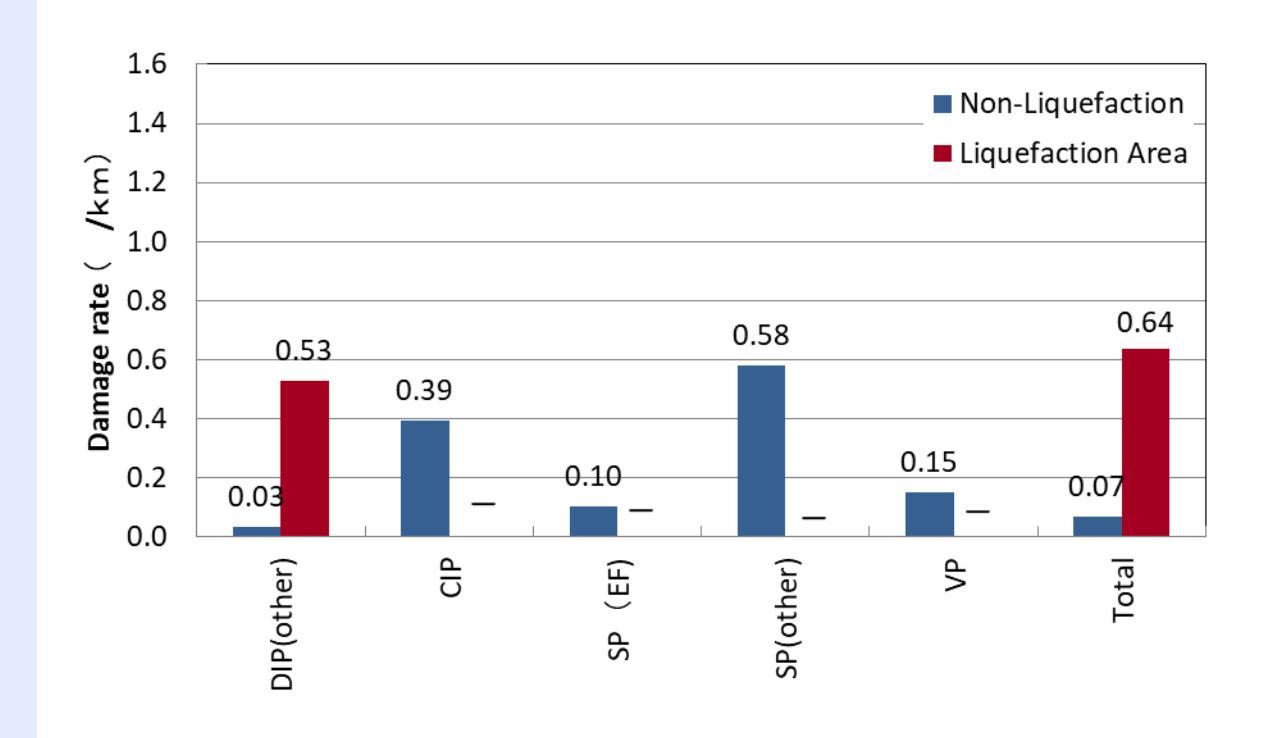
Piping length and Damage rate

Pipe type	DIP (ER)	DIP(other)	CIP	SP(welded)	SP(other)	VP	PE(EF)	PE(other)	SUS	Other	Total
Pipe length (km)	5.3	15.1	1.1	0.5	0.1	0.5	0.4	0.0	0.0	1.2	26.7
Number of location		8		3	3	3					17
Damage rate (/km)*	0	0.53	0	-	-	-	0	0	0	0	0.64

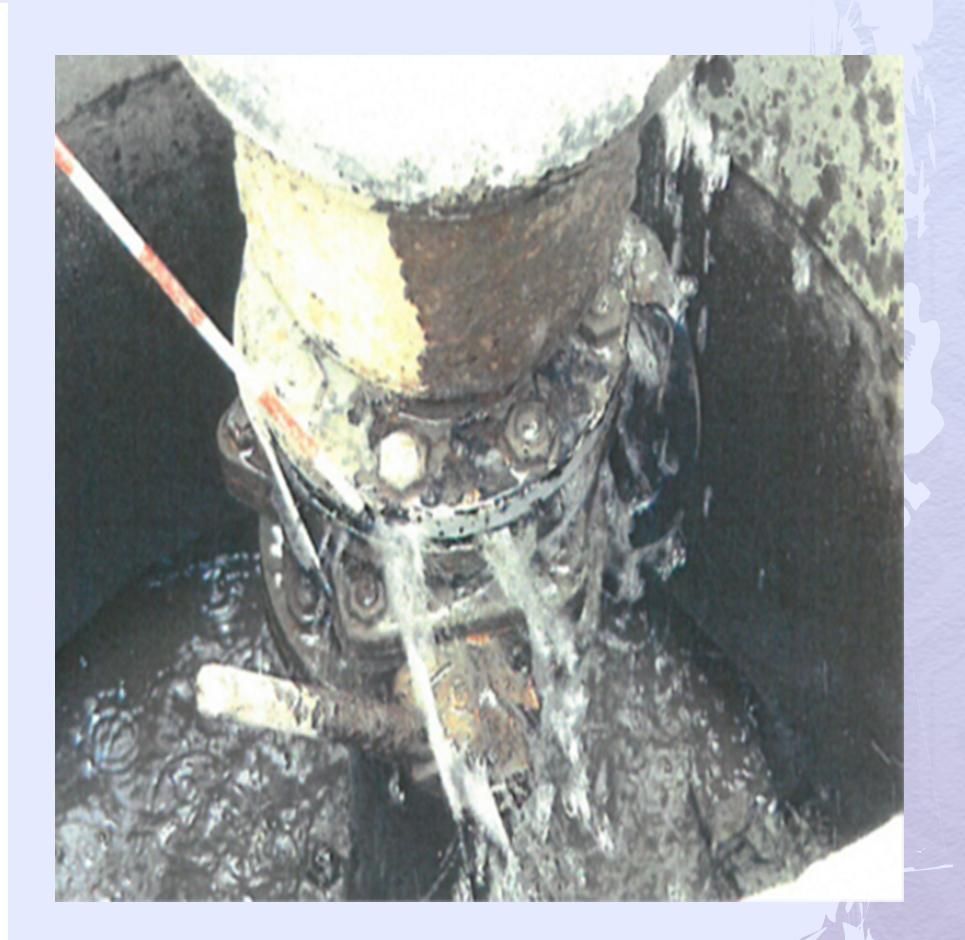
Floating valve body Float valve body Float valve body guide Valve chest
