Improving the Safety of Water Lifelines

Gee-Yu Liu (劉季宇), NCREE

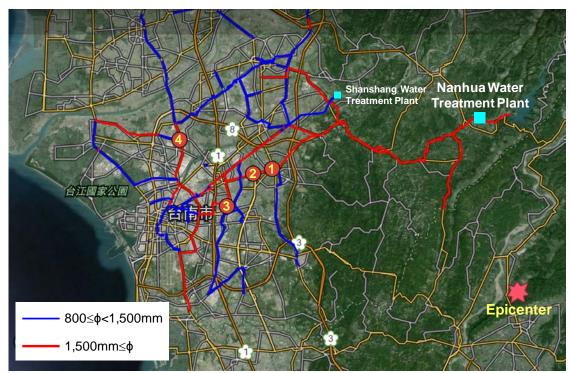
Meinong earthquake (2016/2/6, M_L6.6)

- Four major damage sites in water mains
- Water supply completely resumed on 2/24 (18 days after)

Leaks occurred along a \$\phi2000mm steel pipeline 1,205-meter long, which was installed by pipe jacking method at a depth of 8 meters.

φ2000mm pipes were damaged due to the collapse of a 16-story building.

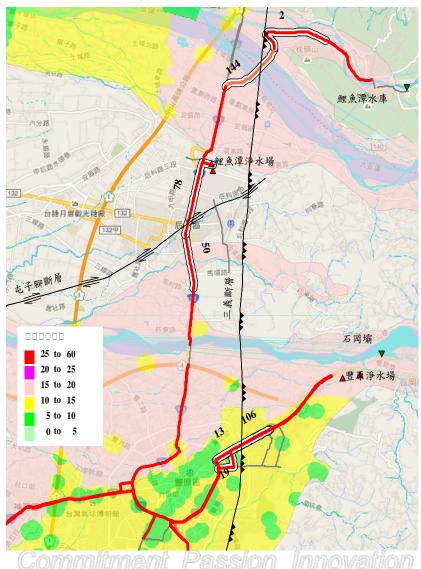
Risk assessment

- Quantitative risk assessment completed
 - Hazard
 - Strong motion, fault crossing, soil liquefaction, landslide
 - Vulnerability
 - Importance
- Among 1,687 pipelines from all water mains, 232 are suggested to be retrofitted:
 - First priority: 82
 - Second priority: 97
 Third priority: 53

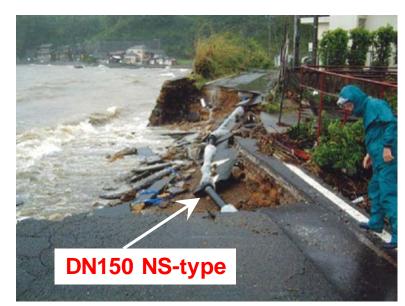
Japan NS-type DIP in typhoon (courtesy Prof. Miyajima)
