Review of an Equation to Estimate Seismic Damage to Water Mains in Light of the 2016 Kumamoto Earthquake

ABSTRACT

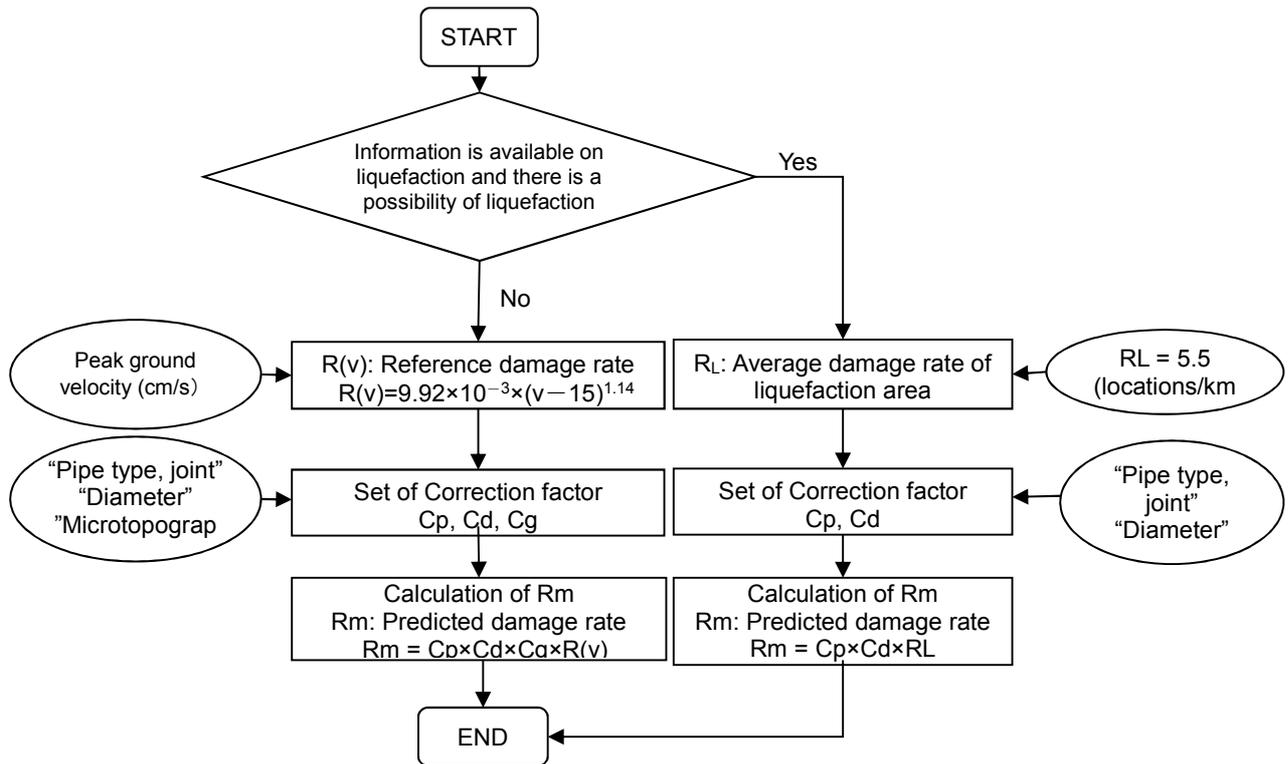
Figure 1. Process of estimating the number of pipe failures in earthquakes

Figure 1 and Table I show the procedure of estimating pipe damage using the equation and its correction factors as updated upon the 2011 Great East Japan Earthquake [3]. The equation is to estimate pipe damage per 250-meter grid cell of a service area. The estimation is carried out using the information on pipe material/joint, diameter, microtopography, peak ground velocity (PGV) of earthquakes, as well as liquefaction data (if applicable). The result is expressed in the number of damaged locations per kilometer. Another characteristic of the equation is that it is designed to estimate on the safe side to avoid an underestimate of seismic impact.

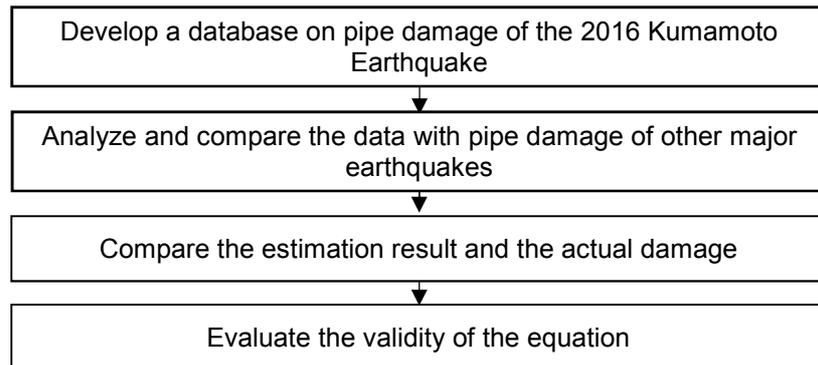
Figure 2. Review process of the equation.

Figure 2 shows the review process of the equation. The validity of the equation was tested using the data on pipe damage in the 2016 Kumamoto Earthquake. The assessment covered and considered the transmission, conveyance and distribution mains with over 50 mm diameter that sustained damage (but excludes those used for water pipe bridges as well as other above-ground, exposed mains).

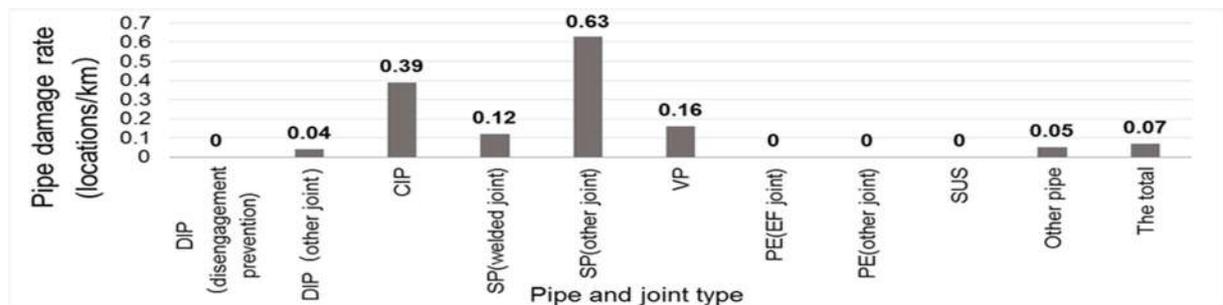
Pipe material*1	DIP (disengagement prevention)	DIP (other joint)	CIP	SP (welded joint)*2	SP (other joint)*3	VP	PE (EF joint)	PE (other joint)	SUS	Other pipe
Pipe damage (no. of locations)	0	72	36	8	59	55	0	0	0	3
Pipe Installation length (km)	583	1882	92	68	93	346	97	8	5	63

Figure 3. Pipe damage rate by pipe material in Kumamoto City

The pipelines in Kumamoto City stretches 3,238 km. The total number of pipe damages was 233, which translates into 0.07 per kilometer. As Figure 3 shows, the number of damage by pipe material was 0.63/km for SV (other joint), 0.39/km for CIP, 0.16/km for VP, 0.12/km for SP (welded joint), and 0.04/km for DIP (other joint). Overall, the damage rate was lower for larger diameter pipes (Figure 4).

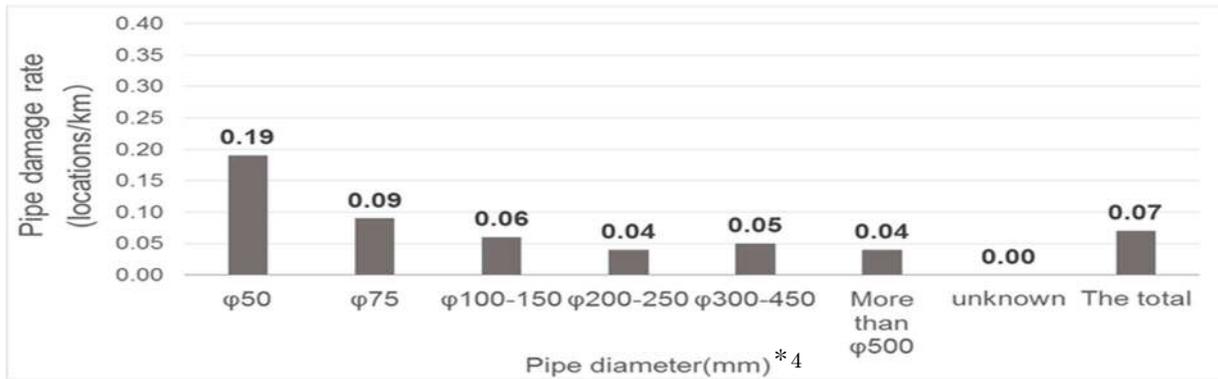
Figure 4. Pipe damage rate by pipe diameter in Kumamoto City

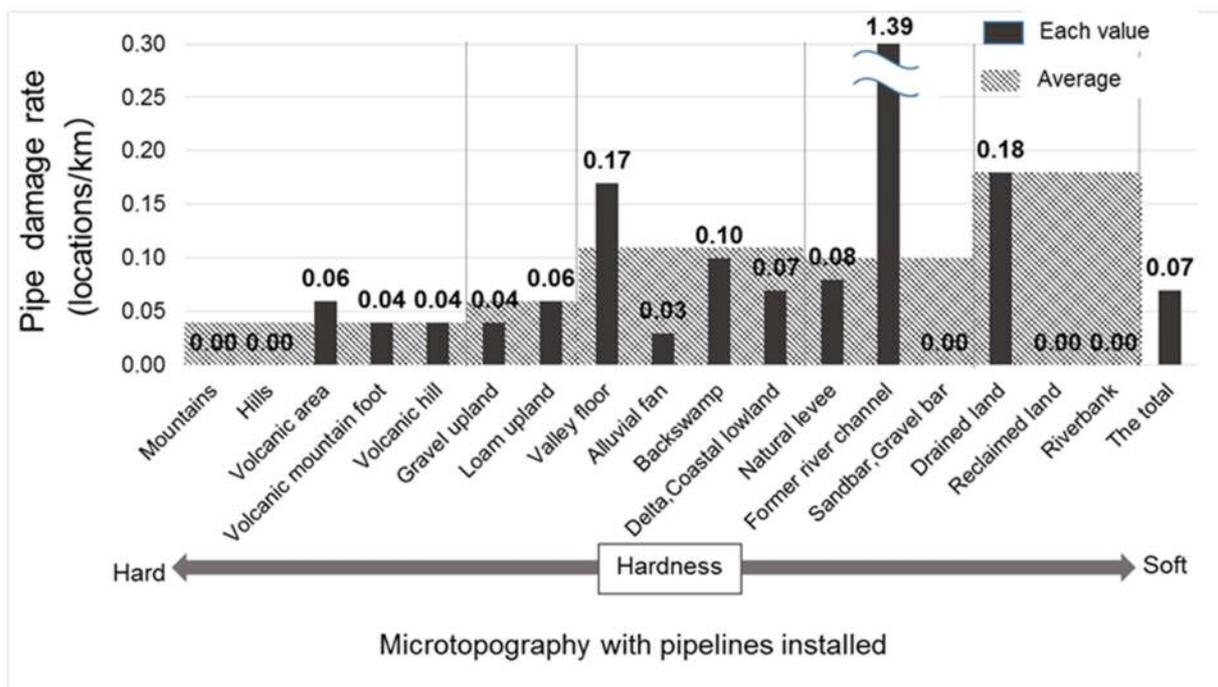
Figure 5. Pipe damage rate by microtopography in Kumamoto City

Figure 5 shows the pipe damage rate by microtopography. As it shows, the former river channel shows the highest damage rate. We consider this is partly because the mains installation lengths along the former river channel is only 5 km, which is shorter compared to other locations. In average, weaker gronds showed larger damage rates.

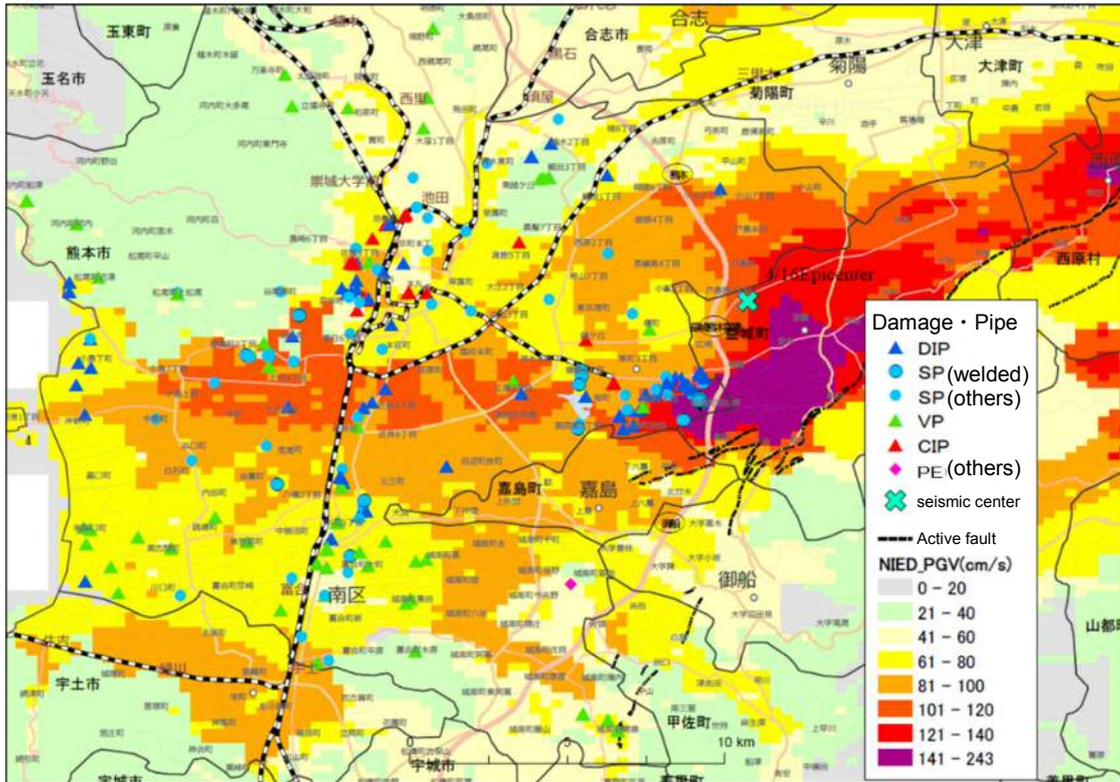
Figure 6. PGV distribution and pipe damage in Kumamoto City from the main shock of the 2016 Kumamoto Earthquake

Figure 6 shows the PGV distribution and pipe damage in the main shock of the 2016 Kumamoto Earthquake. And Figure 7 shows the pipe damage rate by PGV. As is shown in Figure 7, the pipe damage rates are larger where PGVs are greater. And this tendency corresponds to the current reference damage rate curve of the equation.

Also, some of the damaged areas show a PGV of over 120 cm/s. This value is beyond the maximum PGV covered by the equation, which considers the range of $15 \leq v < 120$ (cm/s). However, since the mains installation lengths in Kumamoto City in the areas that recorded a PGV of over 120 cm/s was as short as 20 km in total, we were not able to collect sufficient amount of data as to reconsider the current PGV range of the equation.

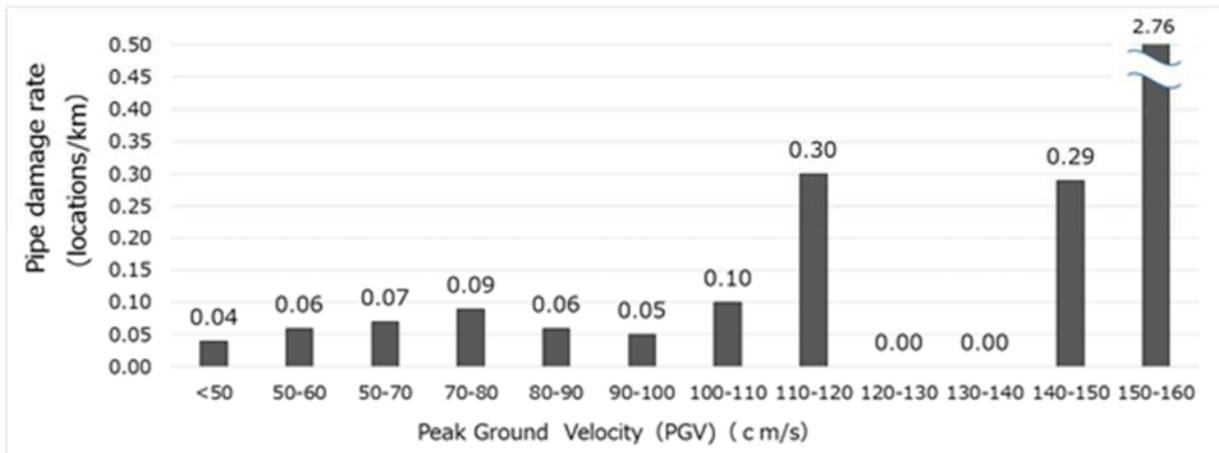
PGV (cm/s)	<50	50-60	60-70	70-80	80-90	90-100	100-110	110-120	120-130	130-140	140-150	150-160
Pipe damage (no. of locations)	32	15	33	46	33	13	37	15	0	0	1	8
Pipe Installation length (km)	750	254	452	519	568	268	358	50	6.9	5.5	3.4	2.9

Figure 7. Pipe damage rate by PGV

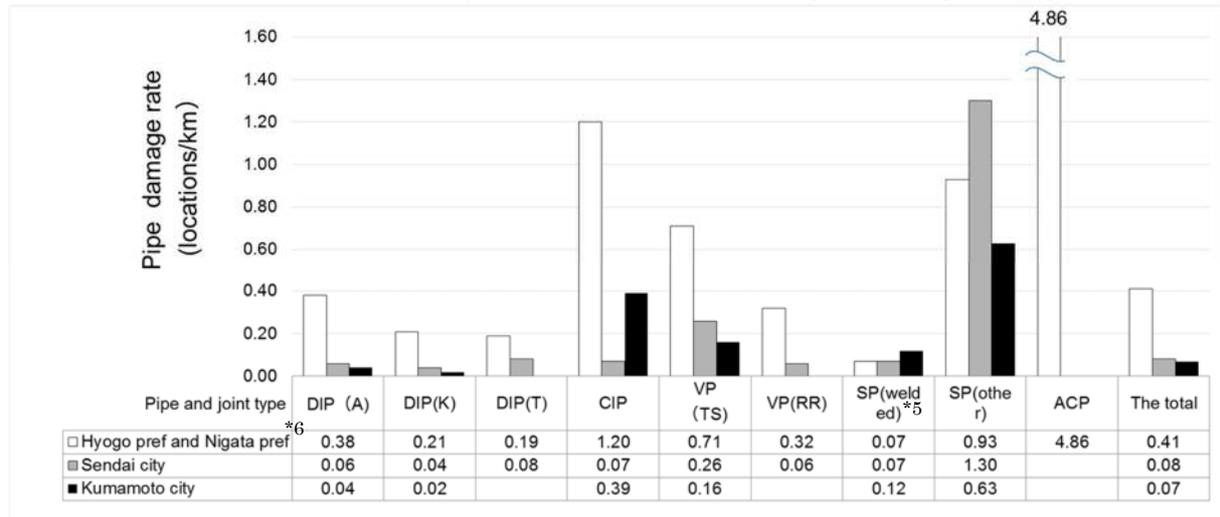
Figure 8. Comparison of pipe damage rate between Kumamoto Earthquake and other major earthquakes

Figure 8 shows the pipe damage rates in the 2016 Kumamoto Earthquake and some of the other major earthquakes that occurred in the past in Japan. The damage rate in the Kumamoto Earthquake was about 1/10 compared to the 1995 Hanshin Awaji Earthquake, 2004 Niigata Prefecture Chuetsu Earthquake, and 2007 Niigata Prefecture Chuetsu-oki Earthquake [7] while it was about the same as Sendai City in the 2011 Great East Japan Earthquake [3].

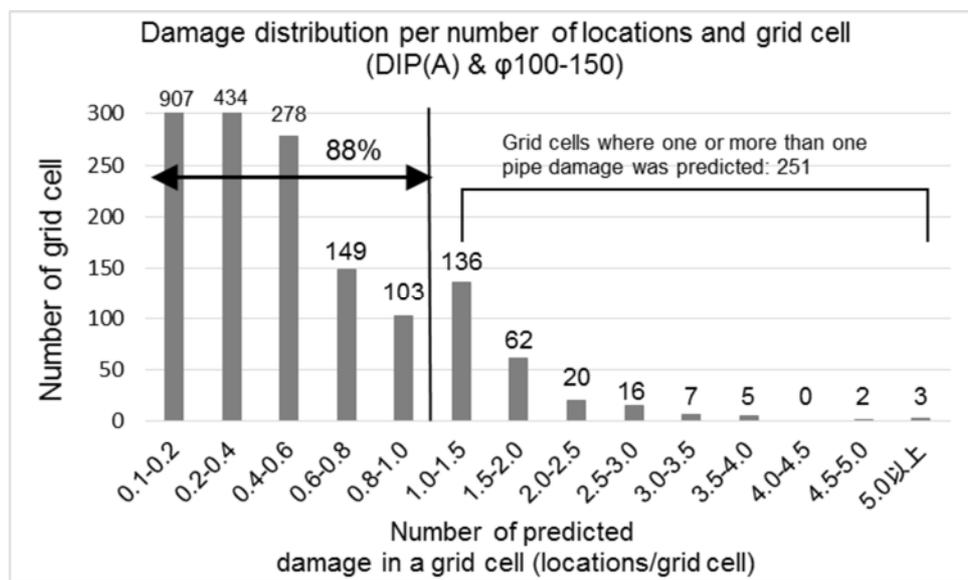
Figure 9. Number of pipe damage estimated by the equation for the reference pipe material/joint with the reference diameter

The equation estimated a total of 251 grid cells to have one or more than one pipe damage (Figure 9). On the other hand, the number of pipe damages that actually occurred was 30 in 19 grid cells out of these 251 ones (Figure 10). The estimate was on the safe side, which corresponds to the design principle of the equation*.

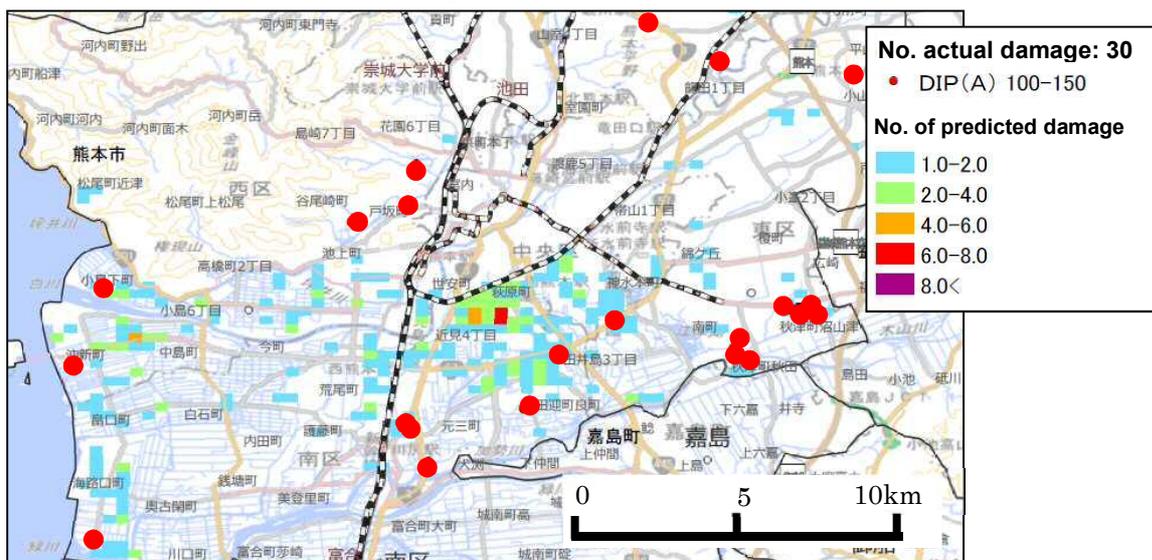
Figure 10. Locations of actual pipe damage and the distribution of estimated pipe damage for the reference pipe material/joint with reference diameter

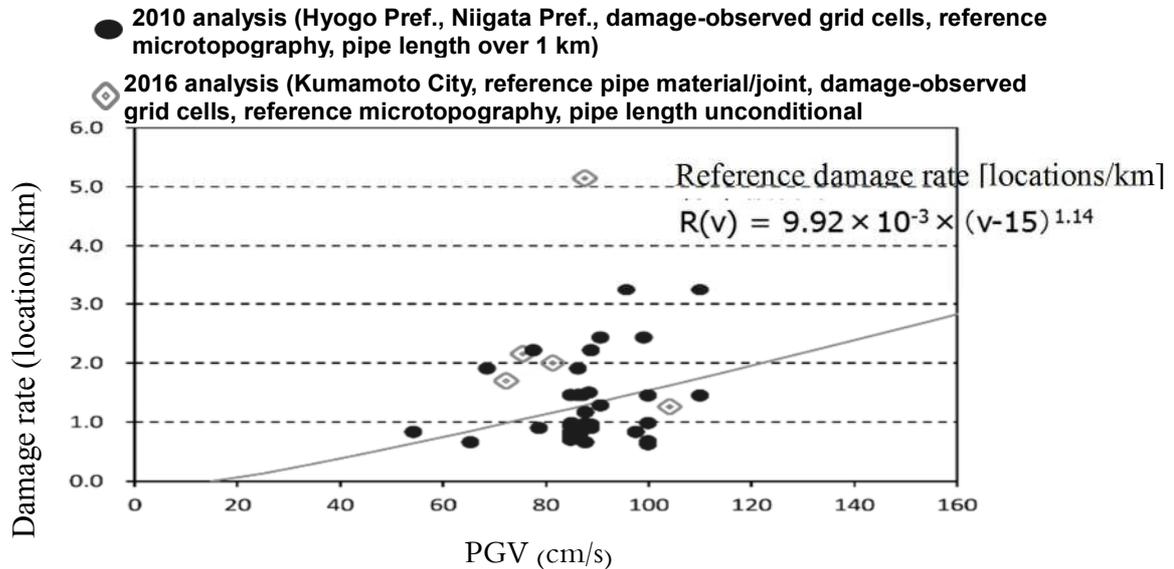
Figure 11. Damage rate of DIP (A) with 100-150 mm diameter in the 2016 Kumamoto Earthquake and in other major earthquakes along with the reference damage rate curve

In addition, for DIP (A) with 100-150 mm diameter, we also compared its damage rate in the 2016 Kumamoto Earthquake with the damage rate in other major earthquakes. Figure 11 shows the result by PGV levels along with the reference damage rate curve obtained from this comparison. It shows that the distribution of pipe damage is similar between the Kumamoto Earthquake and the other earthquakes.
