# **An Investigation of the Seismic Performance of Portland Water Bureau's Water System in an M 9.0 Earthquake**

Michael Saling, Supervising Engineer, Portland (Oregon) Water Bureau

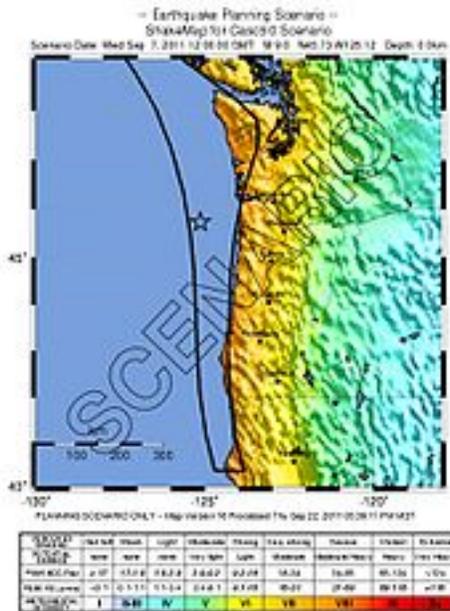
**Figure 1. PWB seismic hazard from the Cascadia Subduction Zone**

Figure 1 shows the location of the CSZ in relation to PWB.
