Performance Test of Steel Pipe for Crossing Fault in United States

ABSTRACT

This report describes the performance tests of Steel Pipe for crossing Fault (SPF), which is an “on fault earthquake-resistant countermeasure” pipe, conducted at Cornell University. In the test results, despite applying deformation of several times the design value, the pipe did not crack or leak and more than 80% of the pipe cross section where water can pass was secured in all the tests.

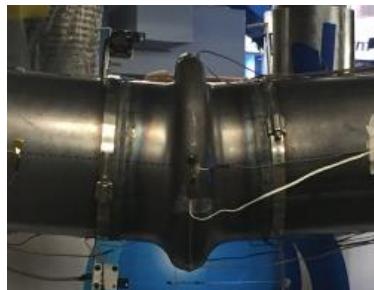
Figure 3-17. Deformation image (at inner surface contact)

The test results are shown in Figures 3-17 and 3-18. Figure 3-17 is a deformed image of the pipe with the allowable bending angle (18° at inner surface contact), showing that the upper wave-shaped section rises gradually and deforms uniformly on the left and right. Figure 3-18 shows the deformation at the stroke limit of the test equipment, when the bending angle reached 36.6° (about twice the allowable bending angle). Even in this state, the deformation of the wave-shaped section was almost symmetrical, and no cracks or leaks were found. Figures 3-19 and 3-20 show the deformation image of the FEM analysis. As shown in Figure 3-19, the deformation at the time of contact of the inner surfaces was almost symmetrical, but in the final deformation shown in Figure 3-20, the upper side of the wave-shaped section collapsed and started to deform irregularly.

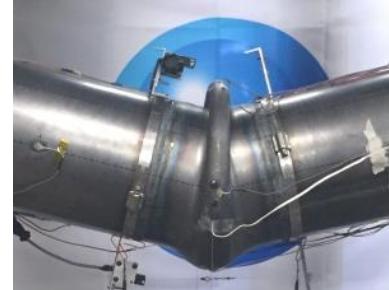
Figure 3-18. Deformation image (final)

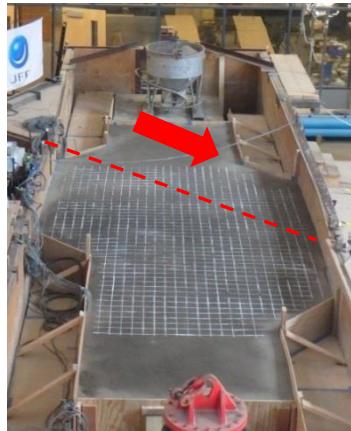
Figure 3-23. Before test

Figure 3-23 shows the condition of a pipeline installed and backfilled in the test equipment. From this state, fault displacement was given along a fault plane with an angle of 50°.

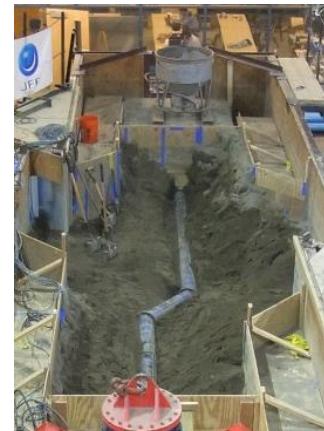
Figure 3-24. After test

Figure 3-24 shows the deformed state of the pipeline after applying fault displacement of 610 mm. As shown in figure, the pipeline bent at the wave-shaped sections equidistant from the fault plane and absorbed the fault displacement.
