Mitigating Risk to Underwater Crossings to Improve Water Supply Reliability: Two Case Studies

Serge Terentieff, Denise Cicala, Xavier Irias, and Raffi Moughamian

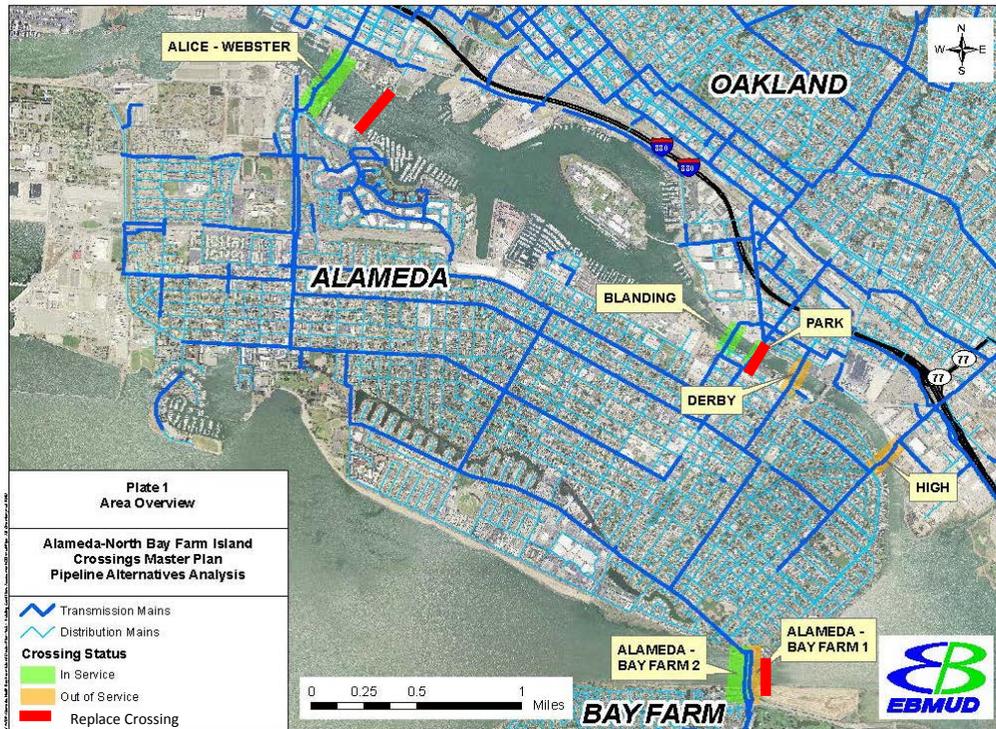
Figure 5: Alameda Crossings. Map Showing All Estuary Crossing Locations

Water service to the City of Alameda (Alameda) is provided by four existing underwater pipeline crossings at three separate locations between the City of Oakland (Oakland), Alameda Island, and North Bay Farm Island (see Figure 5). Failure at any of the three crossing locations could lead to a reduction in the level of service for existing customers and potentially reduce the available water supply to Alameda Island and North Bay Farm Island.

The approximate locations of these three replacement crossings are shown on Figure 5. The overall project scope will include abandoning existing crossings as these new crossings are constructed. EBMUD recently completed the planning effort, including an Environmental Impact Report (EIR) for all three crossings, and is currently proceeding with the design for the first crossing replacement, Crossing No. 1, which is shown in Figure 6A. Crossing No. 1 includes installation of 1,800 feet of
