Mitigating Risk to Underwater Crossings to Improve Water Supply Reliability: Two Case Studies

10th CTWWA/JWWA/WRF Water System Seismic Conference
Tainan, Taiwan – October 18-21, 2017

Raw water supply:
Aqueduct
Interconnections &
River Crossing Repair
Concept

Potable water
supply: Alameda
estuary crossings

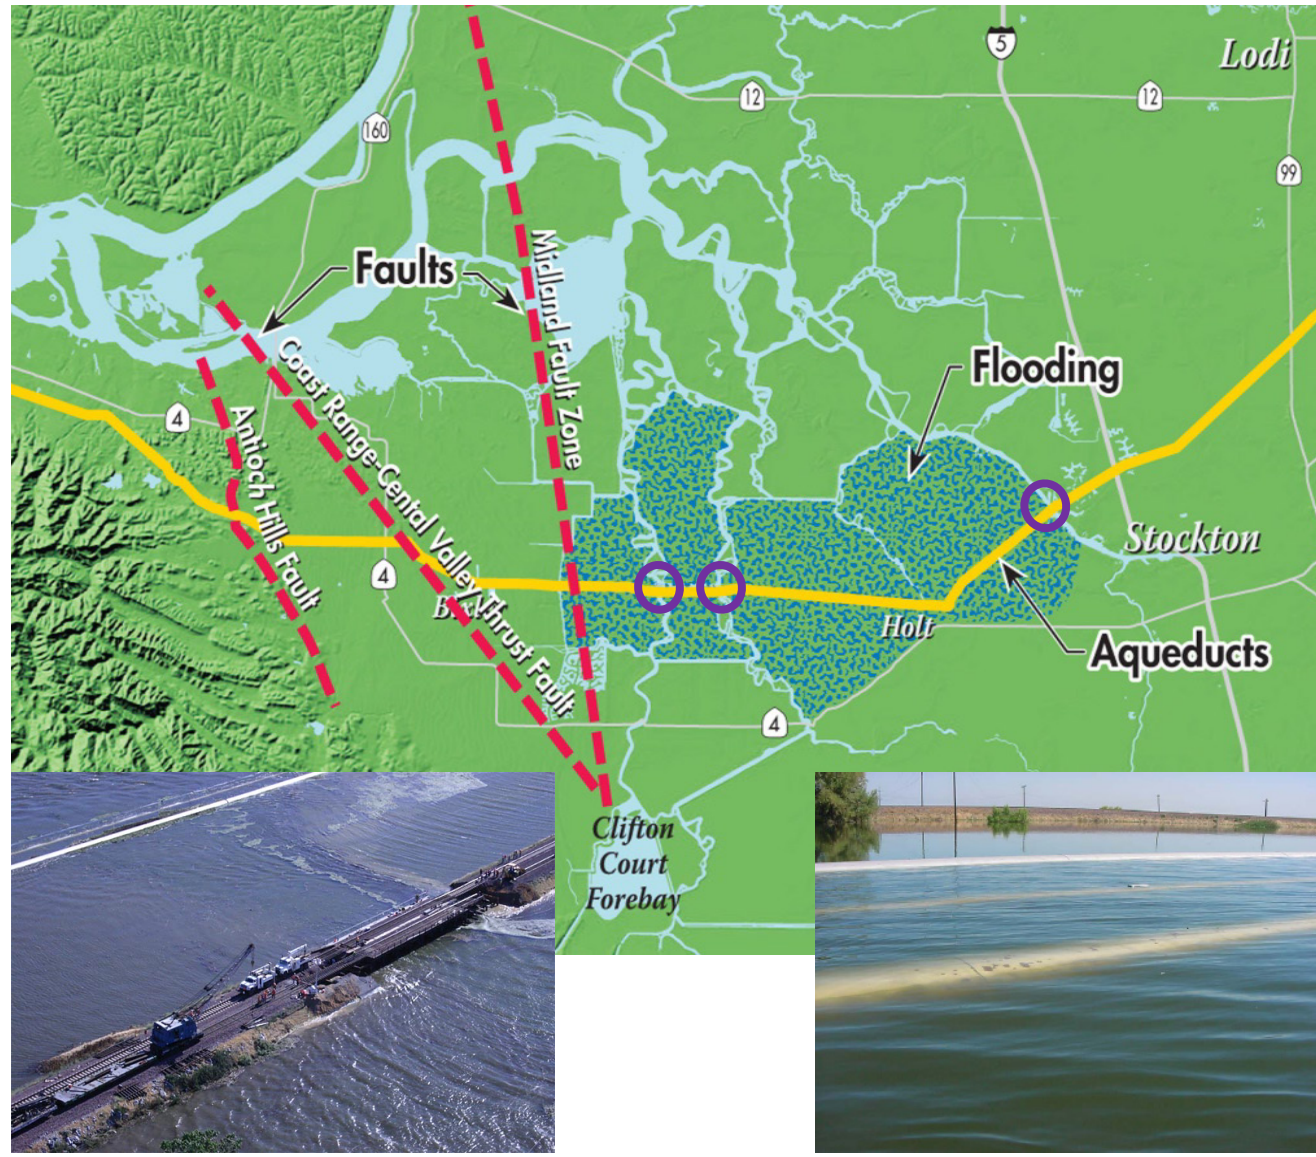
Case Study 1: Natural Hazards & Risks to Mok AQs in the Delta

- Natural hazards:
 - Flooding
 - Seismic Events
 - Subsidence
- Risk to AQs:
 - Structural failure of AQ #1 & 2
 - Damage from levee failure & flooding
 - Damage to AQ #3 at a river crossing

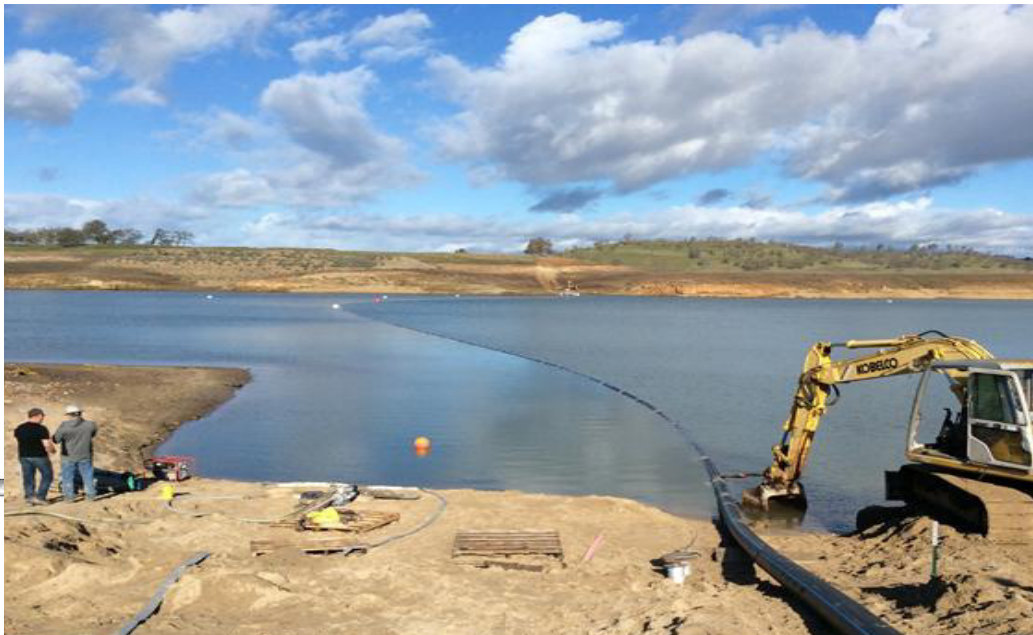
Low Likelihood/High Consequence Event: AQ No. 3 River Crossing Repair Concept at San Joaquin River

- Conventional Repair ~ 8+ Months
- Terminal Storage ~ 6 Months
- “Float & Sink” Repair ~ 6 Months
