Mitigating Water System Pipeline Damage — Seattle Public Utilities Case Study

10th Japan-U.S-Taiwan Workshop Water System Seismic Practices October 18 -20, 2017

> Bill Heubach Seismic Program Manager Seattle Public Utilities

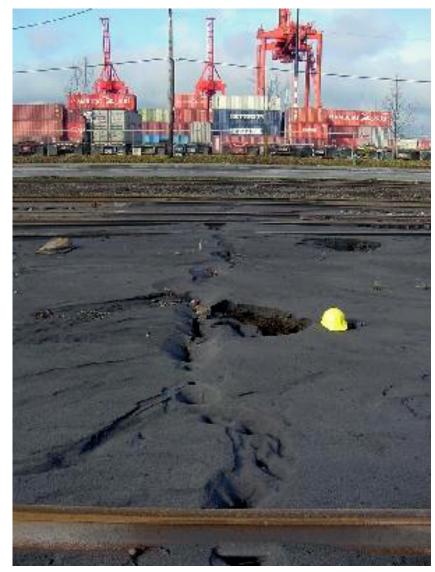
Liquefaction South of Downtown
