RECENT ADVANCES IN SEISMIC RETROFIT OF RC STRUCTURES IN TAIWAN

Shyh-Jiann Hwang and Wu-Wei Kuo

Department of Construction Engineering

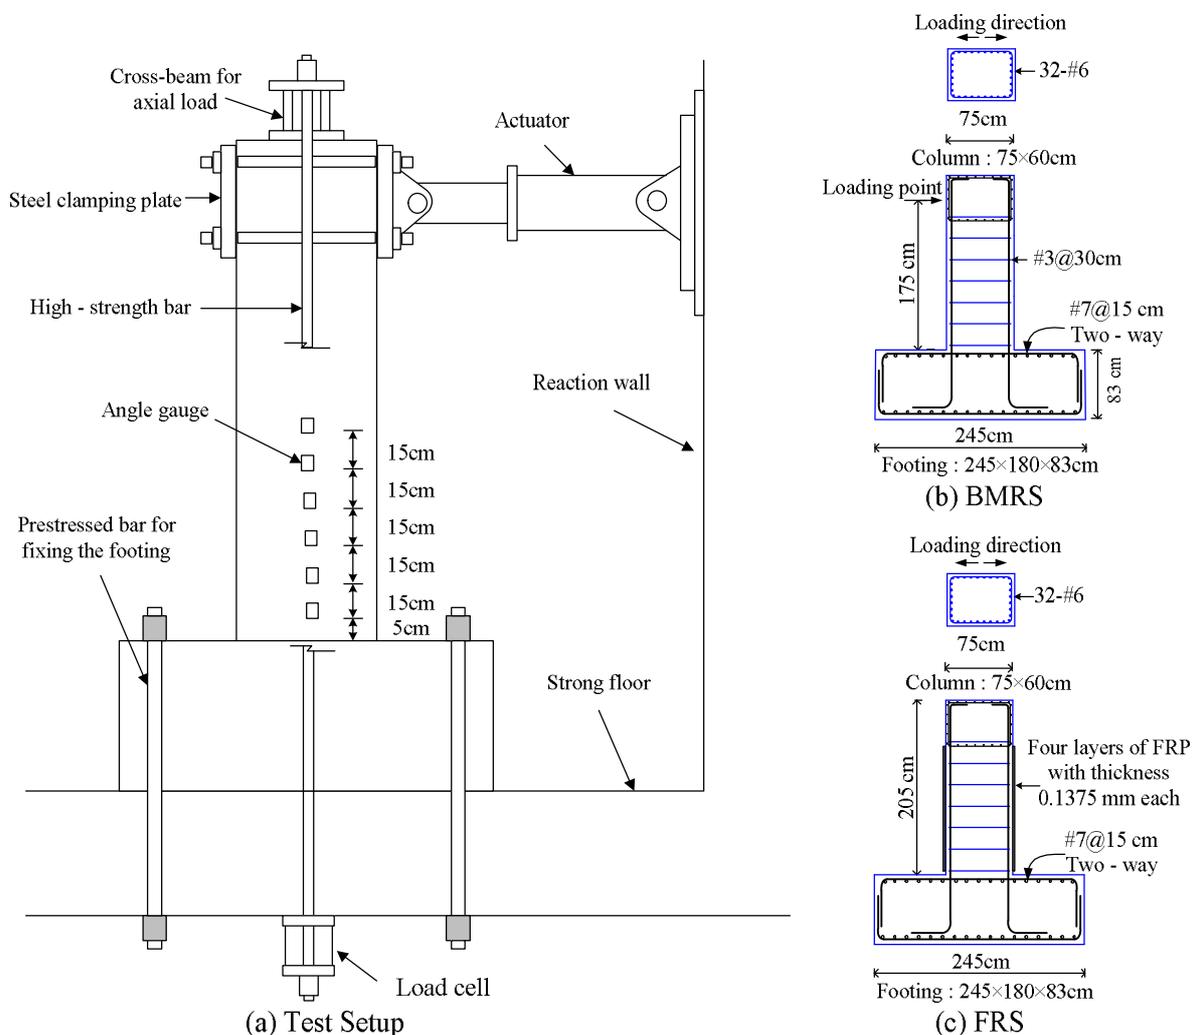
Two reinforced concrete columns were tested: the column in its original form (BMRS) and the column retrofitted with FRP laminates (FRS). The configuration and details of the each specimen are presented in Fig. 1. Concrete strength was 16.7 MPa for BMRS and FRS.

Fig. 1: Specimens configuration and details

Details of the original column BMRS include light transverse reinforcement without cross tie (Fig. 1). The response is elastic until a load of 714 kN (drift ratio of 1%), after which the strength degrades (Fig. 2).

Column FRS was jacketed using four layers of FRP sheets with a thickness of 0.1375 mm for each (Fig. 1). The column showed excellent response with an increase in both lateral load carrying capacity and drift ratio. Strength degradation did not begin until a drift ratio of 3.5% was reached.

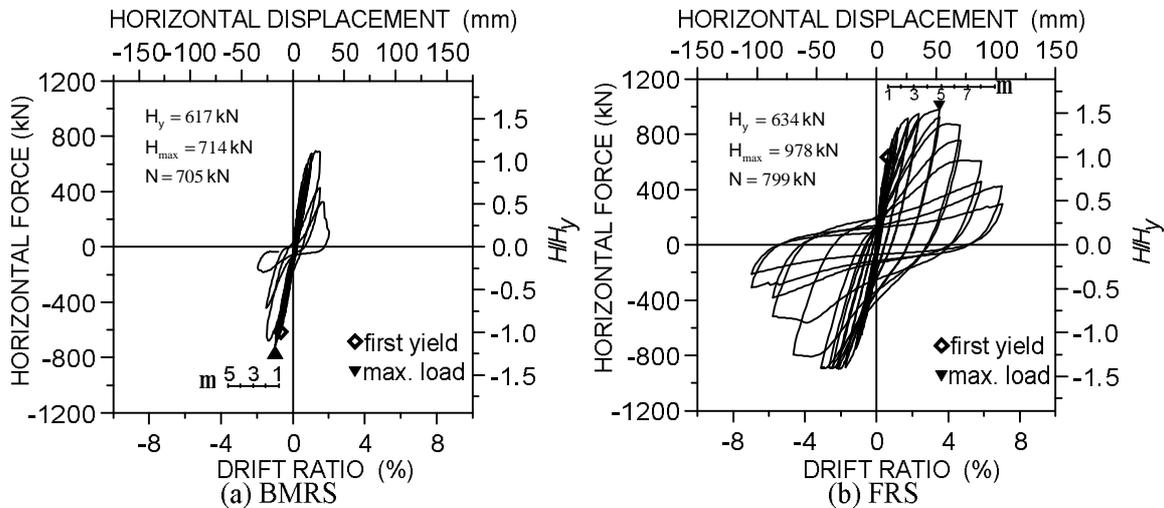
Fig. 2: Load displacement response of test specimens

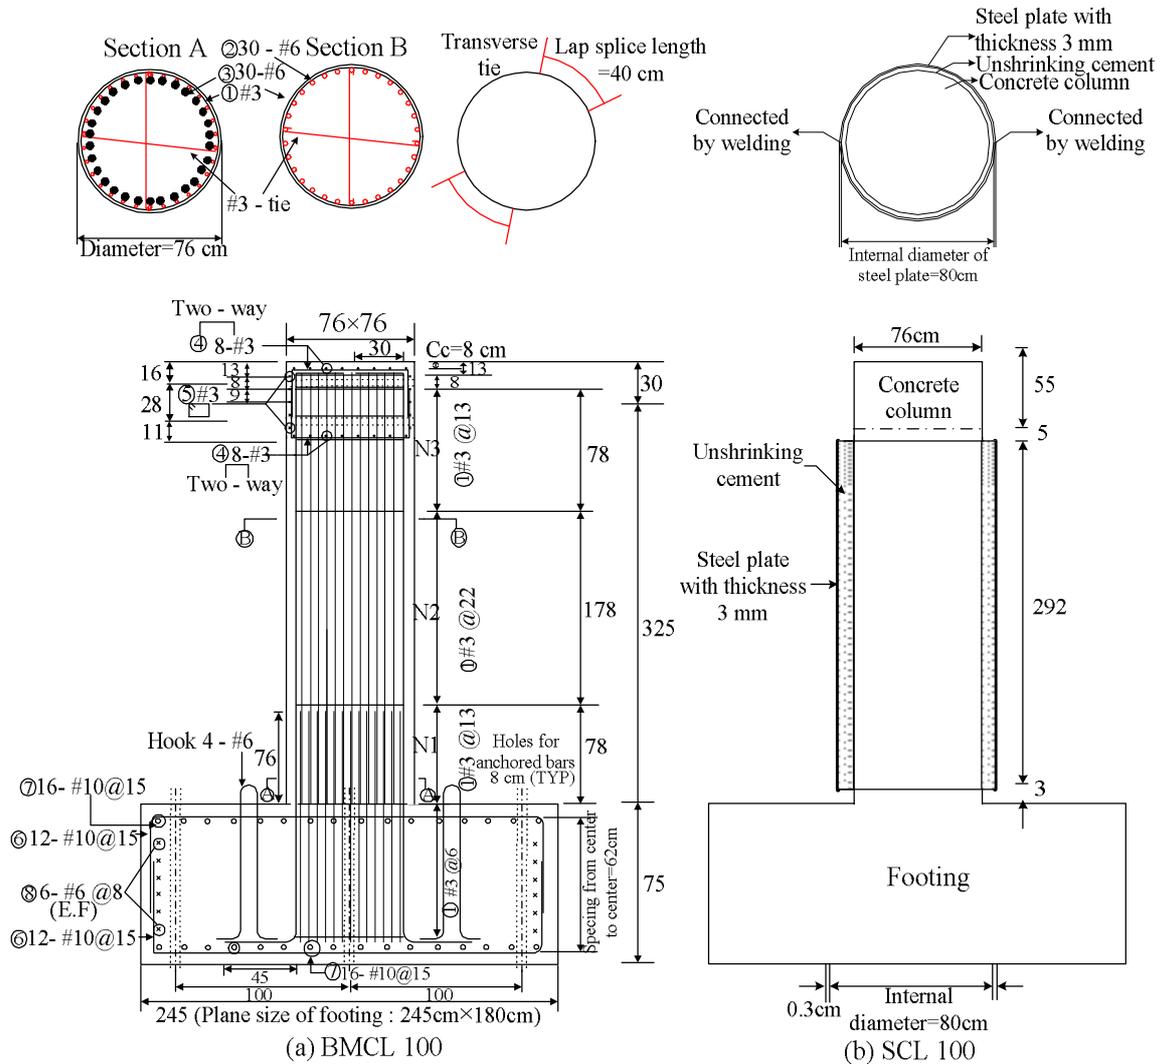
Two columns were tested. The specimen details are presented in Fig. 3. Figure 4 presents the hysteretic response for each specimen.

The test specimen was a cantilever with the longitudinal reinforcing bars spliced just above the footing. The lap splice length of the original circular column BMCL100 corresponding to 40 bar diameters (Fig. 3). The circular ties were spaced at a distance of 130 mm with two orthogonal cross ties for each layer (Fig. 3). One nominally identical column SCL100 was retrofitted with steel jacket of 3 mm thickness. The jacket was placed 30 mm above the column base and extended 2920 mm (almost entire column length; Fig. 3).

Fig. 3: Specimens configuration and details

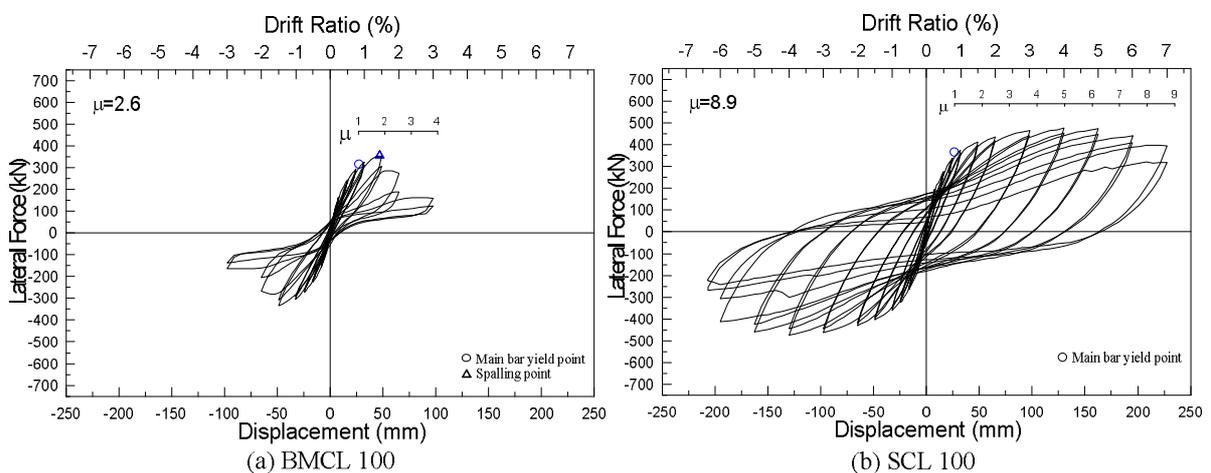
The original specimen BMCL100 exhibited a bond-dominated failure mechanism. The lap splice failed at a lateral load of 352 kN, after which the specimen lost strength and stiffness (Fig. 4). The retrofit column SCL100 showed excellent response with an increase in both lateral load carrying

capacity and drift ratio. Strength degradation did not begin until a drift ratio of 5% was reached (Fig. 4).

Fig. 4: Load displacement response of test specimens

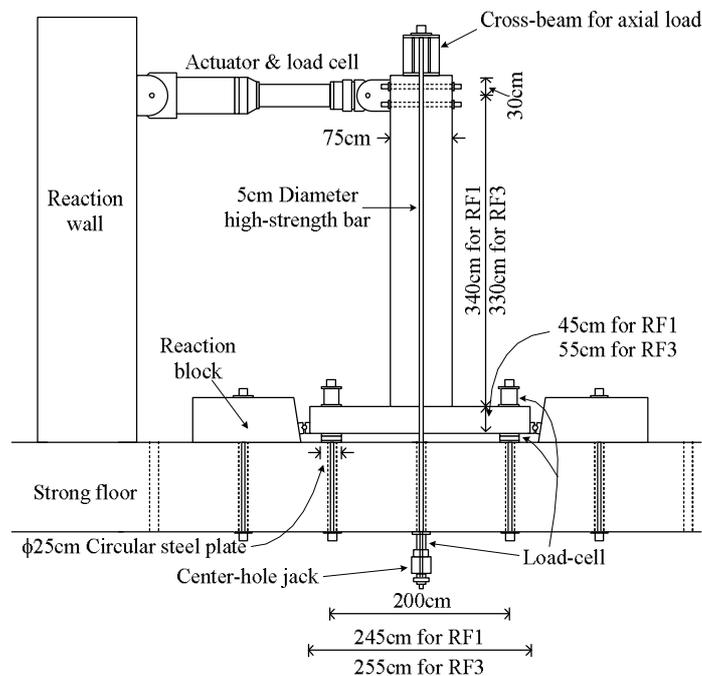
Two reinforced concrete column footings were tested: the column in its as-built form (RF1) and the footing retrofitted with RC overlay (RF3). The test setup is shown in Fig. 5. The configuration and details of the each specimen are presented in Fig. 6. Concrete strength was 41.7 MPa for RF1 and RF3.

Fig. 5: Test setup

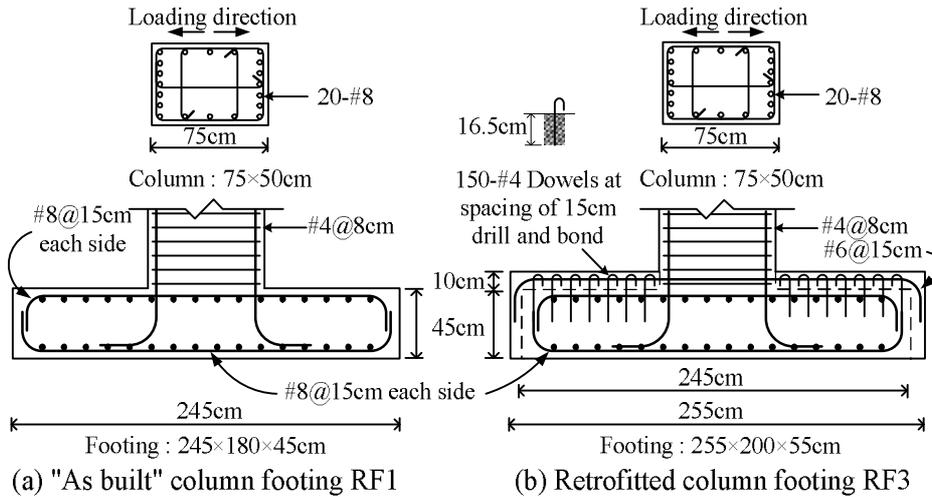
Details of the original footing RF1 include insufficient anchorage of column bars and none of joint hoop (Fig. 6). The maximum force-carrying capacity developed by RF1 was less than the nominal flexural strength of column, indicating insufficient footing strength of RF1 (Fig. 7).

Retrofit column footing RF3 was strengthened by adding reinforced concrete overlay with a thickness of 100 mm (Fig. 6). New concrete was connected with original footing by #4 dowels, as illustrated in Fig. 6. The thickness 100 mm of the reinforced concrete overlay was chosen to cover up the

Fig. 6: Footing details

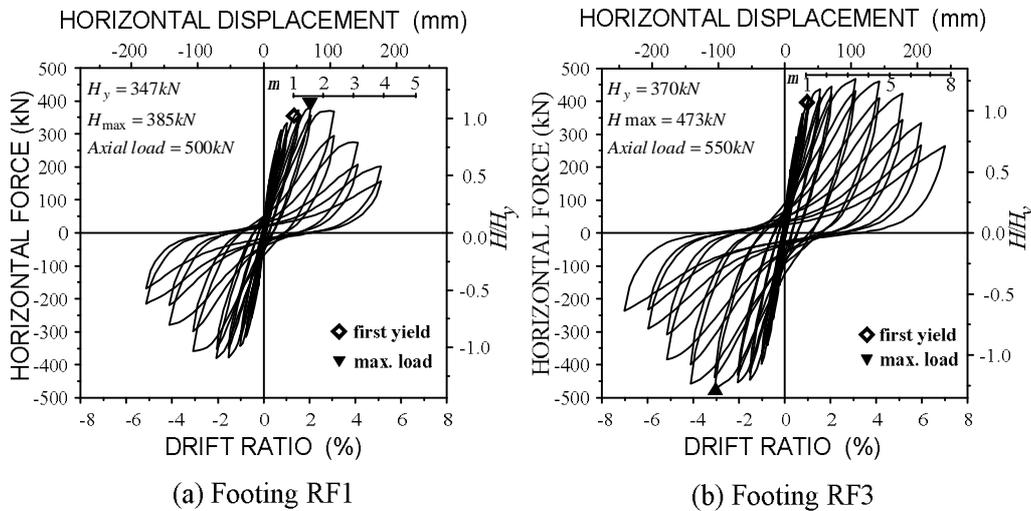
deficiency in joint strength and to provide enough development length of the column longitudinal reinforcement according to the ACI 318-95 Code (1995). As shown in Fig. 7, the retrofit column footing RF3 developed higher strength and more ductile hysteretic behavior than the as-built column footing RF1.

Fig. 7: Hysteretic response of column footings

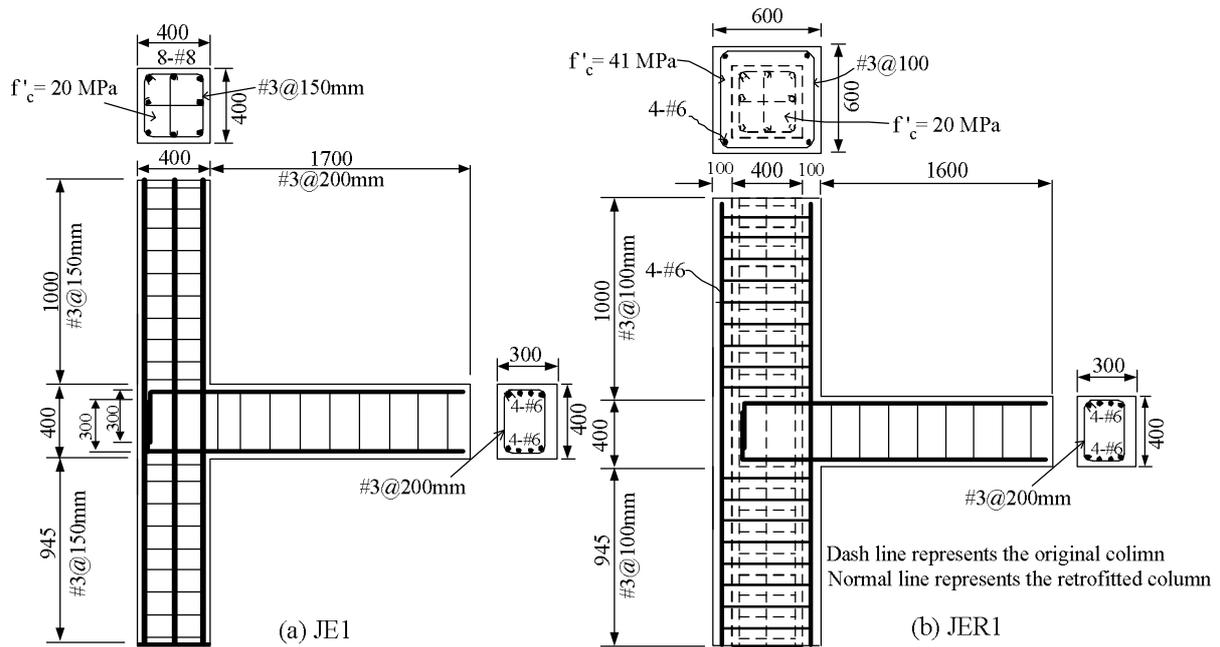
Two reinforced concrete exterior beam-column joints were tested: the specimen in its as-built form (JE1) and the specimen retrofitted with a concrete column jacket (JER1). The configuration and details of the each specimen are presented in Fig. 8. Concrete strength was 20 MPa for JE1 and JER1, but the concrete strength for the column jacket was 41 MPa.

Fig. 8: Specimen configuration and details

Details of the original specimen JE1 include insufficient shear strength of joint and none of joint hoop (Fig. 8). The original specimen JE1 exhibited a joint shear failure mechanism. The nominal flexural strength of beam was never developed, indicating insufficient joint strength of JE1 (Fig. 9).

Retrofit specimen JER1 was strengthened by adding reinforced concrete column jacket with a thickness of 100 mm for each face (Fig. 8). Column jacketing involved adding additional longitudinal steel along the entire length and through the existing slab. No anchors were installed between new and old concrete interface. As shown in Fig. 9, the retrofit specimen JER1 developed higher strength and more ductile hysteretic behavior than the original specimen JE1.

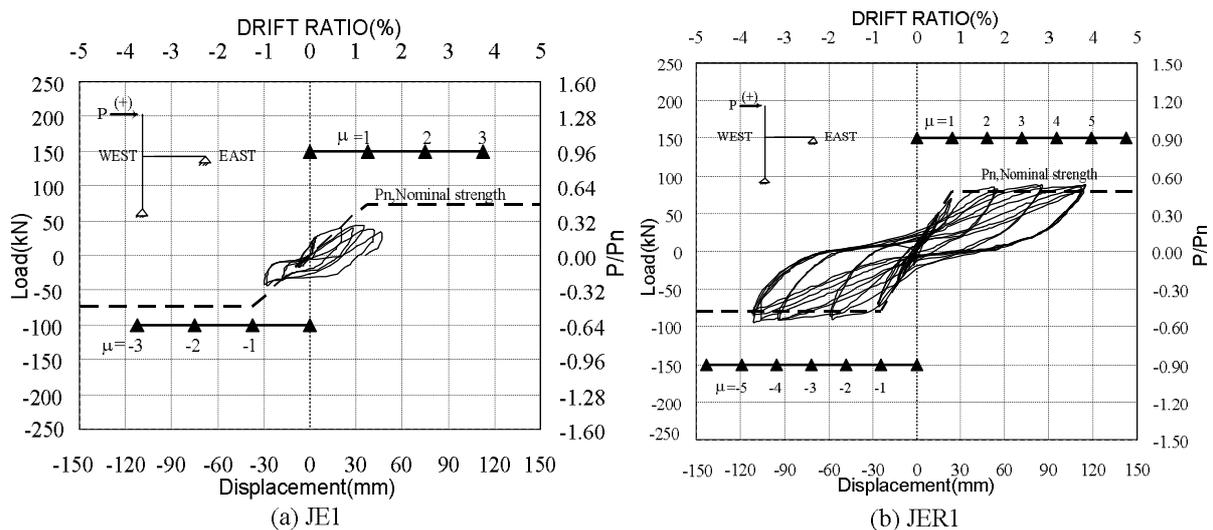
Fig. 9: Load displacement response of test specimens

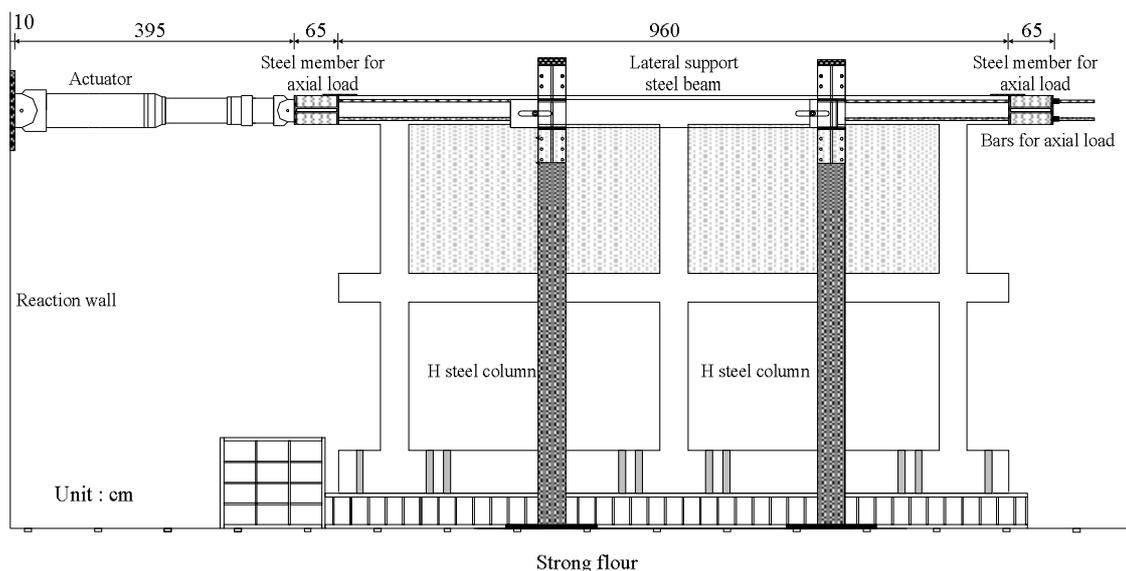
A two-story and two-bay non-ductile frame with RC wall throughout the second floor was tested (NFL-W) to failure and then retested after retrofitting with RC wing walls (NFL-W/rc). The test setup is shown in Fig. 10. The configuration and details of the each specimen are presented in Fig. 11. Concrete strength was 21 MPa for NFL-W.

Fig. 10: Test setup

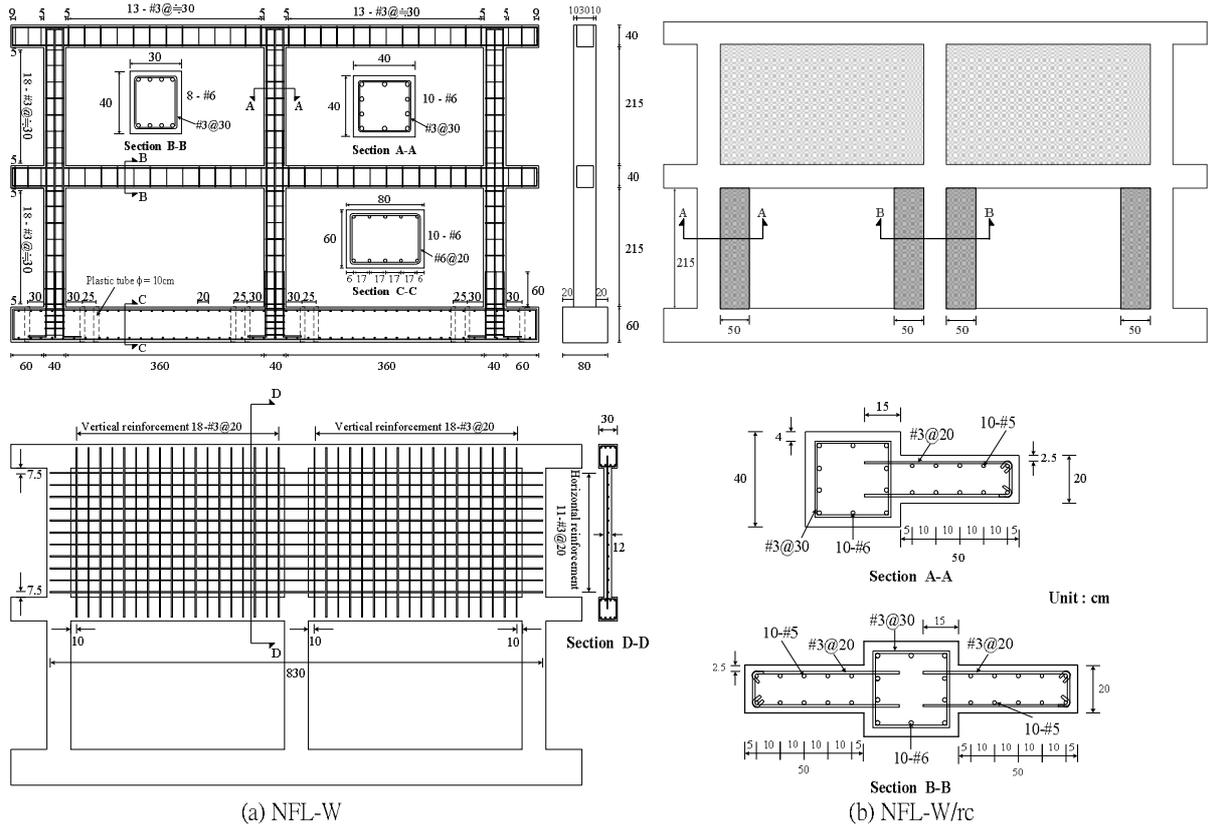
Details of the original frame NFL-W include the substandard reinforcing details such as the beam-column joints without ties, the columns with inadequate lap splices located in the high moment regions, and the insufficient transverse reinforcement in the columns with unreliable 90° end hooks (Fig. 11). The maximum force-carrying capacity developed by NFL-W was 402 kN (Fig. 12) and the shear failures coupled with bond splitting were observed in the base of columns.

Fig. 11: Specimen configuration and details

Retrofitted frame NFL-W/rc was strengthened by adding reinforced concrete wing walls with a thickness of 200 mm (Fig. 11). As shown in Fig. 12, the retrofit frame NFL-W/rc developed stiffer response and higher strength than the original frame NFL-W. The addition of wing wall can also prevent the failure of beam-column joint as well as the splitting of lap splice in the column base.

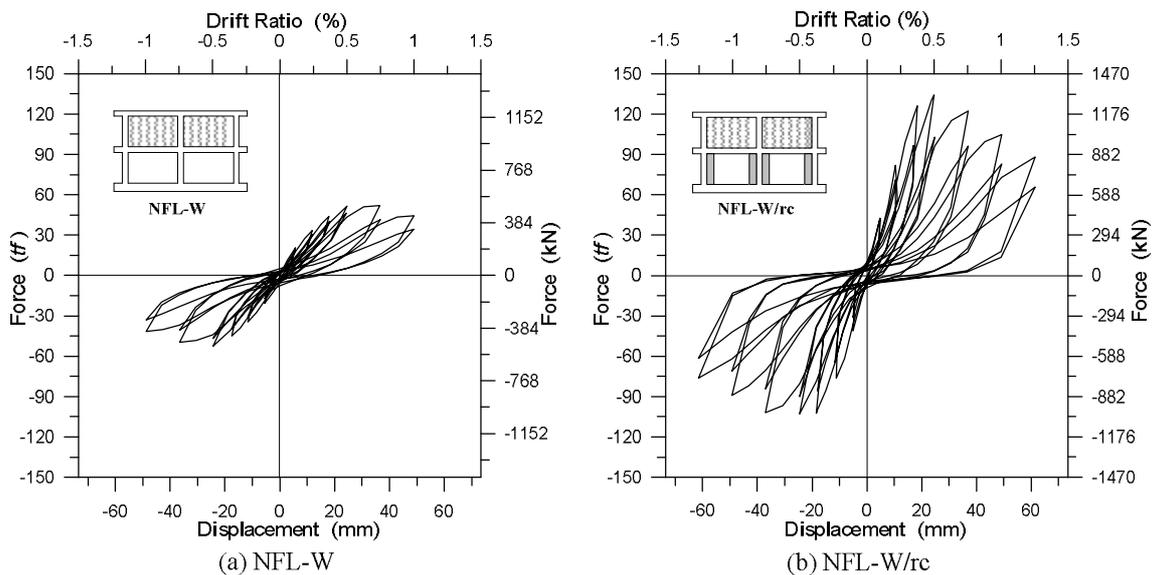
Fig. 12: Load displacement response of test specimens
