## 2. Emergency operation of Water Supply Systems in 0206 Earthquake

### 2.2 Emergency Water Supply Operation

### 2.3. Repairing Pipelines

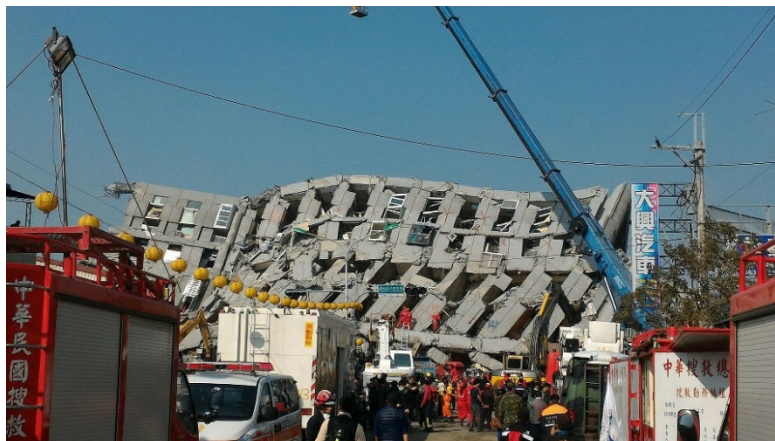
Fig.2 The collapsed 17-story Weiguan Jinlong residential building

#### 1. Due to the earthquake, Tainan Water Supply System had been seriously damaged, it needed time to restore water supply system gradually after repairing damaged water infrastructure , especially the damaged 2,000mm(in diameter) transmission line which was located under the collapsed 17-story Weiguan Jinlong Building ( see Fig.2). TWC used backup 1,750 mm transmission line to transfer water and laying 1,350 mm emergency temporary transmission pipe on the ground ( see Fig.3 and Fig.5) by reducing pressure to supply water. Owing that the total volume of water is insufficient and water pressure is low, the consumers living in highland region and dead end areas are still suffering water shortage problem.

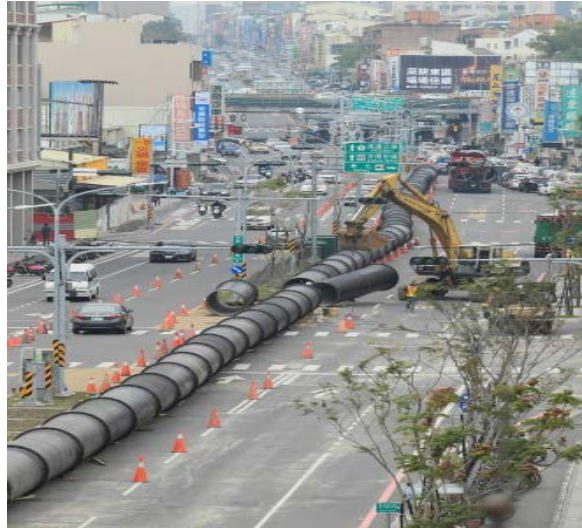
Fig.3 1,350 mm emergency temporary transmission pipe on the ground

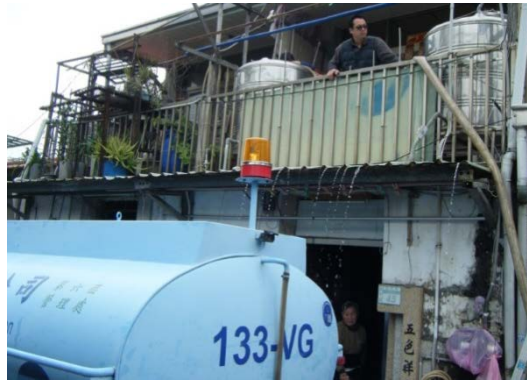
Fig.4 Water tanker injected water into pipeline for supplying water to consumer's water tank

#### 3. Water tanker or Fire-fighting truck injected water into pipeline for supplying water to consumer's water tank.

#### 3. Dead end areas : By using Water tanker or Fire-fighting truck injected water into pipeline for supplying water to consumer's water tank( see Fig.4).

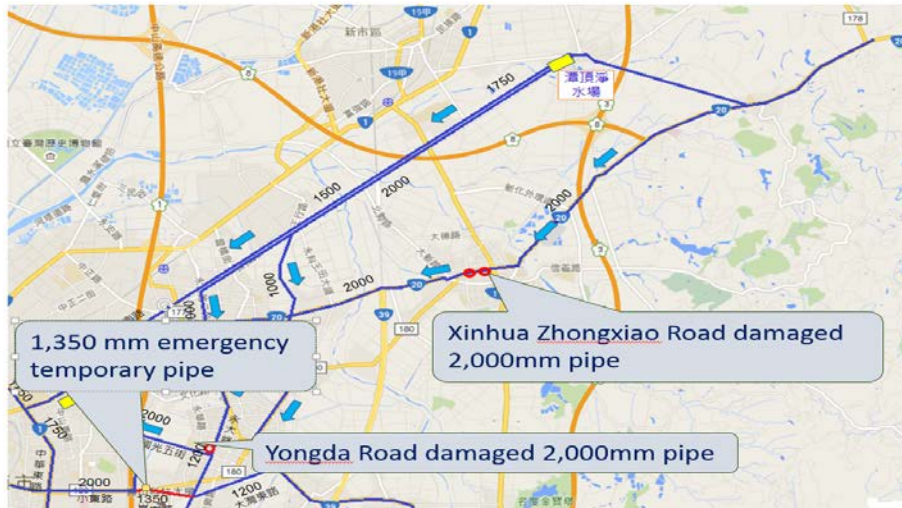
Fig.5 Location of damaged 2,000mm pipe and 1,350 mm temporary pipe

1. After inspection, there were about 7,948 cases of reporting water interruption, and about 4,710 leaky pipes (72 cases are larger than 300mm in diameter). The repairing teams cooperated with outsourcing contractors were dispatched immediately to fix leaky pipes.
2. Yongda Road damaged 2,000mm (in diameter) pipe:  
After the Tainan City Government has cleaned up the collapsed Weiguan Jinlong Building, Repairing teams of TWC rushed to repair the pipe and completed at 24:00 on February 24th then restore water supply.
3. Xinhua Zhongxiao Road damaged 2,000mm (in diameter) pipe :  
The damaged pipe was constructed by pipe jacking method and was under 8 meters from the ground, total length of 1,200 meters. After inspection it was found there were 7 cracks in the pipe. It was repaired at 00 : 30 on February 24th.  
Location of damaged 2,000mm pipe and

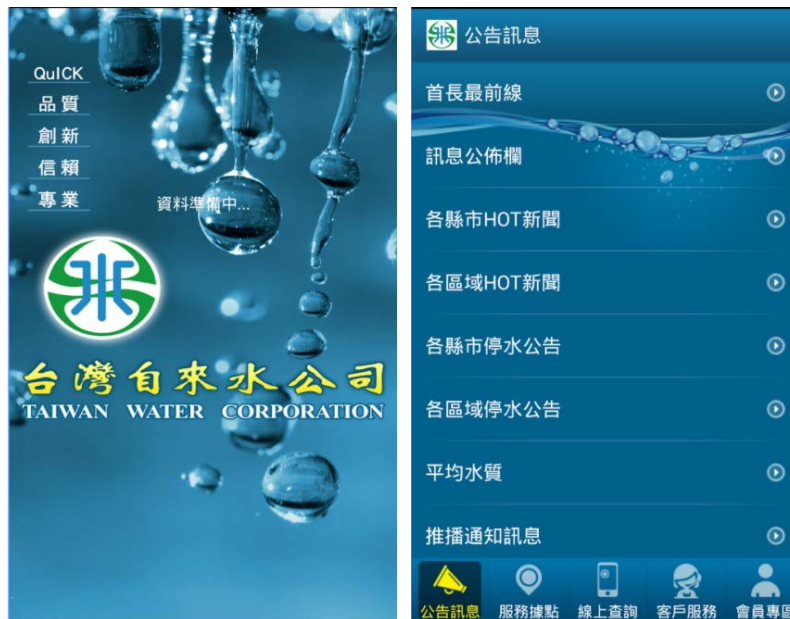
Fig.6 Mobile Water Housekeeper APP

- Daily regular press releases are available on TWC website for information on water and water supply stations.
- Provide free Mobile Water Housekeeper APP for query service (see Fig.6).
- Established FB to provide user for consultation platform.
- Toll-free hotline at 1910.
