# Seismic Evaluation and Retrofit of Existing Water Pipe Bridges in Taipei

## ABSTRACT

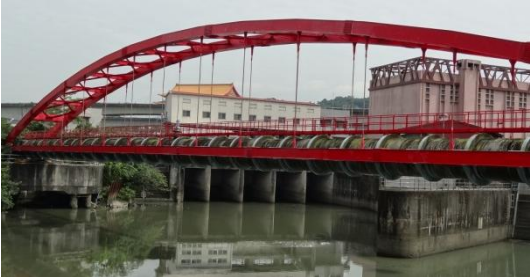
Yuanshan arch water pipe bridge

The four existing water pipe bridges are shown in Figure 1. Yuanshan water pipe bridge is single-span simply supported arch steel bridge having the total length of 100.6 m. It is supported and transversely connected on abutments. The abutments are supported on pile foundations, respectively. The pipe diameter is 2000mm. Yongfu water pipe bridge is multi-span simply supported arch steel bridge having the total length of 360 m with 3 equal spans of 80 m length. It is support on four-column bents, which are transversely connected by the bent cap. The bridge piers and abutments are supported on pile foundations. The pipe diameter is 2400mm. Hsintien water pipe bridge is multi-span simply supported arch steel bridge having the total length of 290 m with 3 equal spans of 80 m length. It is support on single pier type bents, which are transversely connected by the bent cap. The bridge piers and abutments are supported on pile foundations. The pipe diameter is 2400mm. Jiantan water pipe bridge is multi-span simply supported cable-stayed steel bridge having the total length of 140 m with main span of 72 m length. It is support on single pier type bents, which are transversely connected by the bent cap. The bridge piers and abutments are supported on pile foundations. The pipe diameter is 2000mm.

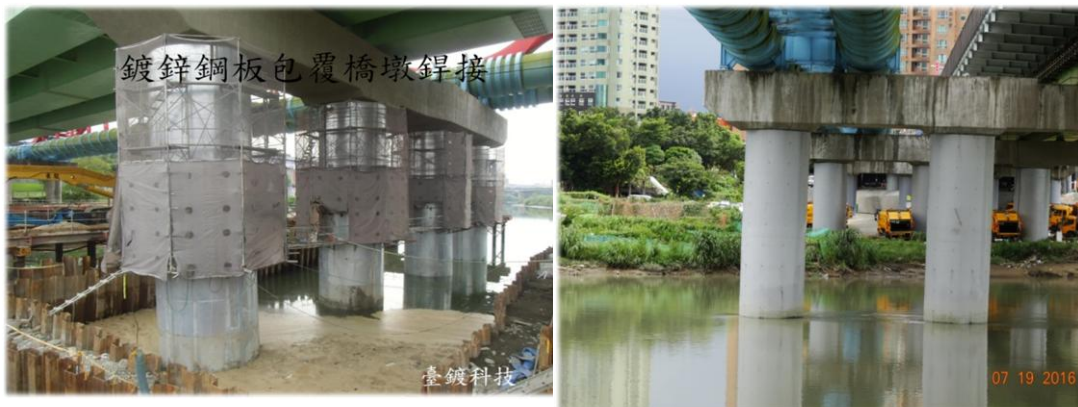
According to the seismic evaluation results of the existing water pipe bridges, the seismic capacity of Yongfu water pipe bridge in longitudinal direction fails to meet the seismic performance criteria. The piers of Yongfu water pipe bridge had been retrofitted by steel jacket for insufficiency of ductility, as shown in Figure 7.

Figure 7. The piers of Yongfu water pipe bridge with steel jacket

- **Pushover Analysis Results:**Yuanshan, Hsintien and Jiantan water pipe bridges have enough seismic capacity to satisfy the seismic performance criteria but the seismic capacity of Yongfu water pipe bridge in longitudinal direction fails to meet the seismic performance criteria. The piers of Yongfu water pipe bridge had been retrofitted by steel jacket for insufficiency of ductility.
