# Verification and evaluation method for the seismic performance of potable water mains lined with cured-in-place pipe (CIPP)

Hiromasa Ishizeki and Masakatsu Miyajima

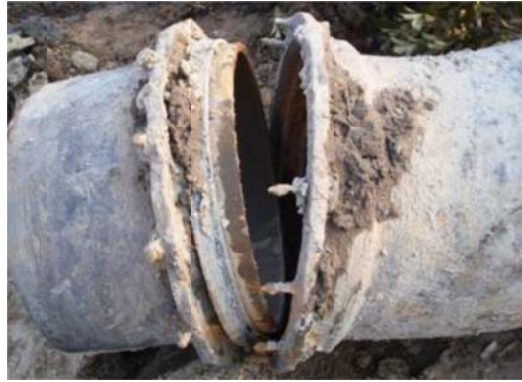
Figure 3. Joint pullout in a ductile iron pipe, [5]

Our research has also found that PALTEM CIPP survived in existing ductile iron pipes with conventional non-seismic-resistant joints. A research of Investigative Commission 2013 for Seismic Strengthening of Pipelines [4] over existing pipes has found that failure ratios of existing water pipelines were significantly higher for steel pipes with screwed joints, cast iron pipes (CIP) and ductile iron pipes (DIP) than for other types. The majority of failures were from joint pullout in ferrous pipes. An example of joint pullout in a DIP is shown in Figure 3.

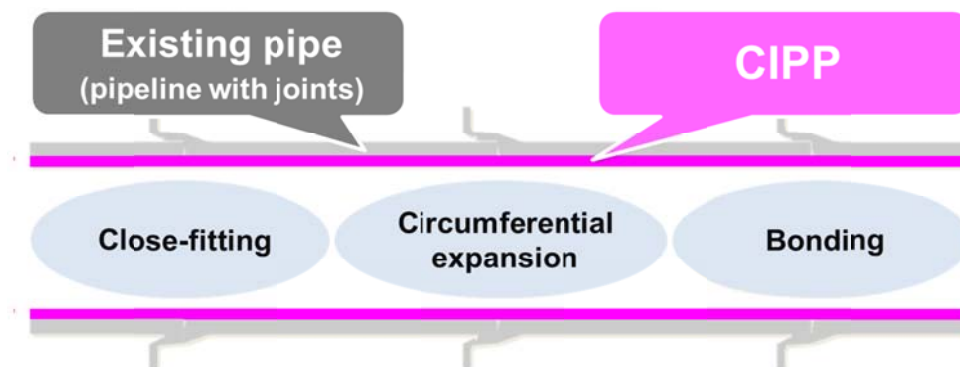
Figure 4. Three reinforcing effects of CIPP

CIPP's three characteristics related to pull-out resistance: close-fitting by inversion pressure, circumferential expansion by internal water pressure and bonding strength of epoxy resin are assumed to be the main causes for the non-displacement phenomena. Figure 4 illustrates a structure of a host pipe retrofitted with a CIPP and the reinforcing characteristics of CIPP.

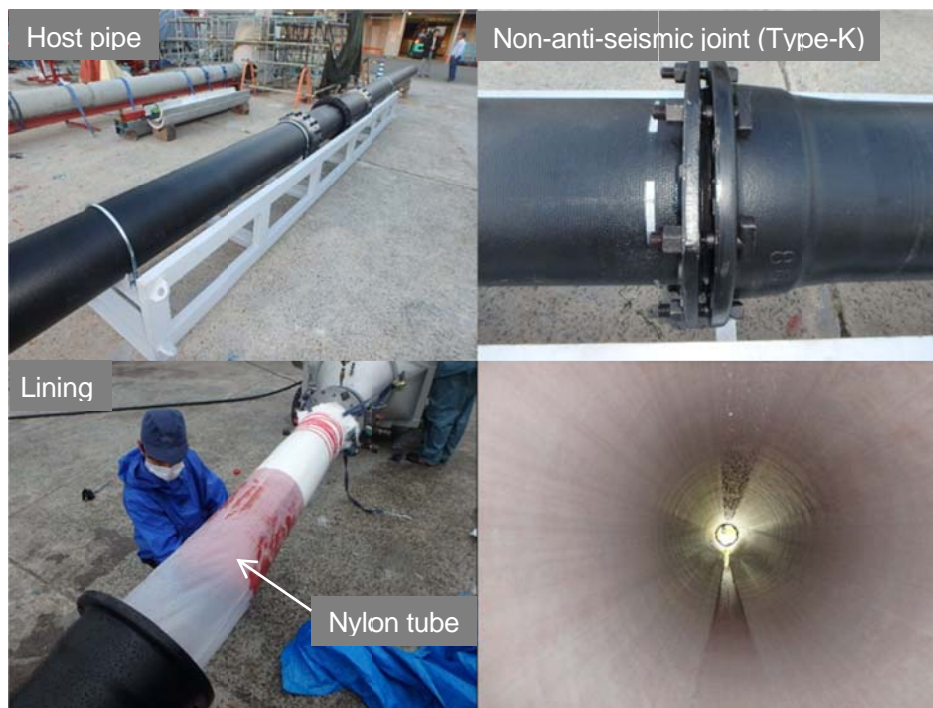
Figure 6. Stages of specimen preparation

- 1) A pair of ID 300 mm, L=6 m, mortar-lined ductile iron pipes were connected via non-anti-seismic joints.
- 2) A  $t=0.2$  mm nylon tube was inserted. This nylon tube was used in order to create the most severe condition by eliminate the bonding strength between the host pipe and the CIPP which, in an actual installation, depends on interior surface status such as quality of cleaning or roughness due to deterioration.
- 3) A DN 300 mm,  $t=4$  mm CIPP was installed through the two connected ductile iron pipes.

The stages of specimen preparation are shown in Figure 6 and the structure of the joint is illustrated in Figure 7.

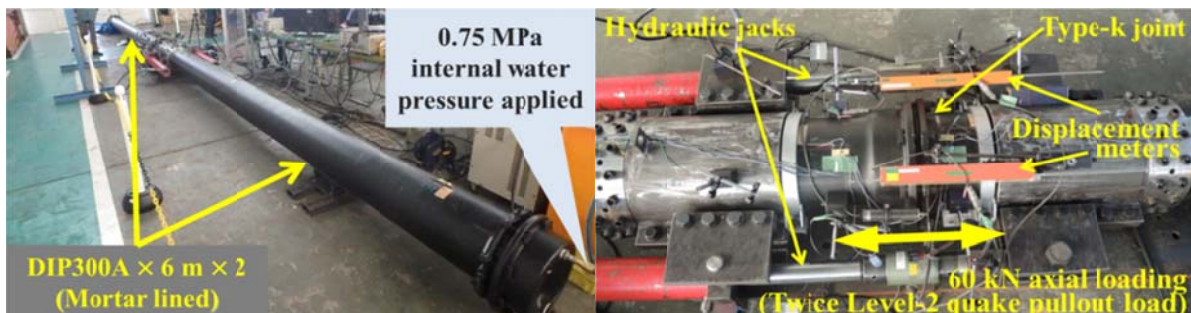
Figure 8. Experimental setup

The experimental setup is shown in Figure 8.

- 1) Joint displacement (pullout) was not observed even under the 60-kN load.
- 2) The load was then increased until joint displacement occurred, and approximately 400 kN was needed to cause joint displacement.
- 3) The CIPP inside the ductile iron pipeline did not suffer any damage nor showed any leakage through the entire experiment.

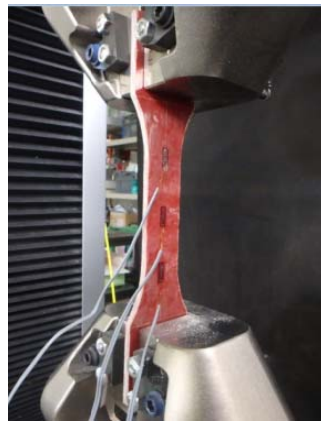
Figure 10. Setup of Level-1 cyclic strain test

In general, a stress level that leaves 0.2% strain is assumed as the yield stress for materials such as glass, concrete, plastic, and rubber. Hence, we decided that the result of the cyclic test showed a satisfactory margin of safety. In addition, the test pieces didn't show any reduction in strength after the cyclic test. The 0.6% strain maintains safety factor of 3 to the breaking stress of this CIPP material, which is approximately 2.0%. The test setup is shown in Figure 10 and Table 3 shows the results.
